Military Boeing 707 Strikes Birds After Liftoff; Damage to Engines No. 1 and No. 2 Results in Loss of Power and Impact with Terrain

FSF Editorial Staff

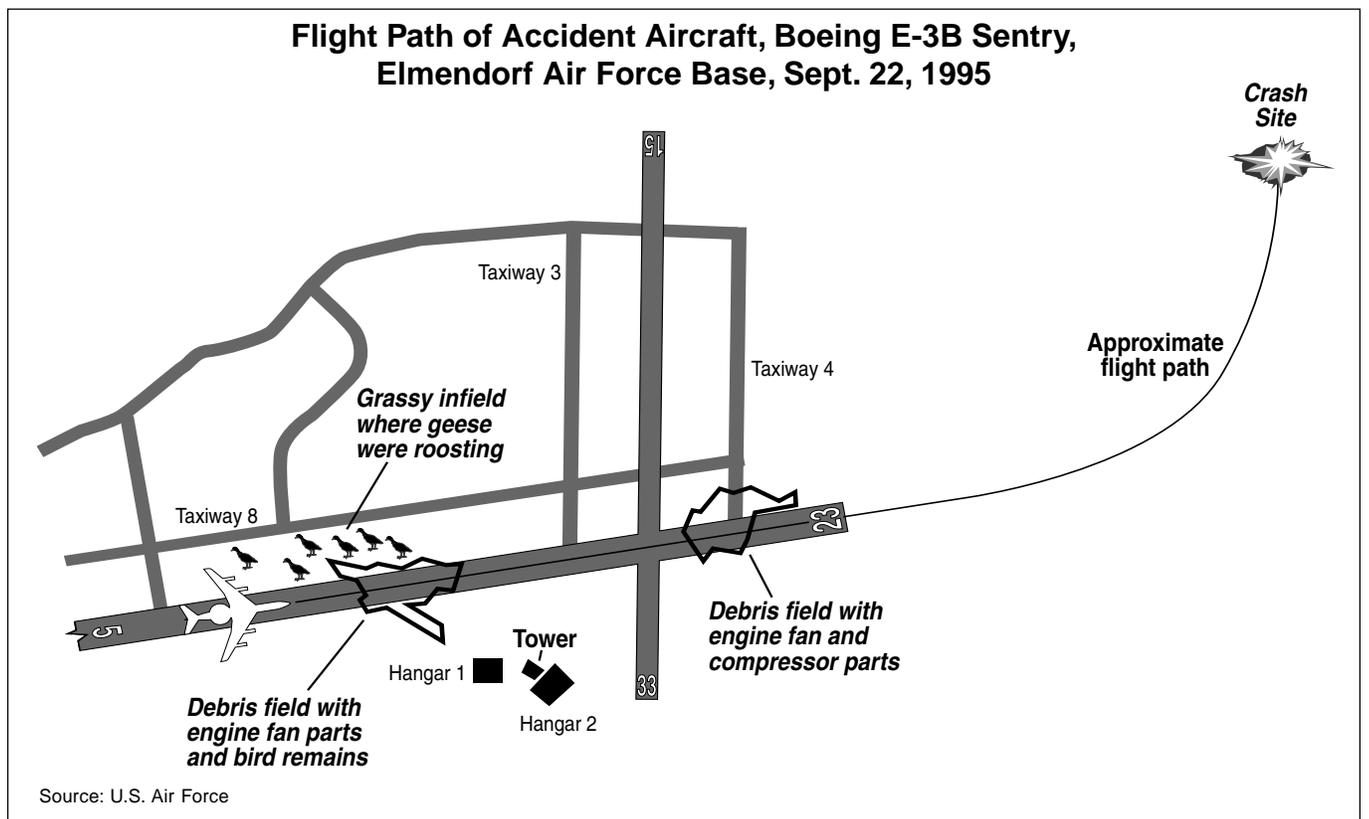
Figure 1

At 0747:11, the aircraft commander said, "We're going down," the report said. The aircraft impacted a hilly, wooded area on the base, less than 1.6 kilometers (one mile) from the departure end of the runway (Figure 1, page 3). The aircraft broke up, exploded and burned. All 24 crew members were killed in the accident.

Investigators reviewed the flight and wreckage path of the accident aircraft. “The [aircraft] lifted off and flew approximately [1.28 kilometers (0.8 mile)] before contacting trees,” the report said. “The [aircraft] then flew approximately [0.72 kilometer (0.45 mile)] before making contact with the ground and crashing in a fireball.”

The main ground-impact area began approximately 91.5 meters (300 feet) from the initial ground-impact point and extended approximately 45.7 meters (150 feet) to the peak of a hill, the report said.

The report described the wreckage path: “At approximately [96 meters (315 feet)] from the initial ground impact, there is a broken tree approximately [41 centimeters (16 inches)] in

diameter where the nacelle from the no. 2 engine impacted approximately [15 centimeters (six inches)] above ground level. Based on the patterns of fire damage, this tree caused significant structural breakup of the left wing.”
