## Anatomy of a Runway Collision

*When the captain relinquished his command authority to the first officer, a chain of events began that ended in tragedy.*

*John A. Pope  
Aviation Consultant*

### **ACCIDENT PREVENTION**

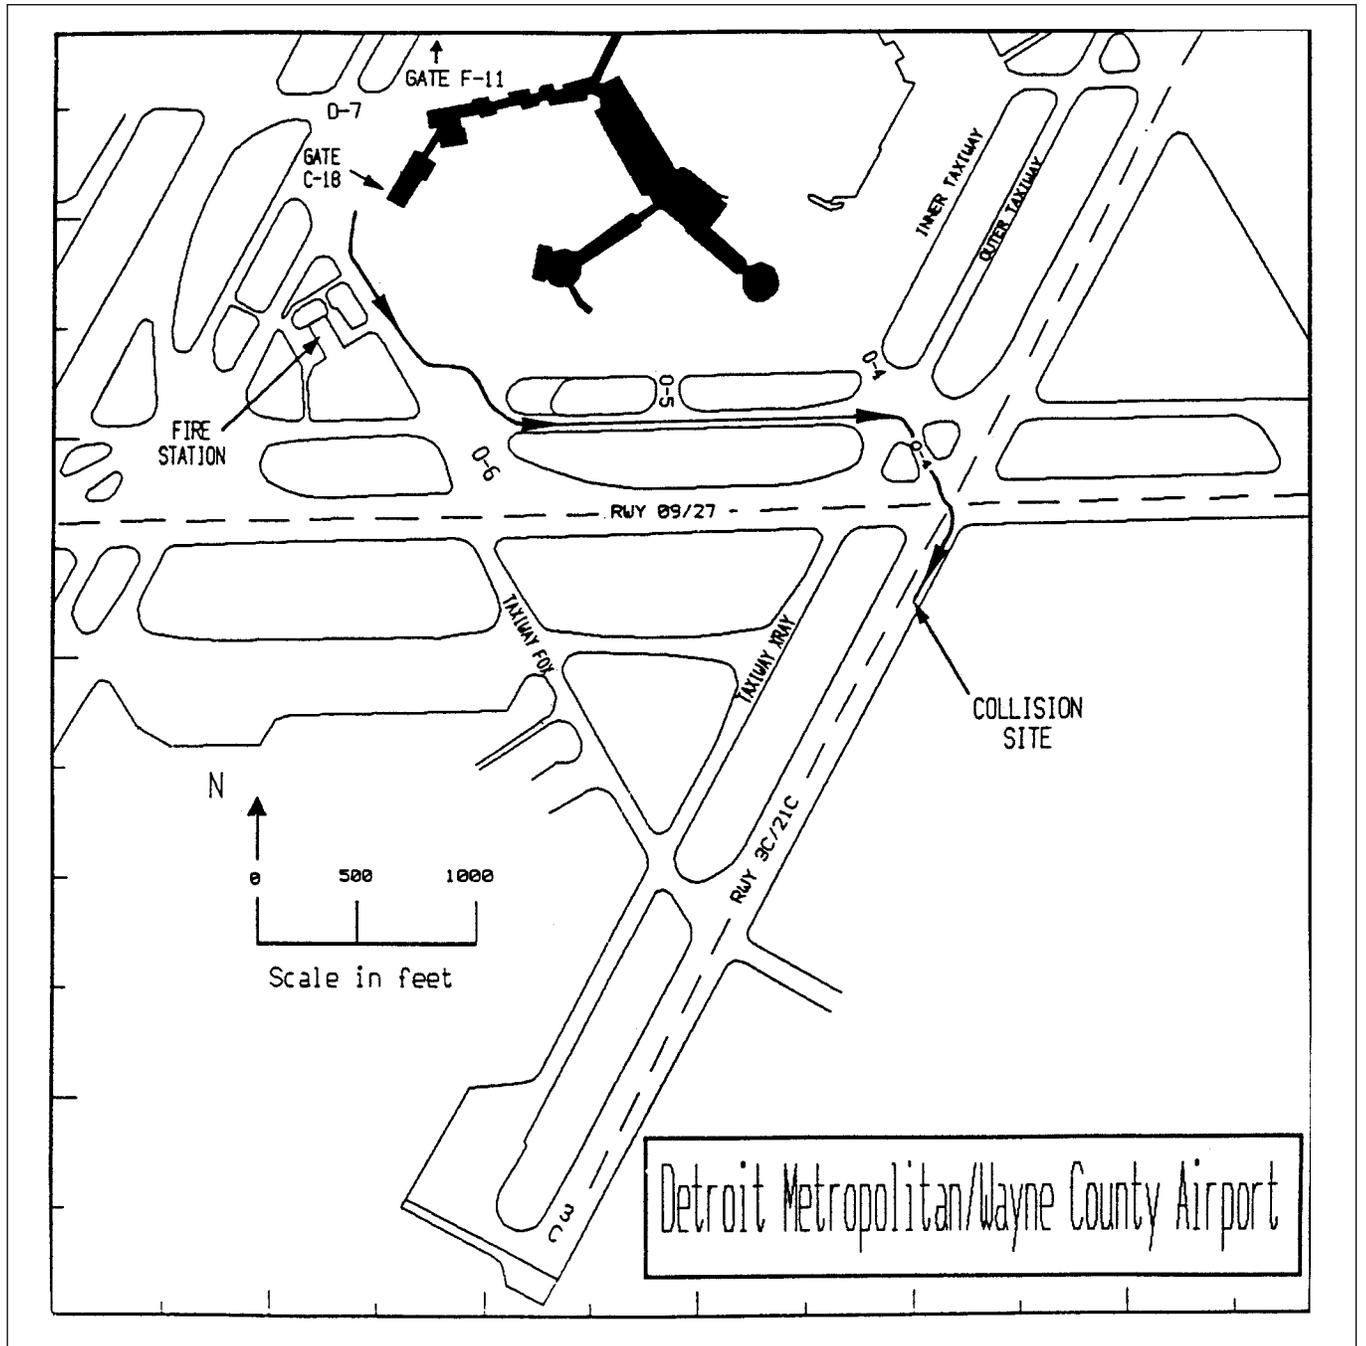
- At 1331, the first officer explained details concerning takeoff data for contaminated runways.
- At 1336, as they were initially searching for the yellow taxiway line, the first officer said, “Just kinda stay on the ramp here.” The captain replied, “Okay. Until the yellow line I guess, huh?” (This exchange, said the NTSB, may have been particularly significant since the airplane was never positioned on the taxiway centerline that paralleled the ramp area and led to the Oscar 6 taxiway entrance — Figure 1).

- Approximately 1338, as the incorrect decision to turn left at the Oscar 6 sign was being made, the captain asked a series of questions about which way to turn. The first officer appeared to convince himself about their location and then told the captain to turn left and that they were on Oscar 6. The airplane was actually on the outer taxiway.

Figure 1. Detroit Metropolitan/Wayne County (Metro) Airport layout and DC-9 taxi route.

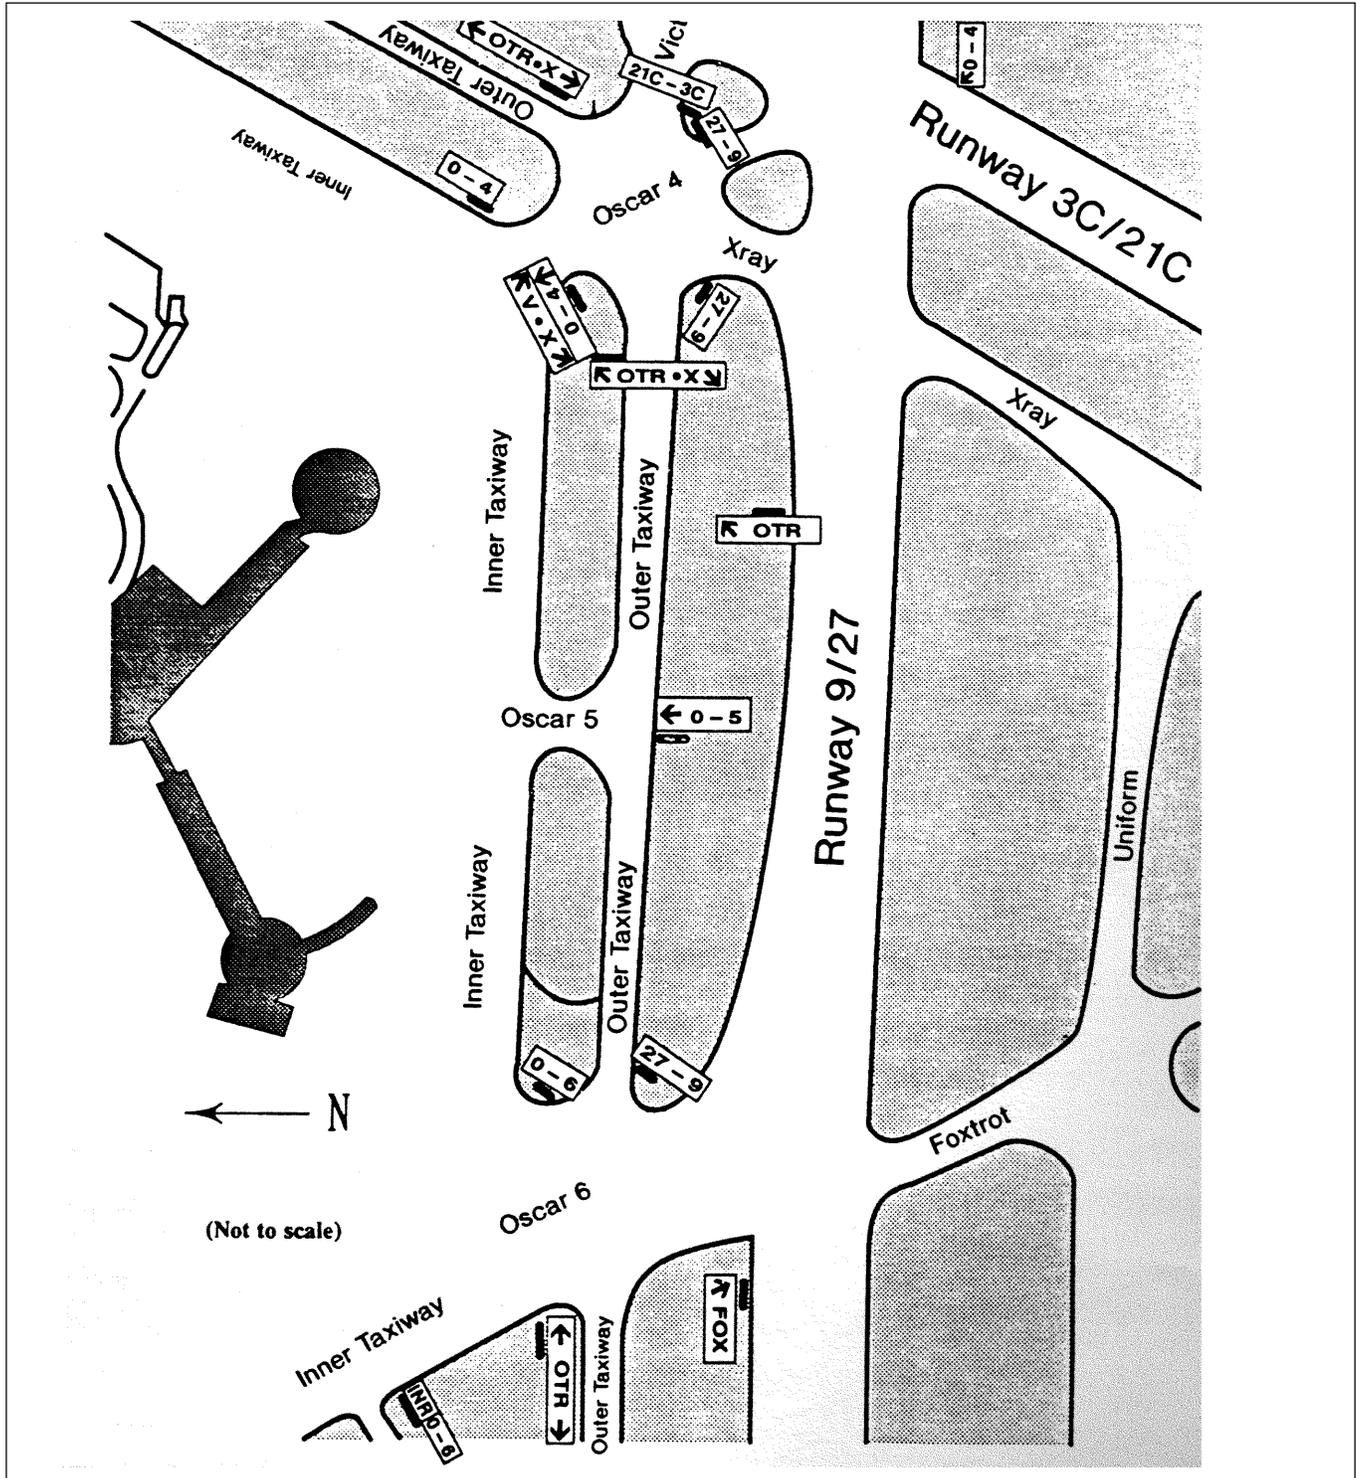
These statements, said the NTSB, should have made it evident to the captain that they were lost on the airport. “The arrows to Oscar 5” statement clearly referred to a taxiway identification sign (Figure 2), and taxiway 5 is not near taxiway Foxtrot. That should have prompted the captain to stop, determine his position and call for progressive taxi instructions (step-by-step routing directions).

Figure 2. Detroit Metro taxiway signs in the Oscar 4, Oscar 5 and Oscar 6 areas.
