## After Loud Bang, Captain Rejects Takeoff; DC-10 Runs Off End of Runway

*The accident raised crew-training issues and renewed concern about rejected takeoffs when runways are wet or contaminated by slush or snow, the official Canadian accident report said.*

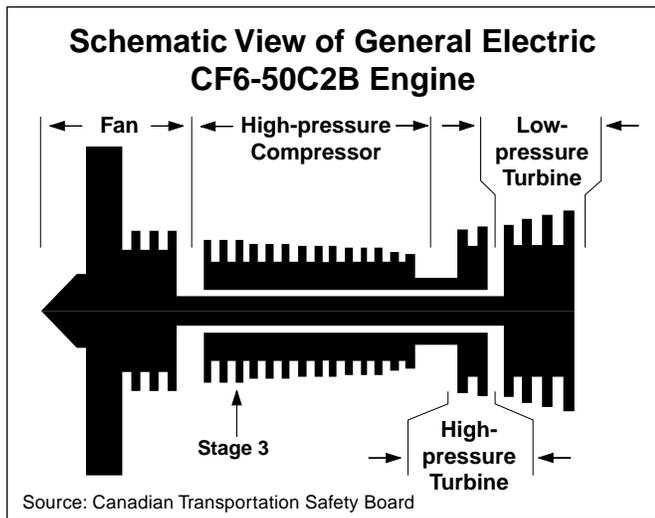
**Figure 2**

“The first notable blade damage was in stage 3 blades, mostly on the trailing edges,” the report said (Figure 2, page 4). “Stage 4 contained one blade that separated about 30 percent from the tip. The remaining stages of the compressor rotor showed nicks, tears and tip damage caused by hard-body impacts. The degree of damage diminished toward the aft stages of the high-pressure compressor, and final stages 12 through 14 showed light-to-moderate leading-edge and trailing-edge blade damage in the forms of nicks, tears and missing fragments caused by hard-body impacts.”

A detailed metallurgical examination of the high-pressure compressor blades “determined that there was fatigue damage to high-pressure compressor blades from stage 3 on,” the report said. But it added that a laboratory examination of the physical evidence “did not yield sufficient information to pinpoint the cause of the fatigue cracking [or] to estimate the crack-propagation rates.”

Investigators were not able to determine which compressor blade broke first, the report said. “It was also not possible to determine whether the compressor stall initiated the compressor-blade failures, or whether a blade failure initiated the events leading to the stall. Nevertheless, the gradual increase in EGT and fuel flow on [the No. 1] engine since Oct. 14, 1995 [as indicated in engine trend-monitoring data], and the stained and tarnished appearance of some fatigue-fracture surfaces of the compressor blades indicate that the damage to the compressor had built up gradually, and that, on the day of the occurrence, the combination of the compressor condition and the demand for power during takeoff created conditions that resulted in a compressor stall.”

The report said there was no evidence of foreign-object damage (FOD) to the stage 1 and stage 2 high-pressure compressor fan blades.
