FLIGHT SAFETY FOUNDATION

Accident Prevention

October 1998

MD-83 Crew Continues Flight Operations with Suspected Engine Malfunction

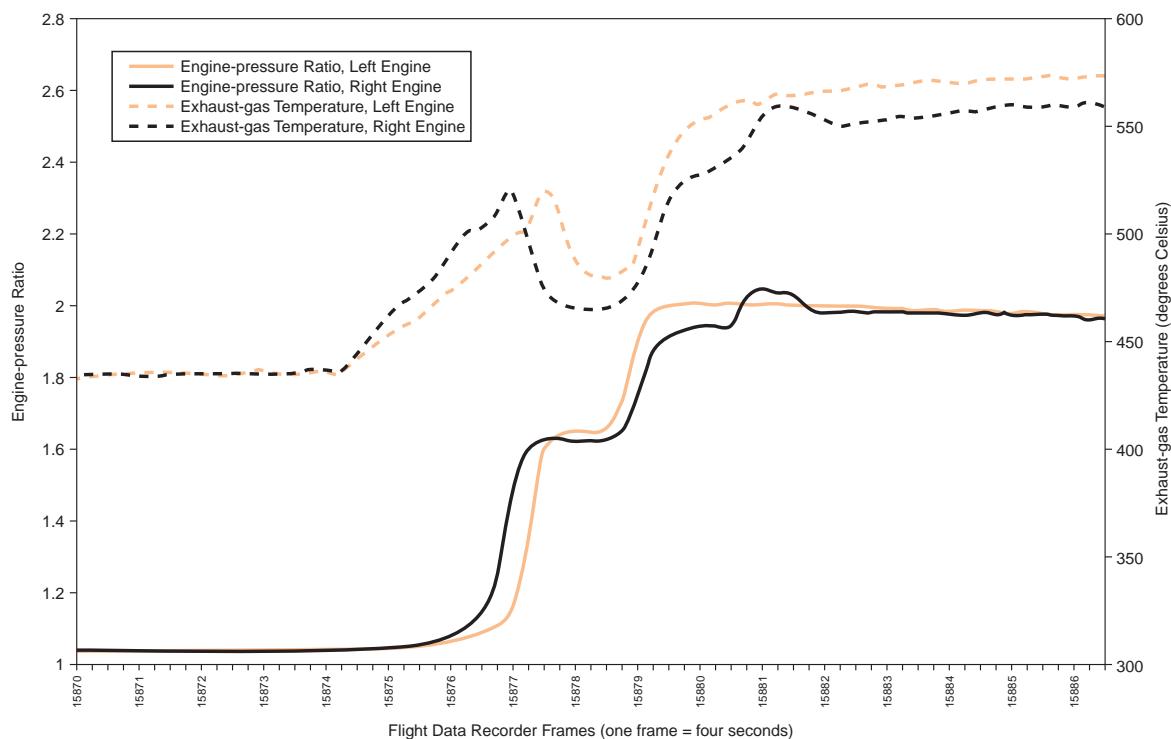
Figure 1

Figure 1, page 3, shows the engine-pressure ratio (EPR) values and the exhaust-gas temperature (EGT) values recorded by the airplane's flight data recorder (FDR) during the takeoff from Dalaman.

The FDR showed that when the crew advanced the power levers for takeoff, the left engine accelerated to 1.4 EPR two seconds more slowly than the right engine. The AIB said that the difference between the left-engine acceleration rate and the right-engine acceleration rate was within normal tolerances.

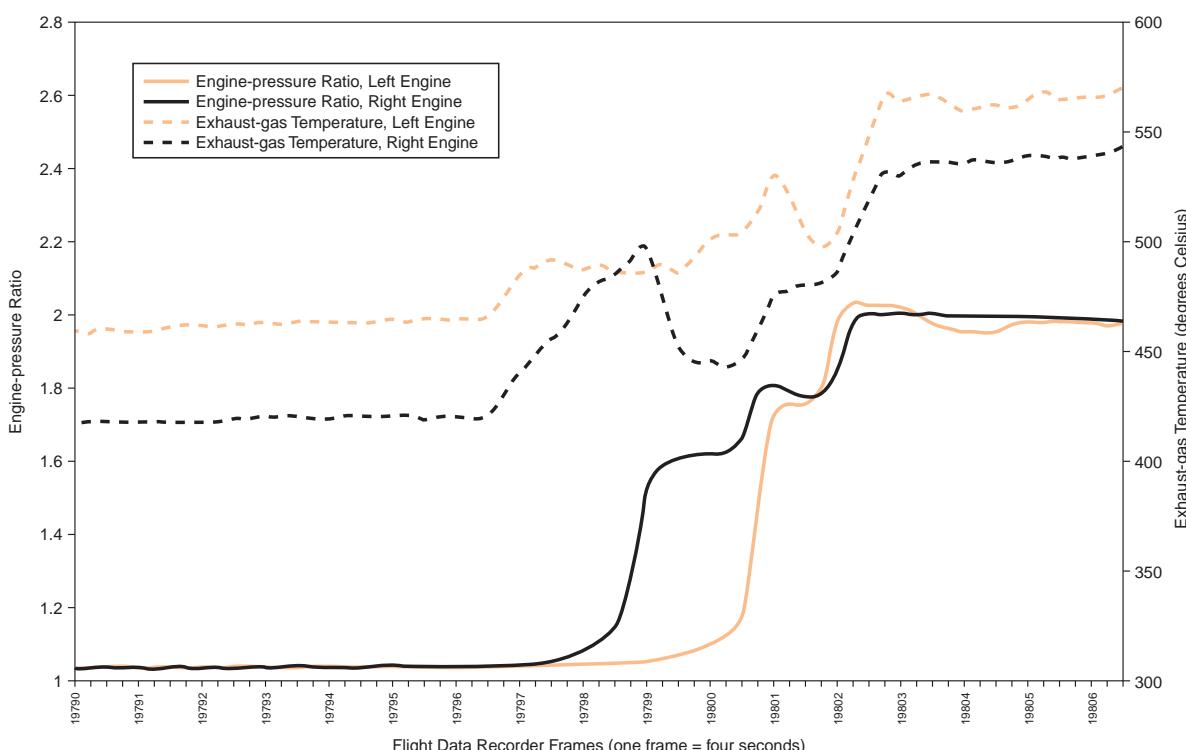
Figure 2

The FDR showed that left-engine acceleration was slower than right-engine acceleration during the takeoff (Figure 2).

"The left-engine acceleration rate from idle to 1.4 EPR was approximately eight seconds slower than the right-engine acceleration rate," said the AIB. "In Dalaman, the difference had been only two seconds."

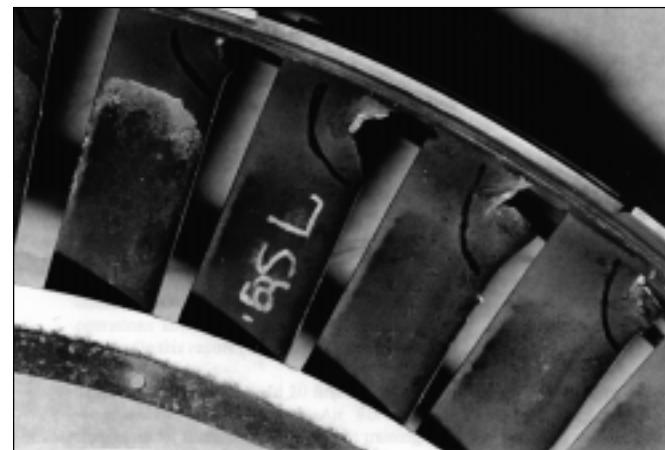
Further examination of the left engine showed that one rotor blade had separated from the eighth-stage compressor and had damaged the high-pressure compressor. The photo shows damage to left-engine seventh-stage compressor stators.

Left-engine seventh-stage-compressor stator damage. (Photo: Finnish Accident Investigation Board)

"[The] rotor blade had fractured from the root, and only the root piece was remaining in the [eighth-stage compressor] disk," said the AIB. "The liberated blade part had caused the compressor damage. The rotor blades were severely damaged in the leading and trailing edges. The blade tips had torn, and pieces were missing. Several blade roots had [a] rough surface, which looked like corrosion."

The AIB said that JT8D-200 series engines have a history of eighth-stage rotor-blade fractures, and that Pratt & Whitney had issued two service bulletins (SBs) regarding modifications of the rotor blades.

"[SB] 5881 had been incorporated for the left engine [of the incident airplane]," said the AIB. "The recommendations of SB 6044 had not yet been incorporated."

The AIB said that SB 5881, issued in 1990 after two rotor-blade failures, recommended making small "squealer" cuts in the blades to revise their natural frequency (resonance) and reduce blade-root stress.

The AIB said that SB 6044, issued in 1991 after 16 rotor-blade failures, recommended making larger squealer cuts to further improve blade resonance and reduce blade-root stress.
