## Uncontained Disk Failure in Right Engine of DC-9 During Initial Takeoff Run Results in Rejected Takeoff and Aircraft Evacuation

*U.S. National Transportation Safety Board investigators determined that the Turkish maintenance station that had last inspected the compressor disk had overlooked a detectable flaw that caused the disk to fragment.*

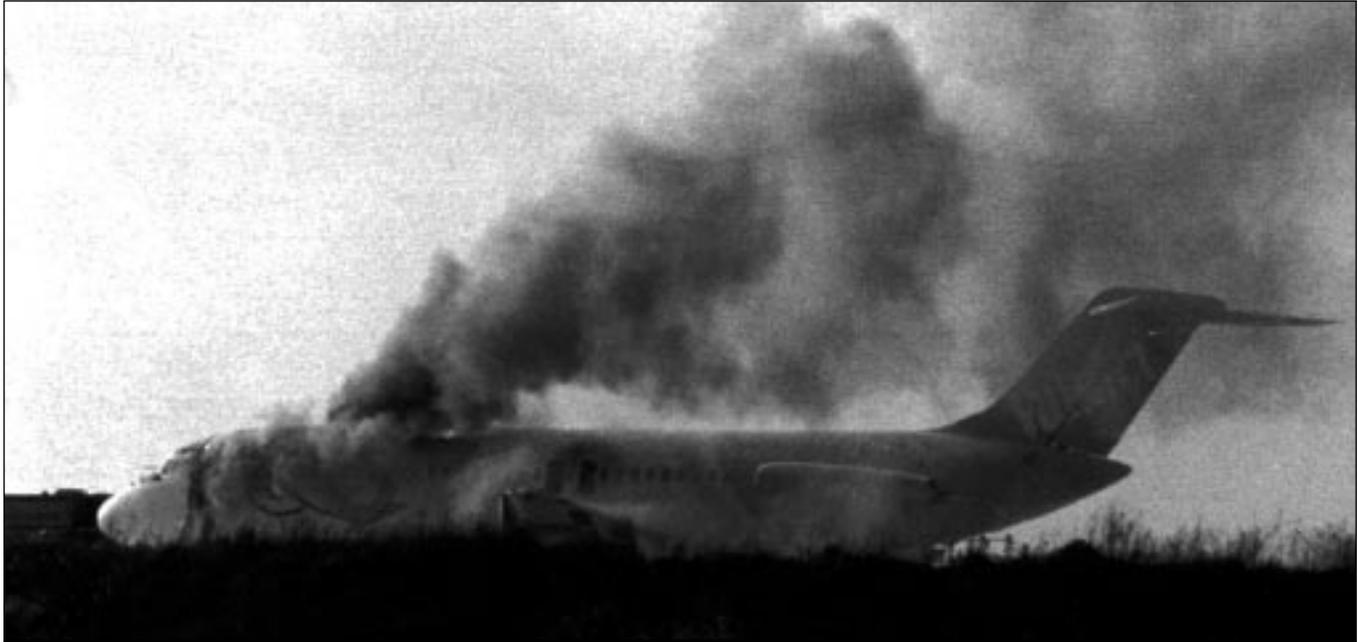
*All crew members and passengers successfully evacuated ValuJet Flight 597, a DC-9 that was destroyed by fire after an engine failure during takeoff roll.*

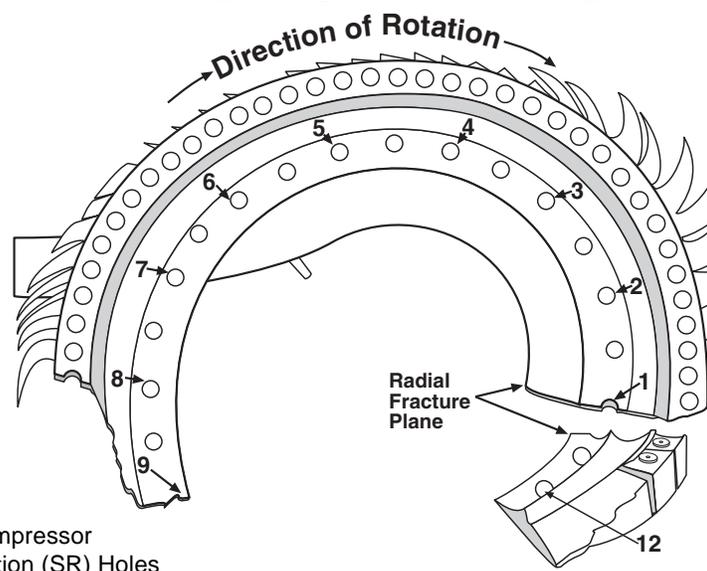
**Figure 1**

Investigators were able to recover only two pieces of the fractured seventh-stage HPC disk (Figure 1), and a substantial portion of the disk was not recovered, the report said. “One piece, about half of the disk, was found resting on the accessory gear box, visible through the circumferential tear in the cowling,” the report said. “The seventh-stage compressor blades retained in the disk were bent opposite the direction of rotation.”

**View Looking Forward of the Recovered Portion of the Seventh-stage HPC Disk From the Right Engine of ValuJet Flight 597**

A metallurgical examination of the failed right-engine seventh-stage HPC disk revealed fatigue cracking in the vicinity of one of the disk’s stress-reduction (SR) holes. “Although the fracture

was heavily damaged, analysis of fatigue striation measurements ... indicated that a crack of about 12 millimeters (approximately one-half inch) existed in the disk at the last reported overhaul in 1991 ... . Thus, the [NTSB] concludes that a detectable crack existed ... when the disk was overhauled by THY in 1991, and [was] therefore detectable by FMPI [fluorescent magnetic particle inspection] or MPI [magnetic particle inspection].”

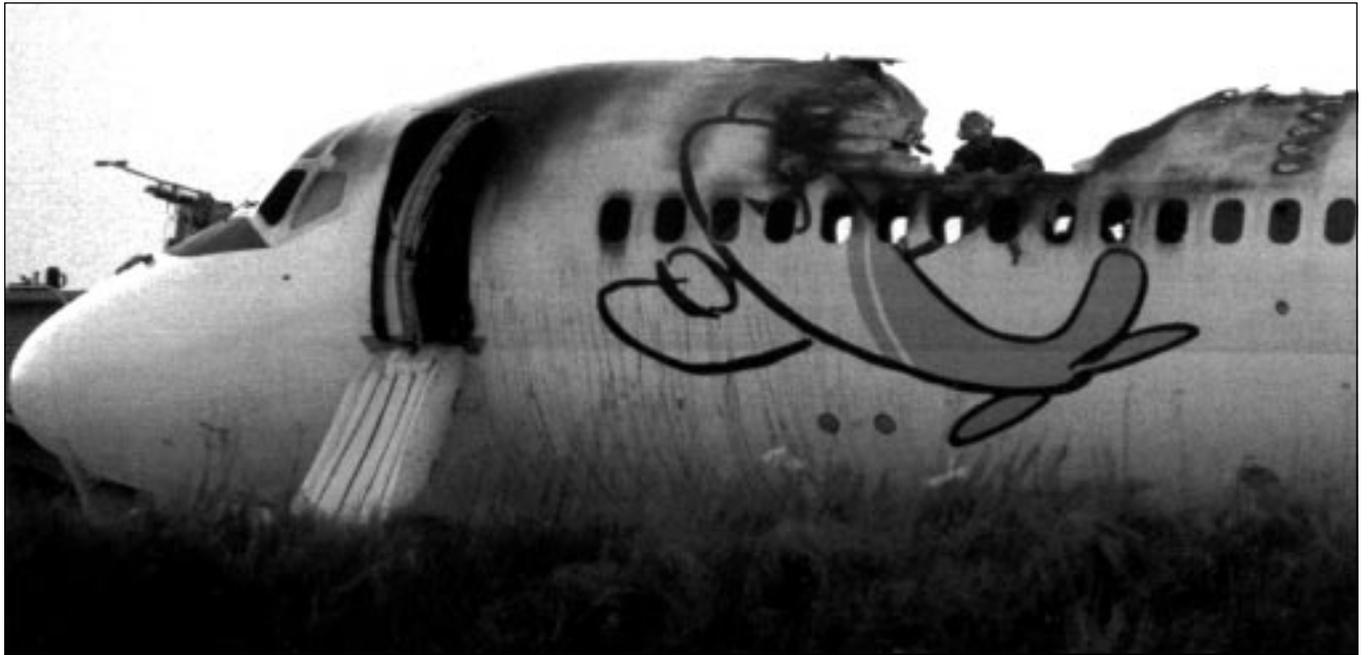
*The NTSB said that passengers did not follow prescribed evacuation procedures, but noted that the 57 persons aboard ValuJet Flight 597 had evacuated the aircraft by the time fire trucks reached the burning DC-9.*
