FLIGHT SAFETY FOUNDATION

MAY-JUNE 1998

# FLIGHT SAFETY

## Boeing 757 CFIT Accident at Cali, Colombia, Becomes Focus of Lessons Learned

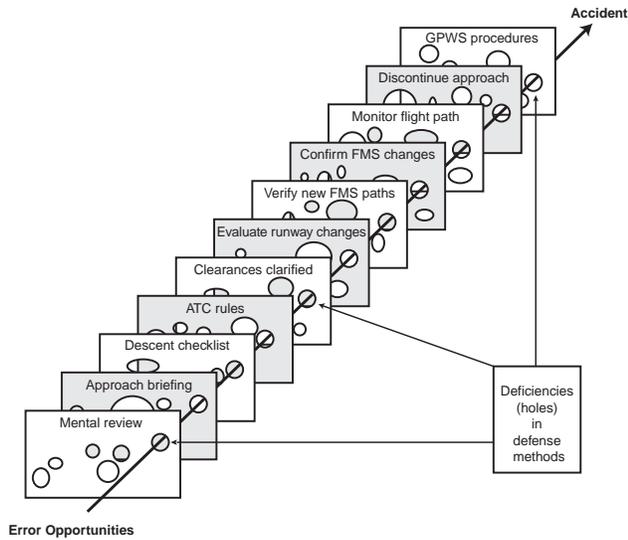
**Figure 3**

These strategies are defenses against a potential CFIT accident. Figure 3 (page 19), which is adapted from an accident-causation model developed by James Reason, illustrates these defenses. These defenses, however, are not perfect and may contain some deficiencies — shown as holes in Figure 3. For this reason, it is important for airlines to improve continually each of these defenses through training. This action will reduce the deficiencies and begin to close the holes.

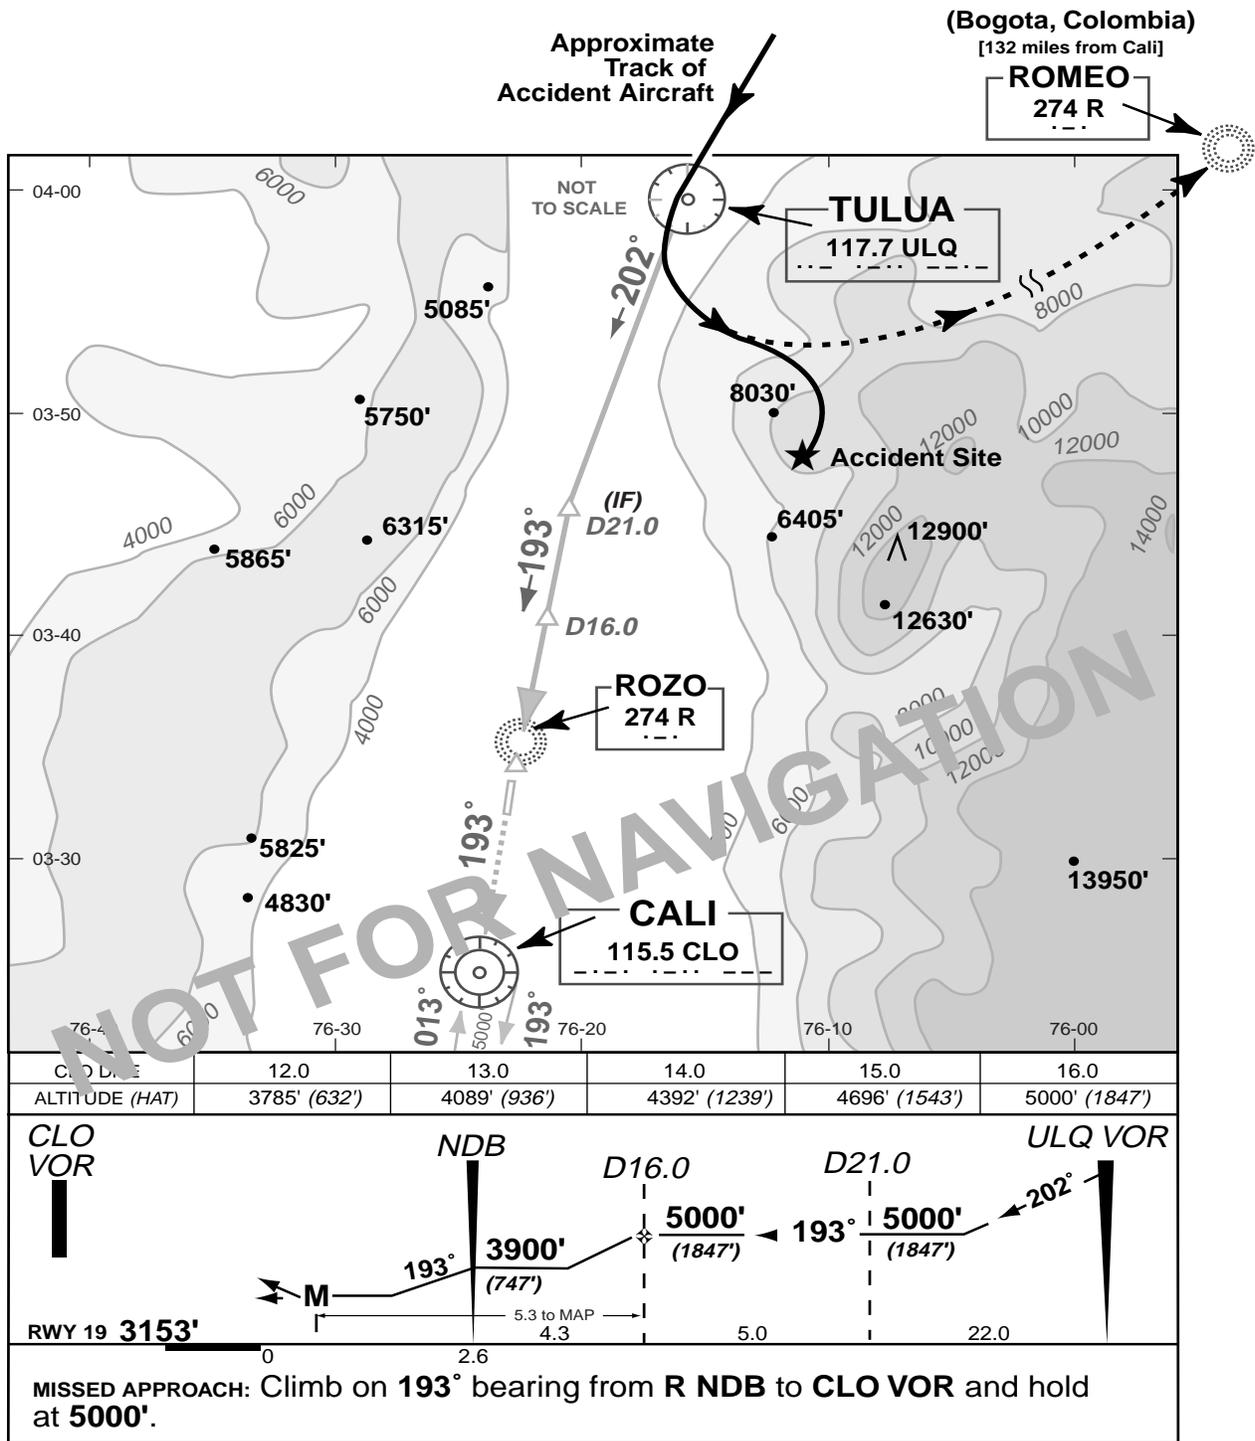
# Approximate Track of Flight 965, Cali, Colombia, on Dec. 20, 1995

An effective briefing should include both nominal and non-nominal items, and should specifically invite feedback from the other crewmember. At Cali, the briefing should have included the previously mentioned approach conditions as well as the planned crossing altitudes and airspeeds over the Cali VOR for the expected instrument landing system (ILS) approach to Runway 01, and over the Tulua VOR for the possibility of a VOR DME [distance-measuring equipment] approach to Runway 19. The VOR DME approach procedure and the aircraft’s approximate track are shown in Figure 1.
