# **AIRCRAFT ACCIDENT REPORT**

**North Central Airlines, Inc.  
McDonnell Douglas DC-9-31, N954N  
and**

**Delta Air Lines, Inc.  
Convair CV-880, N8807E  
O'Hare International Airport**

**Report Number: NTSB-AAR-73-15**

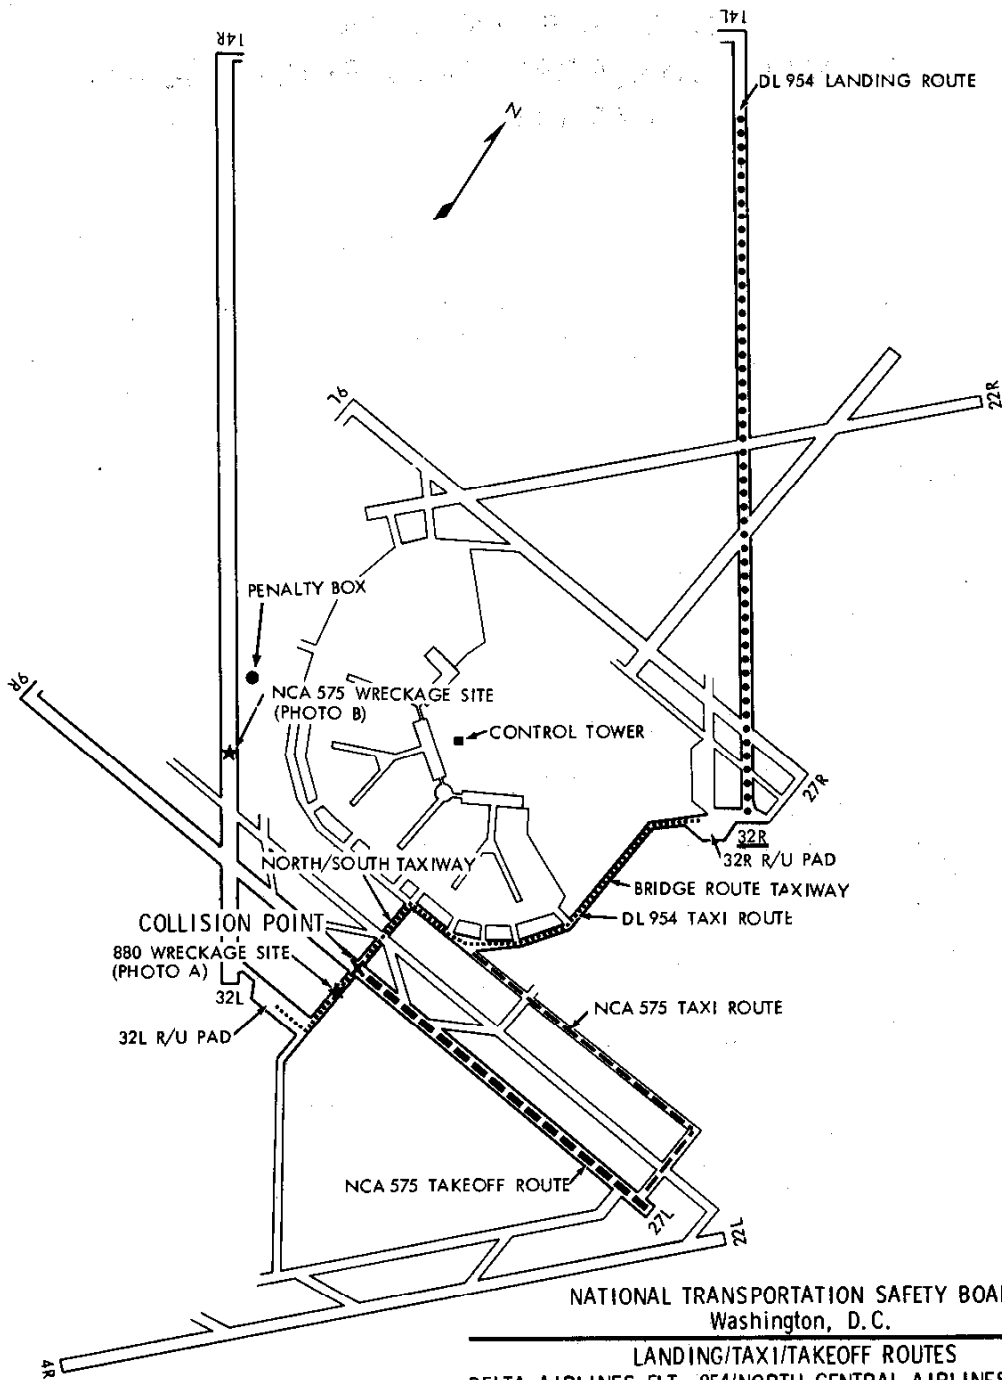
LANDING/TAXI/TAKEOFF ROUTES  
DELTA AIRLINES FLT. 954/NORTH CENTRAL AIRLINES FLT. 575  
CONVAIR 880 N8807E/McDONNELL DOUGLAS DC-9-31 N954N  
Collision at Chicago-O'Hare International Airport  
December 20, 1972
