**AIRCRAFT SERIOUS INCIDENT REPORT**  
**OCCURRENCE NUMBER 00/2518**  
**B767-319ER**  
**ZK-NCJ**

**NZ 60**  
***'ERRONEOUS'* GLIDESLOPE CAPTURE,**  
**AUTOCOUPLED APPROACH,**  
**AND GO-AROUND**

**FALEOLO AIRPORT, SAMOA**  
**29 JULY 2000**

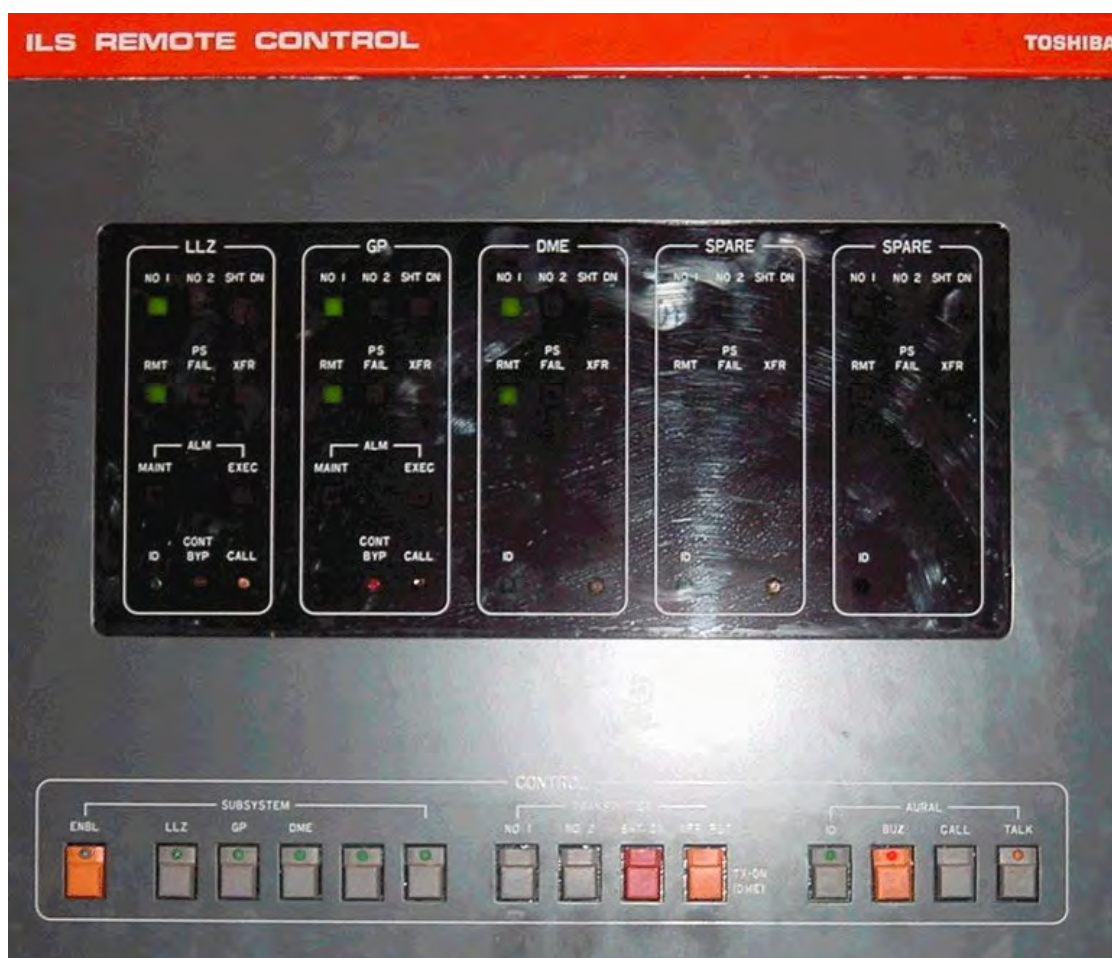
### **ILS remote control at Faleolo—Situated at the base of the tower**

A tower 'monitor', as it is often referred to, is specified in ICAO Annex 10 as a remote control and indicator and indicates the operational status of the respective navigation aid to the controller. The remote indicator is usually simple, e.g. a green light for a normally operating system and a red light for a failed system. To reset the ILS system (in the case of Auckland) the tower staff selects the other runway and then reselects the ILS to the desired runway. Once the equipment is transmitting, the equipment (field) monitors are the sole arbiters of determining whether the equipment should remain transmitting. In the Faleolo tower only the status of the ILS is displayed and no selections are possible other than to silence the audible alarm. At the base of the Faleolo tower is the ILS remote control. This panel is the communication point for the LLZ and GP. It shows the transmitters selected, remotely (at this panel) or local (at the LLZ or GP hut on the field), any maintenance or executive alarms, transmitter transfer or shut downs, and if the equipment is in control bypass, i.e. the executive monitor is **NOT** in control.

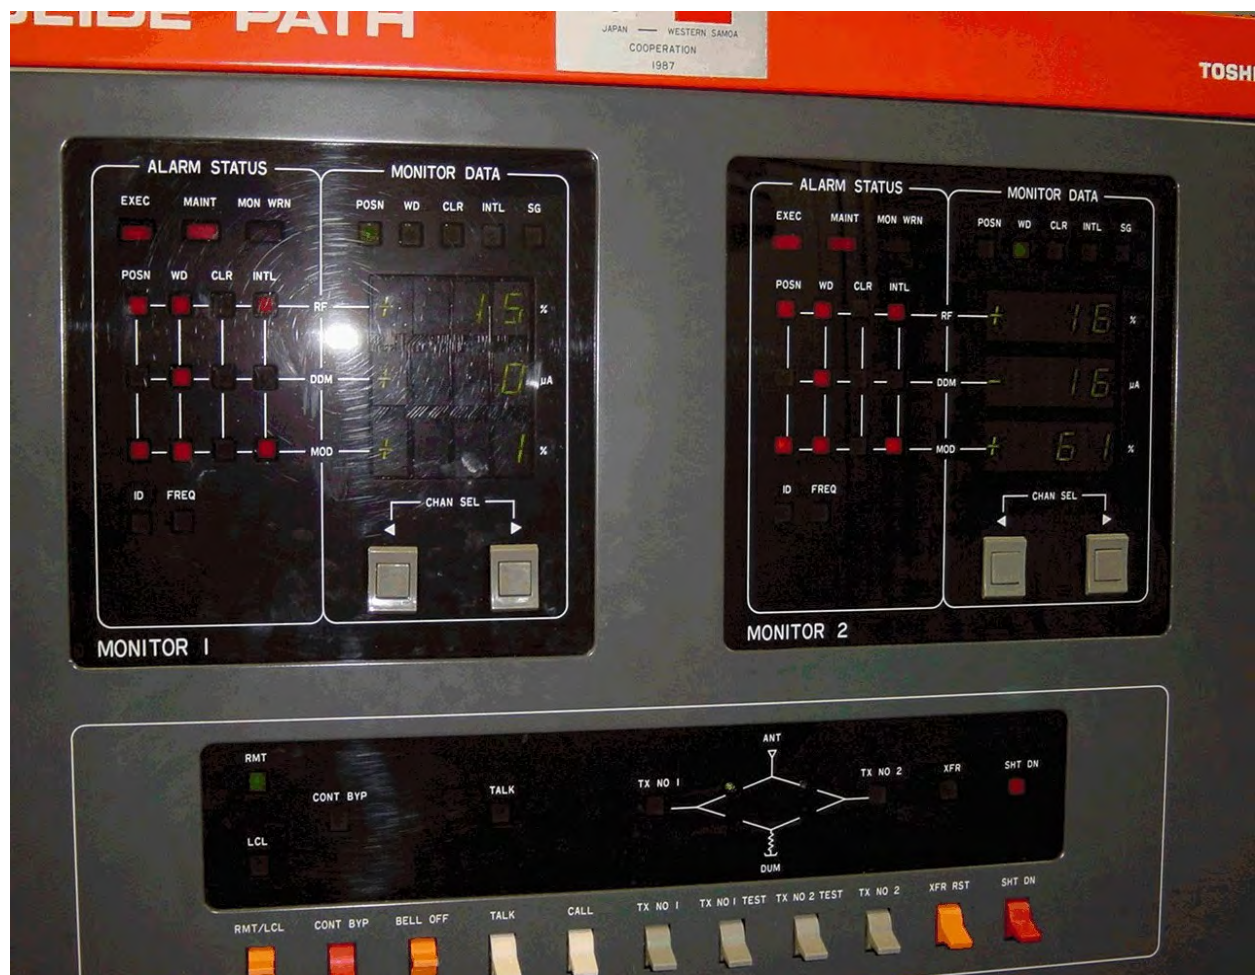
**Glide Path monitors and control panel in the GP equipment shelter on the field at Faleolo**

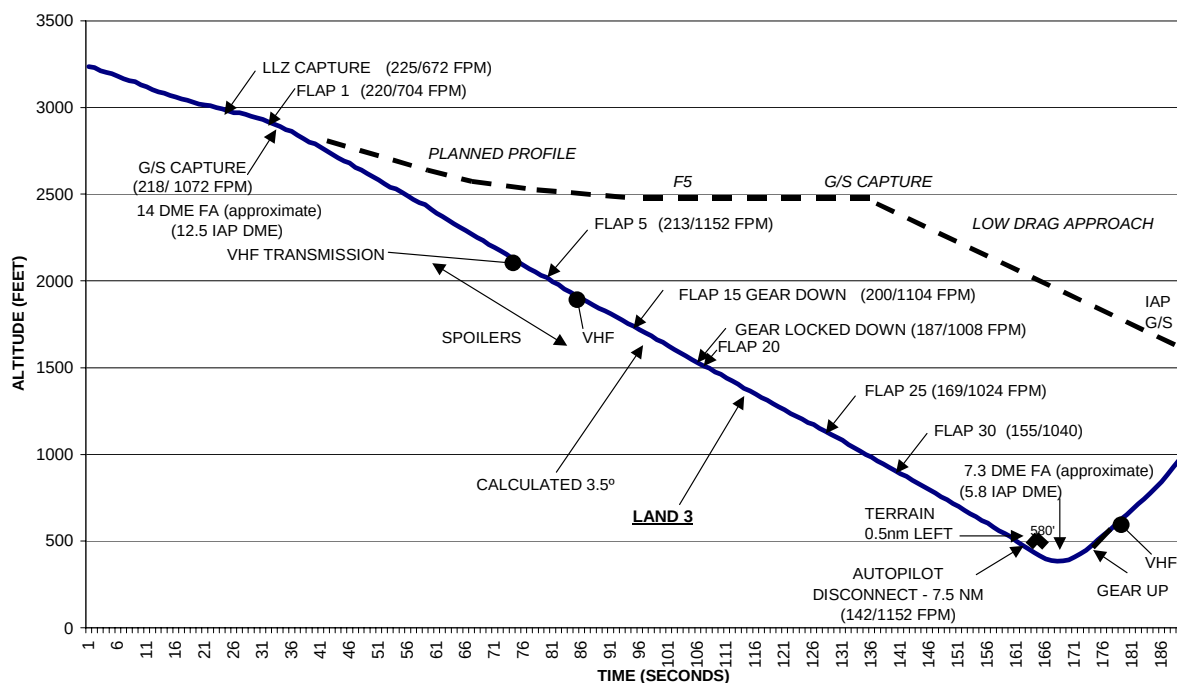
### **NZ 60 Profile - First Approach Apia**

Analysis of the profile for the first approach revealed a subtle steepening of the approach angle from approximately 3.3°, at 'glideslope' capture, to 4.3° prior to the commencement of the missed approach. This would account for the steady rate-of-descent despite the reducing ground speed.

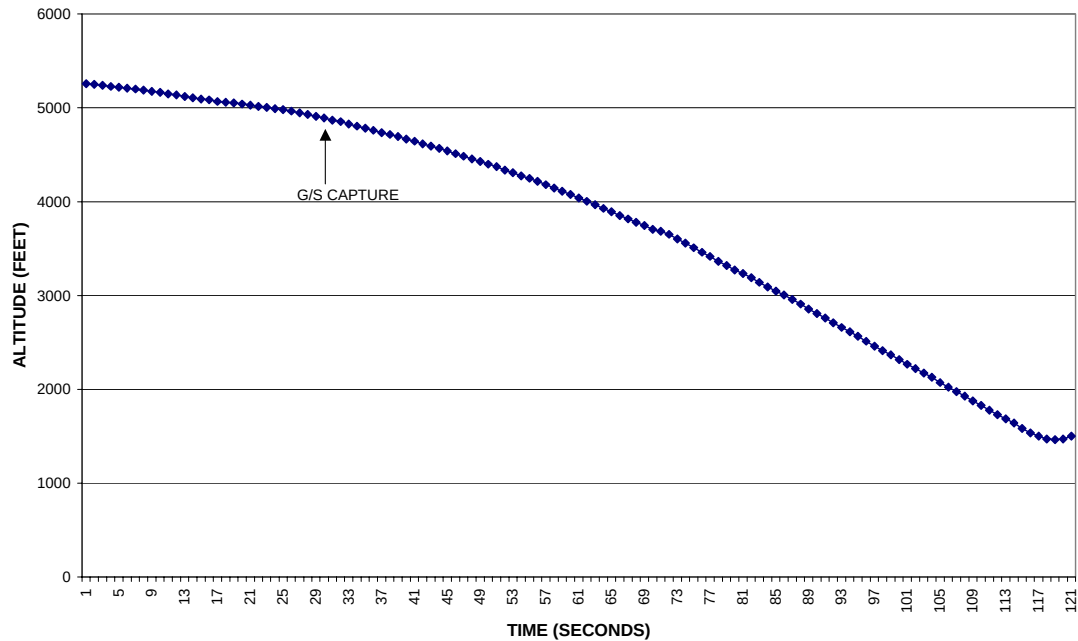
### Proving Flight Two – Profile One

The automatics captured the ‘glideslope’ as expected. In apparent response to the fly down signal, the aircraft continuously pitched down on a steepening approach that commenced at approximately  $3.5^\circ$  and reached  $8.5^\circ$  toward the end. ROD increased throughout the approach from 1200 fpm to 3000 fpm. Despite the deployment of speedbrakes and extension of landing gear, the aircraft could not be slowed and configured for landing.

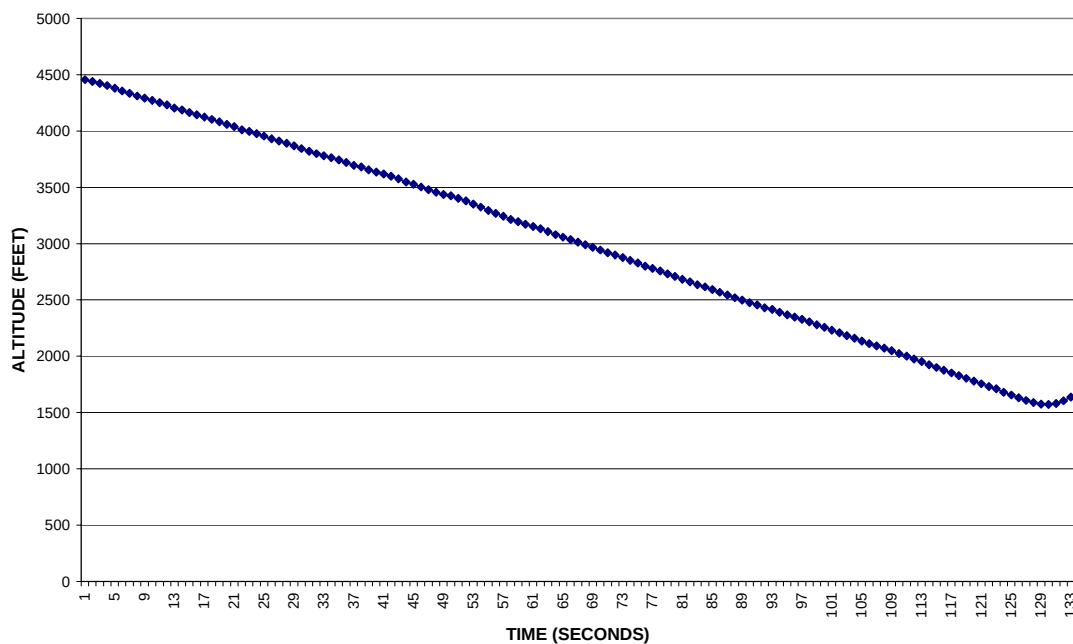
### Proving Flight Two – Profile Two

Having verified the hypothesis with respect to the plus and minus DDM values, this profile was expected to closely replicate the profile encountered by the crew at Faleolo. This was achieved with a reasonably constant ROD of 1200 fpm. Speedbrakes were deployed and landing gear extended early to slow the aircraft, with landing configuration being reached some 2700 ft after glideslope capture. Analysis of the glideslope angle revealed an angle of 3° at glideslope capture increasing to over 6.5° at the bottom. The steeper angle of this approach was most likely attributable to the fly down signal being slightly greater than that encountered at Faleolo.
