NATIONAL TRANSPORTATION SAFETY BOARD

AIRCRAFT ACCIDENT REPORT

**CHINA AIRLINES BOEING 747-SP, N4522V
300 NAUTICAL MILES NORTHWEST OF
SAN FRANCISCO, CALIFORNIA
FEBRUARY 19, 1985**

NTSB/AAR-86/03

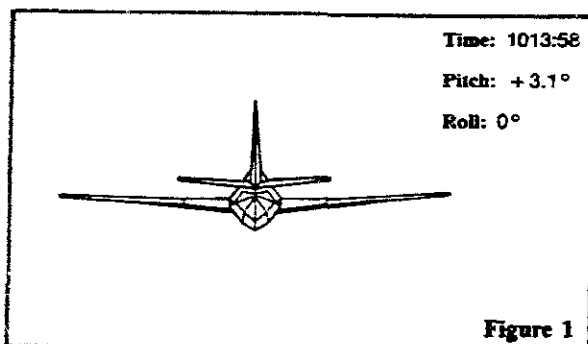
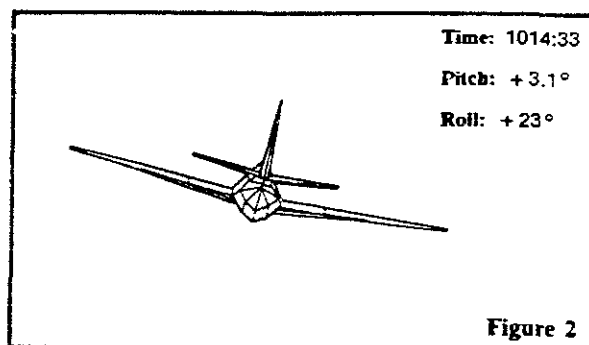
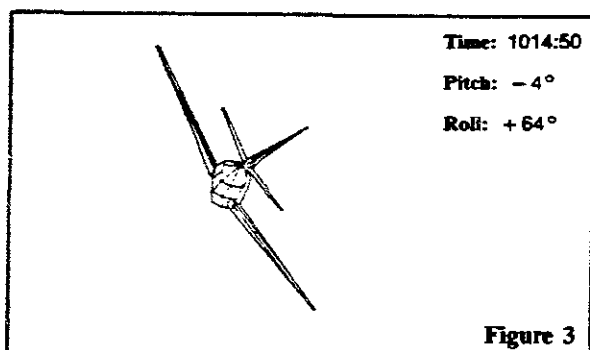
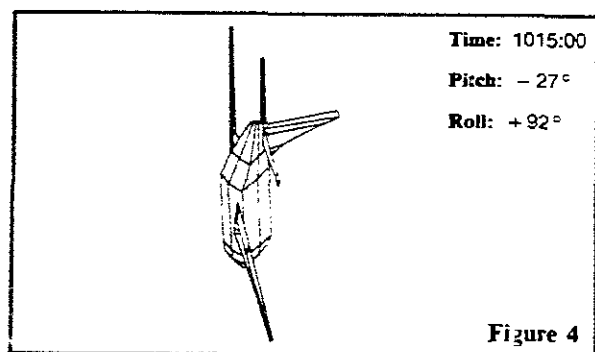
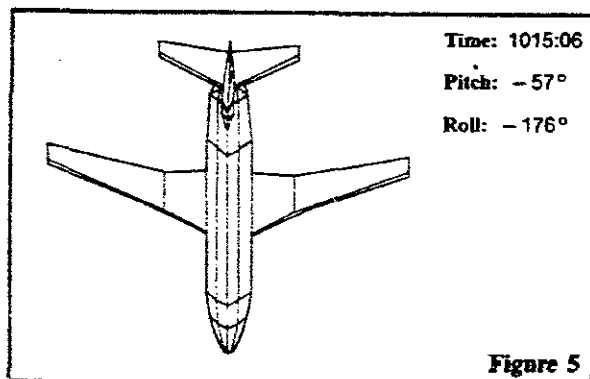
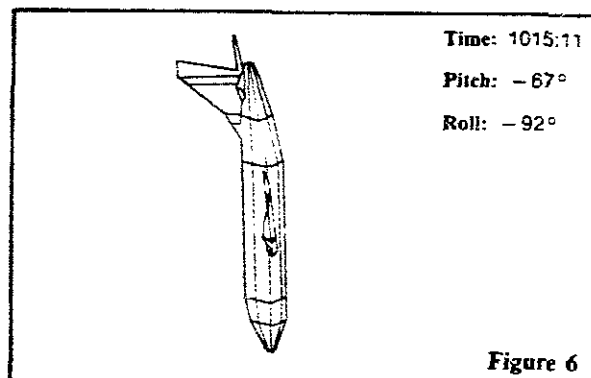
Figures 1.--Excerpts from Computer Animation.

At 1011:10, after the airspeed had decreased to about 251 KIAS, the EPRs on engines 1, 2, and 3 began increasing and, by about 1011:30, they had reached about 1.5 EPR. (At 41,000 feet, 0.85M, and with two air conditioning packs operating, the "max cruise" EPR limit is 1.543 EPR.) Thereafter, these three EPRs remained at about 1.5 until shortly after the start of the upset. During this period, the No. 4 engine's EPR

increased from 0.9 to about 1.02 and remained fairly constant at that reading until 1012:06. Between 1012:06 and 1012:41, the No. 4 EPR increased slightly to about 1.35.

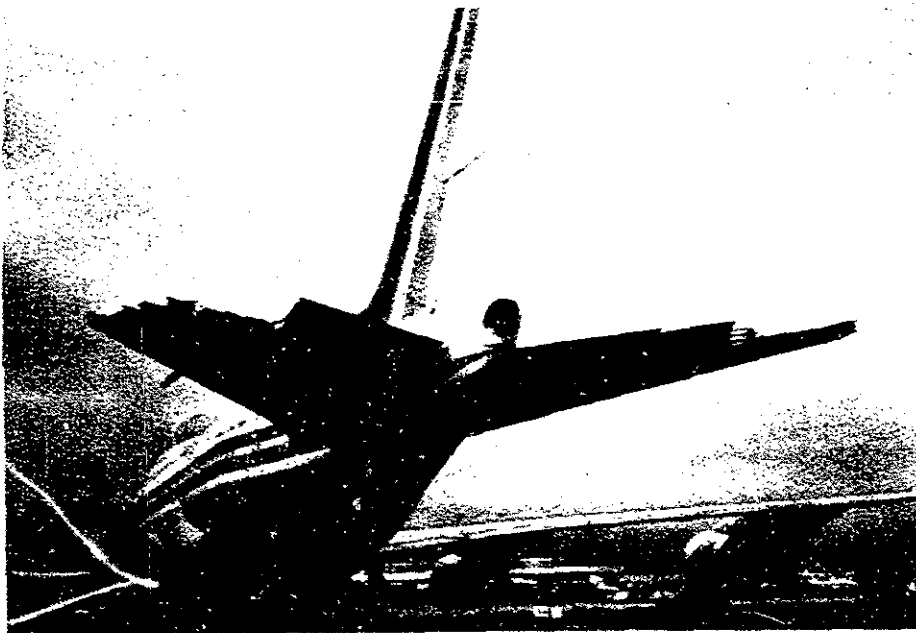
Figure 8.—Photograph of Empennage.

Empennage.--The major damage to the empennage was limited to the Auxiliary Power Unit (APU) compartment, the horizontal stabilizers, and elevators. The APU had separated from its mounts and was resting on the two lower tail cone access doors. The forward side of the APU fire bulkhead appeared to be deflected forward in the area adjacent to the two lower attachment fittings and the two lower support rods had buckled. In the area of the APU, there were several punctures in an outward direction on both sides of the tail cone.
