# AIRCRAFT ACCIDENT REPORT

PAN AMERICAN WORLD AIRWAYS  
BOEING 747, N 737 PA

KLM ROYAL DUTCH AIRLINES  
BOEING 747, PH-BUF

HUMAN FACTORS REPORT

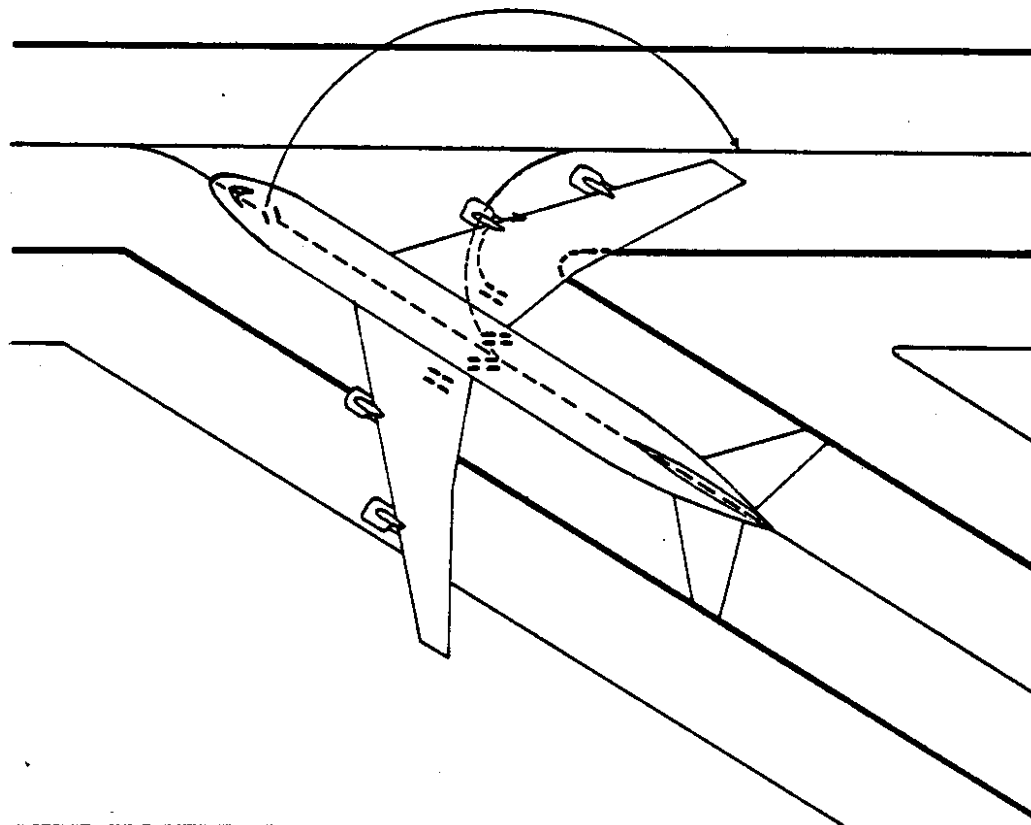
## The Transition From Charlie Three

It was mentioned earlier, that the Pan Am crew counted taxiways as they passed them, but a third is not mentioned. Yet they had almost reached the fourth taxiway when the collision occurred. The study group has calculated that Clipper 1736 was passing the third left at the time the ATC clearance was being delivered to KLM 4805. In the Pan Am cockpit, someone started to speak, then stopped when KLM asked for their clearance. As the controller delivered the clearance to KLM, the Pan Am crew was silent.

Since they were unfamiliar with Tenerife Airport, and since they knew they could expect the same departure as that given KLM, the Pan Am crew was probably concentrating deeply on the clearance being given. The silence and the Pan Am captain's almost verbatim recollection of the clearance attest to this. This concentration on the aural channel rather than the visual channel, along with the very low visibility may have prevented their seeing taxiway C-3 as they passed.

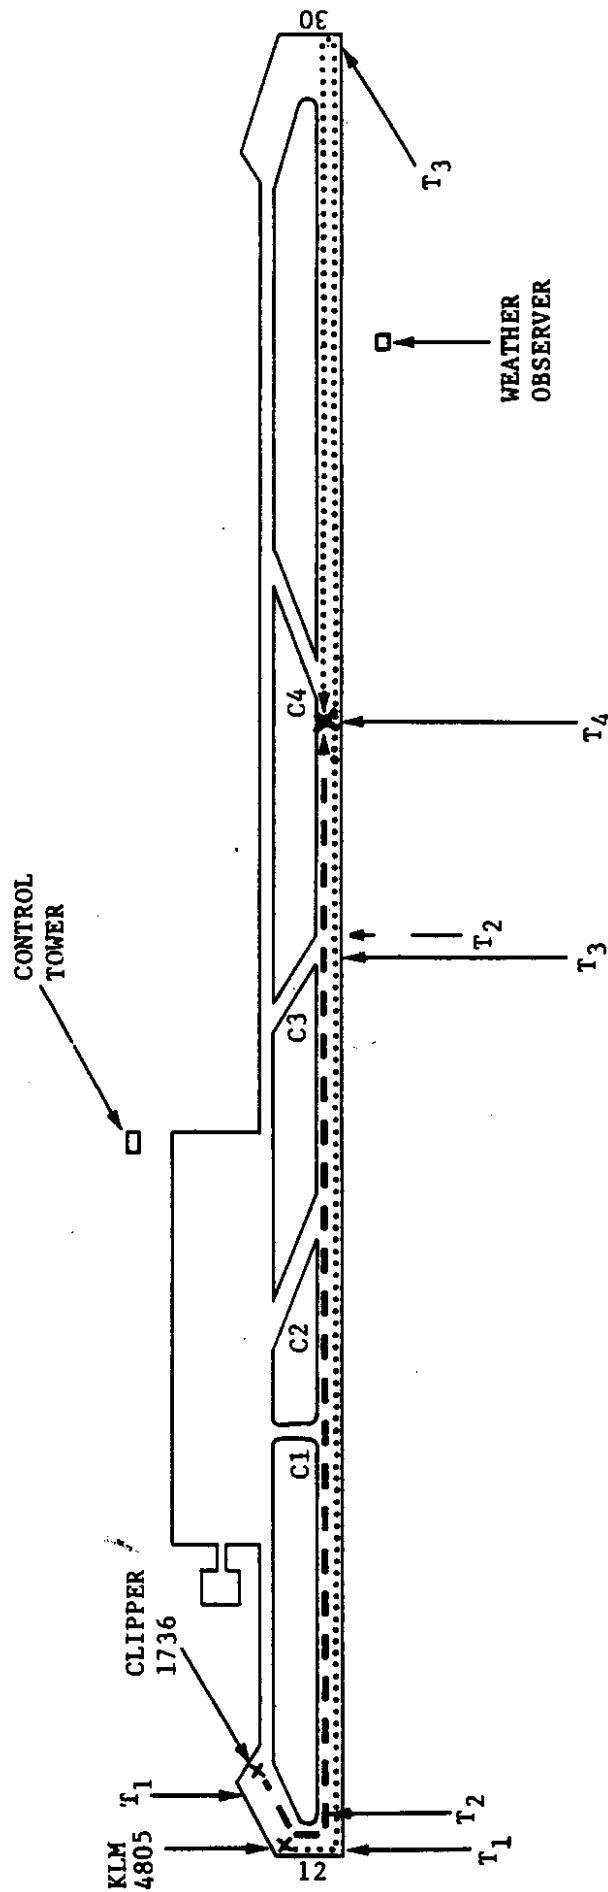
T<sub>3</sub> = 1705:53 (GMT)  
Pan Am passing C3  
KLM receiving ATC clearance

T<sub>4</sub> = 1706:49 (GMT)  
Impact point near C4
