## When is a Hard Landing Hard?

*It can be a difficult decision to report a hard landing when doubt exists, but the ensuing inspection may uncover damage that could endanger a later flight.*

*Delay report 890630-01/1295E. Delay 20:48 hours. Returned from Flight: Flap Asymmetry.*

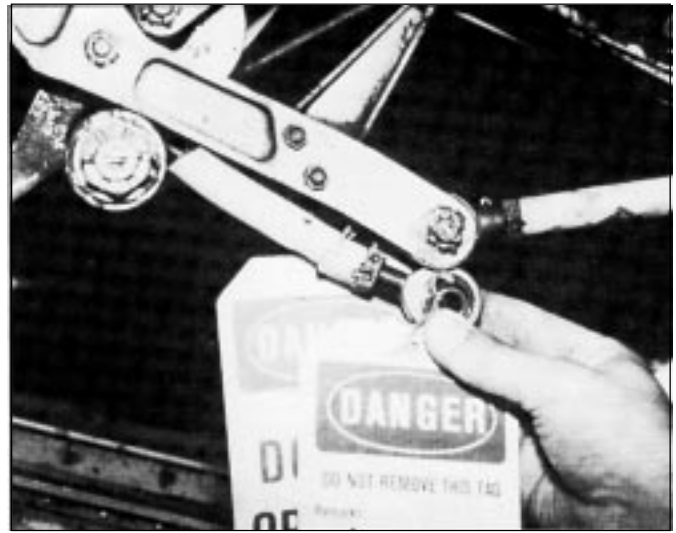
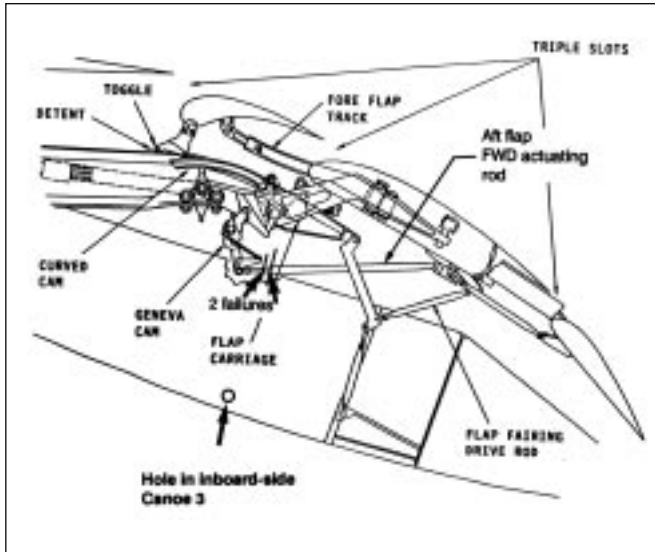
Figure 1

- Data obtained later, however, shows that the landing had indeed been hard and had caused damage. The (partly established, partly assumed) facts are that during the first hard landing, most probably the aft flap forward actuating rod (Figure 1) overloaded, although with no visible damage. This assumption is supported by earlier problems with such rods, as reported by Boeing Commercial Airplane Group to all operators in a service letter that resulted in installation of rods with increased wall thickness from then on (June 1986). Because of the good experience KLM had with the rods (or rather the lack of bad experience), retrofitting was not considered necessary.

ating rod failed because of the forces exerted at some four inches from the rod-end at the geneva cam side. This may have been the result of the hard landing, but could also be the result of misrigging of the length of the rods, or both. The failure of the rod also caused some damage, for a hole covered by tape was discovered in the canoe. The hole was clearly made by something from the inside and could only have been caused by the broken rod.

- Prior to departure, the flaps were extended without any problem because of the lack of airload. During retraction after takeoff, the remaining four inches of the actuator rod were trapped between the geneva cam and the cam support shaft (photograph) and failed once more, near the rod-end. The airload pushed the flap sideways, causing the number 3 canoe drive fitting to split open. Also, the broken number 3 actuating rod buckled and the same rod in canoe number 4 failed. The flap became jammed against the aileron, damaging the latter to such an extent that this, too, had to be replaced, together with a host of other parts.

adding an extra statement that **either** an ACMS printout **or** a pilot's complaint is enough to warrant a hard landing inspection. In this respect, the flight department will be requested to refrain from "negative" information such as "the landing was not considered hard." Furthermore, KLM is evaluating (on the basis of all data about the broken rods), whether to retrofit all systems with rods having increased wall thickness. ♦

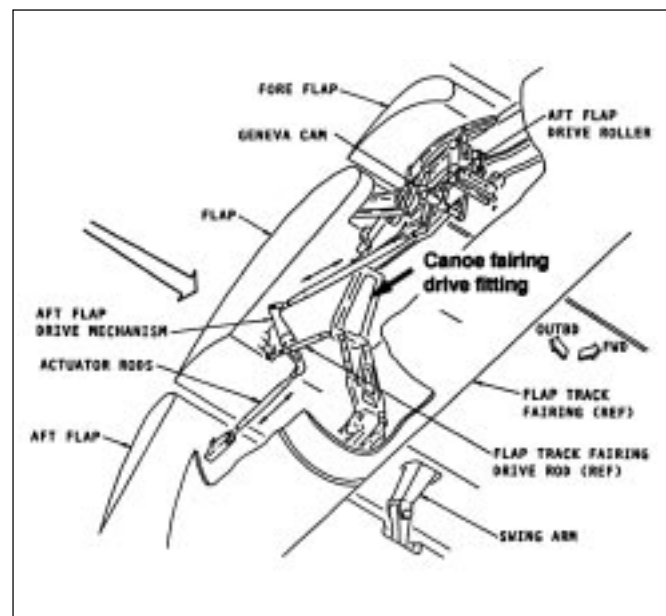
Figure 2

tions. The hole in the canoe and the high-speed tape over it raise some questions. The tape definitely had been installed only shortly before the incident. Remnants of the canoe honeycomb material were found on the remaining parts of the actuating rod, proving beyond doubt that the hole was made by the then already failed rod. Why was no check carried out to determine what caused the hole?

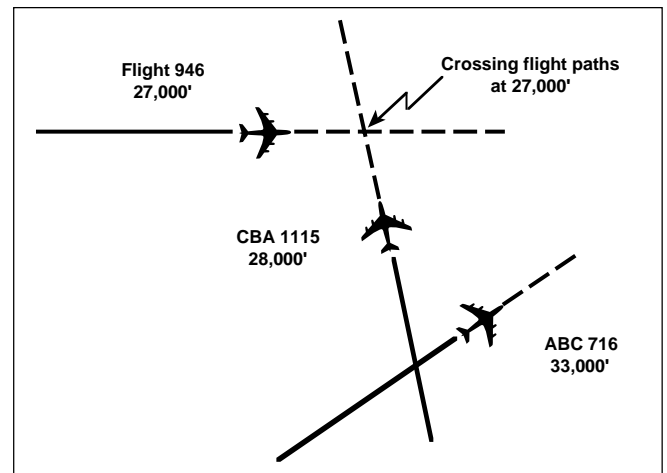
Figure 1

Flight XYZ 946 was eastbound, maintaining 27,000 feet, en route from Chicago to Pittsburgh. Flight CBA 1115 departed Charlotte for Cleveland and was northwest-bound at 28,000 feet on a course that would cross Flight 946's flight path. Flight ABC 716 was eastbound at FL330 en route to LaGuardia, New York. The flight crew of CBA 1115 was nearing the point where they would normally be cleared for descent. (see Figure 1)

- The flight crew of ABC 716, hears CBA 1115 acknowledge the clearance but assumes that the clearance was actually for CBA 1115 and therefore, does not respond.
- The air traffic controller hears the acknowledgement, but fails to recognize the incorrect flight response.
- CBA 1115 descends across the flight path and through the altitude maintained by XYZ 946.

- Similar callsigns. (CBA-ABC)
- Anticipation of a decent clearance by the crew of CBA 1115.
- Failure of the CBA 1115 crew to acknowledge with a complete callsign.
- The assumption of the ABC 716 crew that the clearance was not for them.
- Failure of air traffic control to recognize the incorrect callsign in the readback.
