How Much Is Too Much Wing Ice?

What may appear to be a minor coating of ice on an aircraft wing may be sufficient to impair lift to the point that safe flight is not possible.

John A. Pope
Aviation Consultant

The U.S. National Transportation Safety Board (NTSB) issued Aircraft Accident Report, PB91-910410, NTSB/AAR-91-09, adopted Nov. 16, 1991, which delves into the circumstances involving a DC-9-15 aircraft that crashed while taking off from Cleveland Hopkins Airport, Cleveland, Ohio, U.S., at approximately 0019 hours, Feb. 17, 1991. The following information is taken from that report.

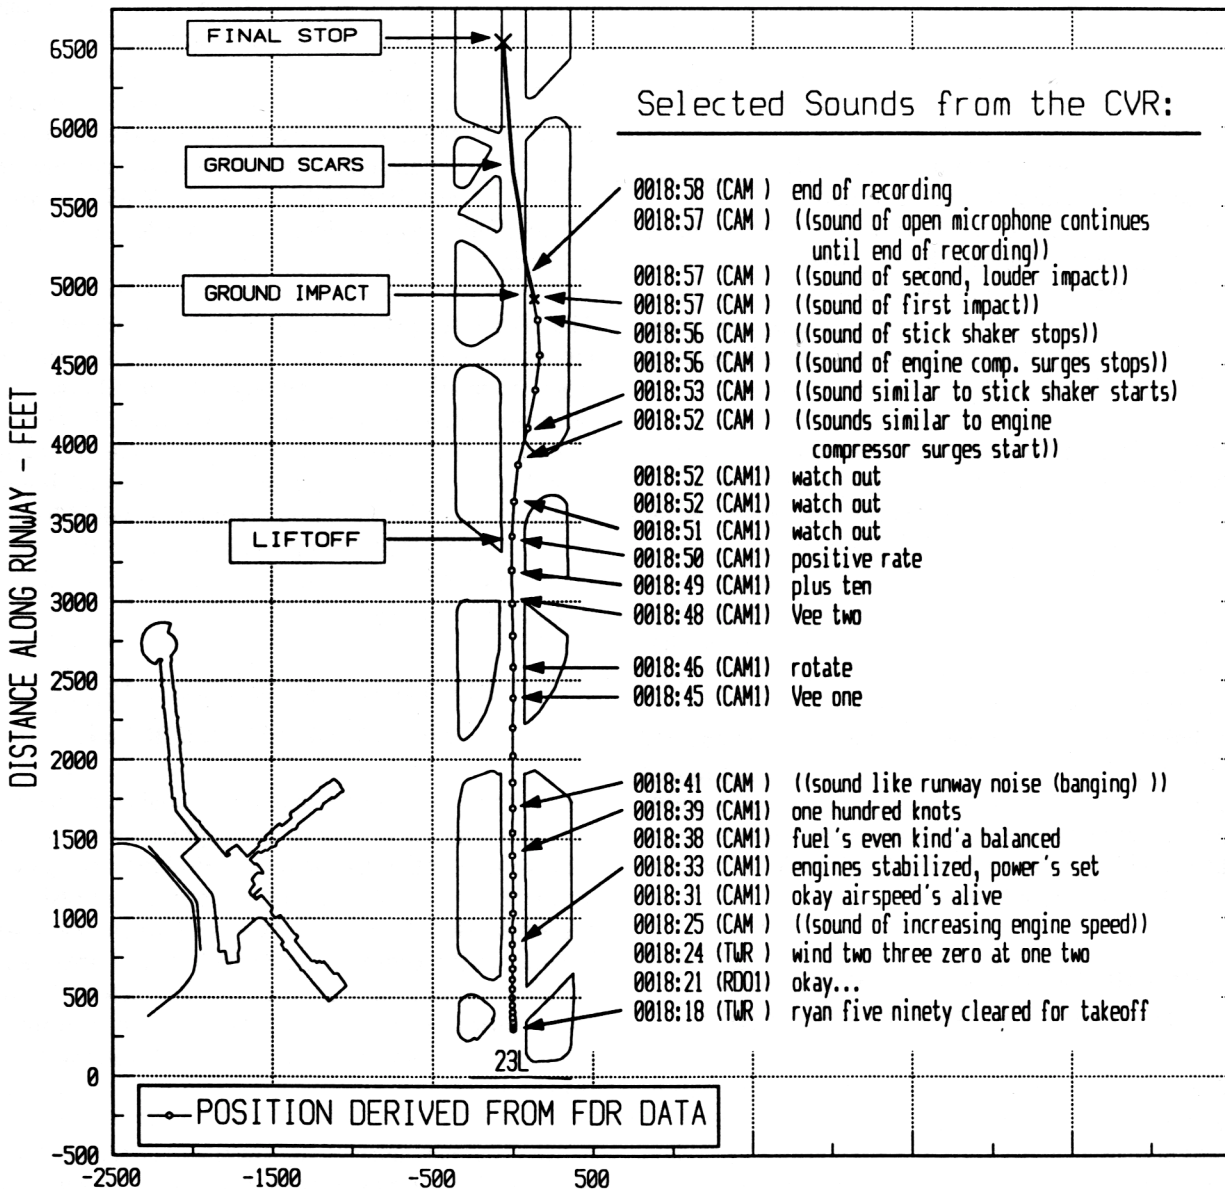
RYAN AIRLINES DC-9-15 TAKEOFF ACCIDENT

The airplane’s left wing struck the grass to the right of the takeoff runway. After leaving an approximately 1,600-foot path of wreckage along the right side of the runway, the airplane came to rest, inverted, on the runway about 6,500 feet from the threshold.
