02/28/84 Scandinavian Airlines System

Official Accident Report Index Page

Report Number	NTSB/AAR-84/15
Access Number	PB84-910415
Report Title	Scandinavian Airlines System Flight 901 McDonnell Douglas CD-10-30 Norwegian Registry LN-RKB John F. Kennedy International Airport Jamaica, New York, February 28, 1984
Report Date	November 15, 1984
Organization Name	National Transportation Safety Board Bureau of Accident Investigation Washington, D.C. 20594
WUN	3894-A
Sponsor Name	NATIONAL TRANSPORTATION SAFETY BOARD Washington, D. C. 20594
Report Type	Aircraft Accident Report February 28, 1984
Distribution Status	This document is available to the public through the National Technical Information Service Springfield, Virginia 22161
Report Class	UNCLASSIFIED
Pg Class	UNCLASSIFIED
Pages	85
Keywords	Landing accident, autothrottle speed control system, crew overreliance, crew procedures, wind shear.

Synopsis

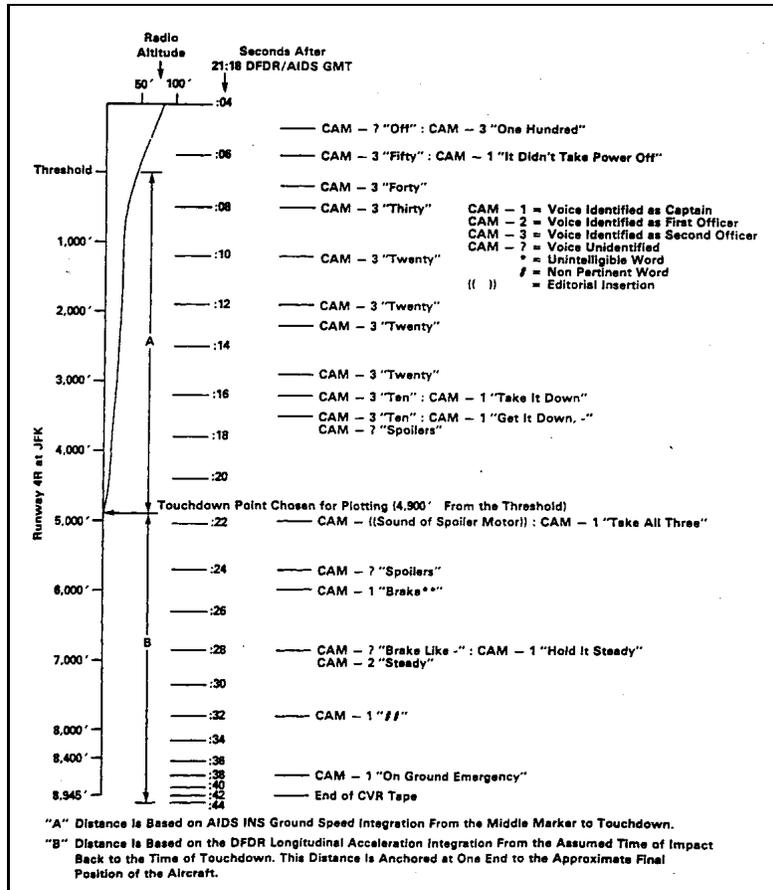
Figure 4.—CVR/AIDS Integration/Runway/Altitude Correlation.

A correlation was made between the CVR cockpit conversation, radio altitude, and position over and on the runway. (See figure 4.) Because CVR times are listed to the nearest second, this correlation is only approximate.

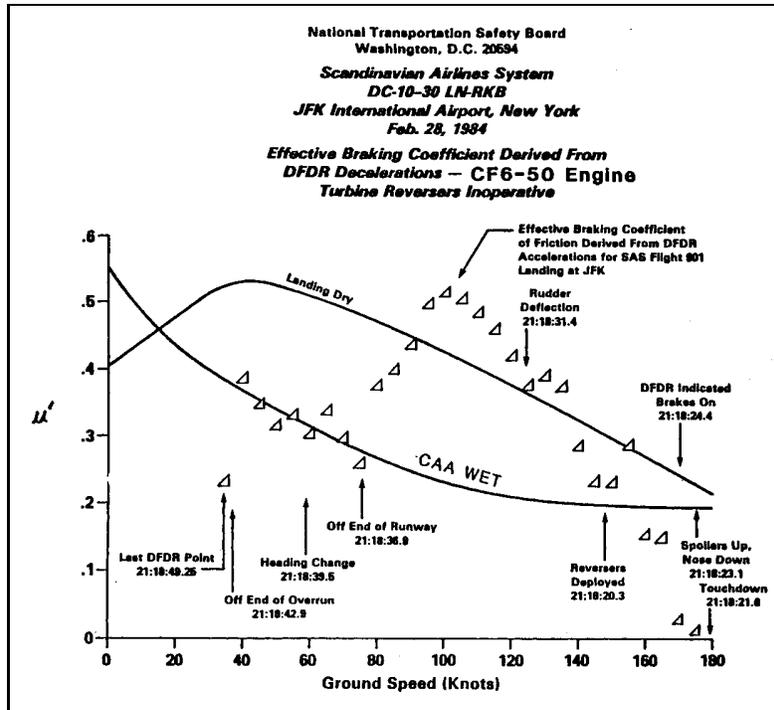
Figure 5.—Effective Braking Coefficient Derived from DFDR.

Calculations made by the Douglas Aircraft Company show calculated effective braking coefficient of friction (μ prime) as a function of groundspeed for the landing ground roll. (See figure 5.) The force attributed to braking was derived using deceleration data from the DFDR and calculating the drag, lift, and thrust forces on the aircraft. (The effective braking coefficient cannot be directly equated to friction values as measured with the Saab equipment.)

Assumptions used in analysis:	
1) Aircraft weight = 172,800 kg = 380,959 lb	
2) Aircraft c.g. = 18.7% MAC	
3) Runway headwind = 1.2 knots	
4) Turbine reversers connected and deployed
