AIRCRAFT ACCIDENT REPORT

RUNWAY OVERRUN DURING LANDING
AMERICAN AIRLINES FLIGHT 1420
MCDONNELL DOUGLAS MD-82, N215AA
LITTLE ROCK, ARKANSAS
JUNE 1, 1999

**NTSB/AAR-01/02
PB2001-910402
Notation 7195A
Adopted October 23, 2001**

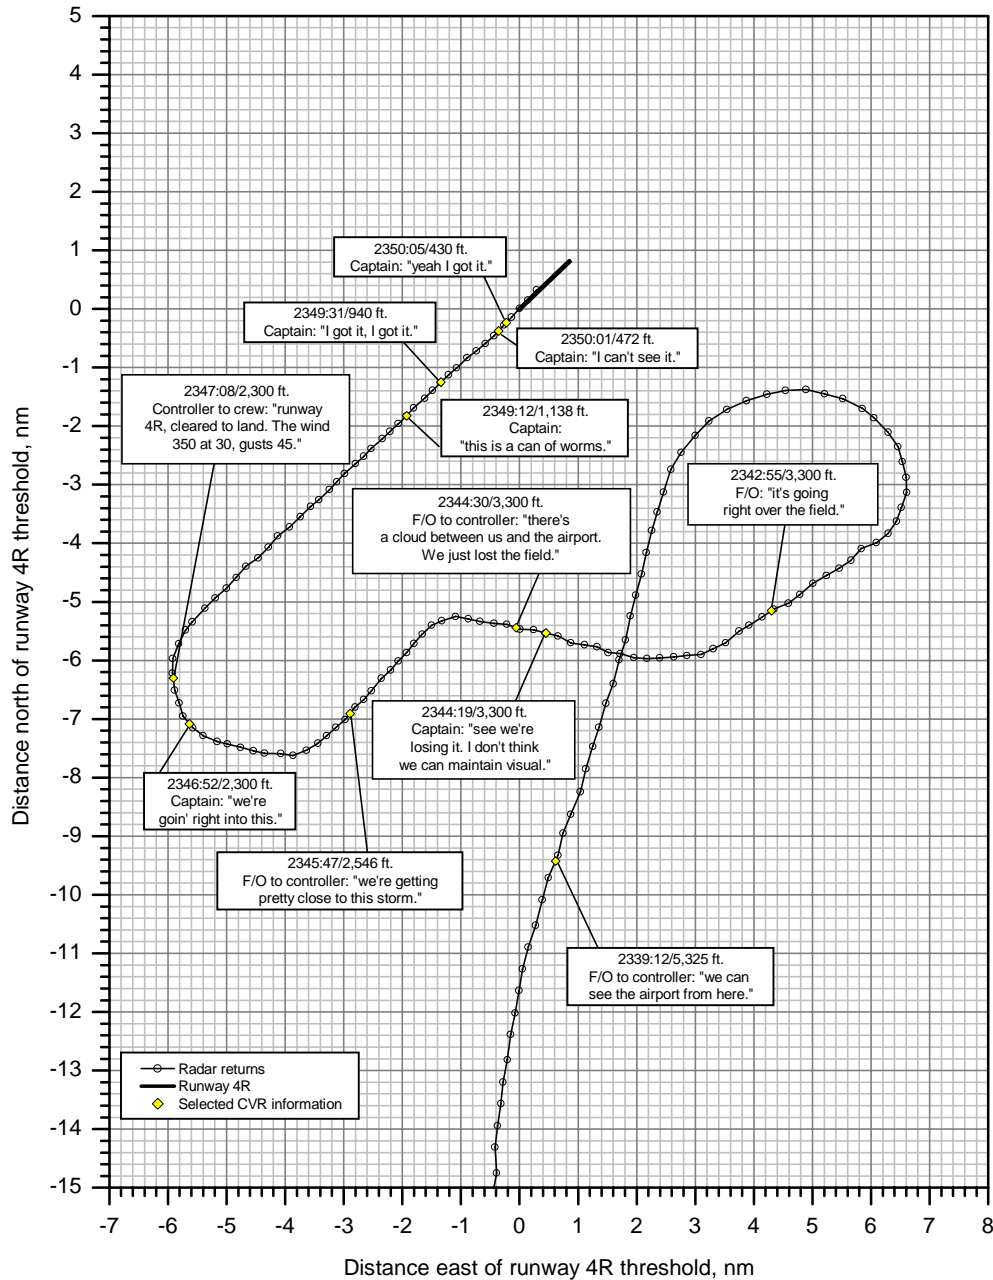
Figure 1. Flight 1420's Approach Path to the Airport and Key CVR Comments

The CVR indicated that, at 2350:00, the first officer said, "we're way off." Flight data recorder (FDR) information indicated that the localizer deviation value was about one dot to the right at that point.¹⁸ About 1 second later, the captain stated, "I can't see it." About 3 seconds afterward, the first officer asked, "got it?" to which the captain replied, "yeah I got it." At 2350:13 and :14, the CVR recorded the sound of the ground proximity warning system (GPWS) radio altitude callout "sink rate."¹⁹ Calculations based on FDR data indicated that the airplane was descending through an altitude of about 70 feet afl at the time of the first sink rate warning and about 50 feet afl at the time of the second warning. Figure 1 shows flight 1420's flightpath to Little Rock and runway 4R along with key CVR comments and the airplane's location when the comments were made.

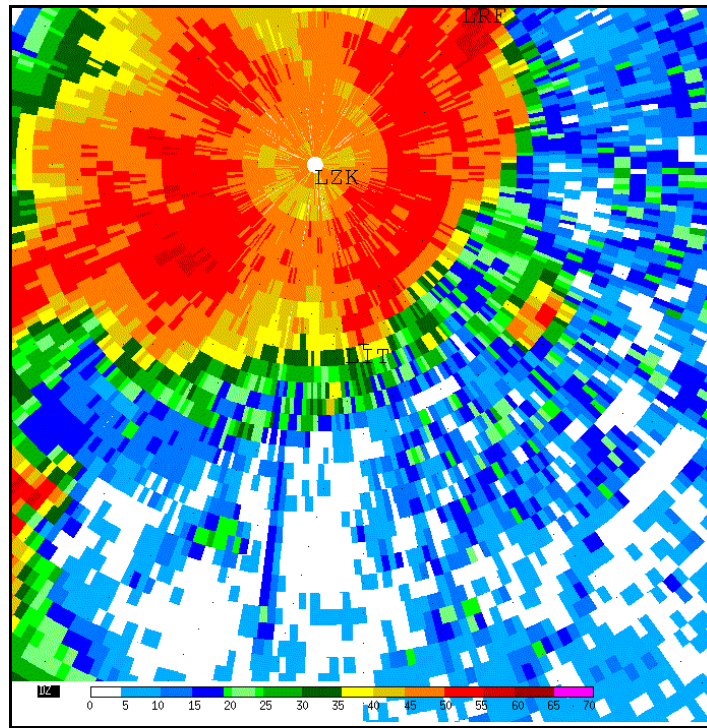
Figure 7. 0.4° Base Reflectivity Scan at 2334:27

The WSR-88D's base reflectivity images provided the radar reflectivities at the individual elevation scans. The images documented the line of thunderstorms moving across the Little Rock airport area during flight 1420's approach. The WSR-88D 0.4° elevation scan of base reflectivity that was completed at 2334:27 depicted reflectivities of 50 dBz, or NWS level 5 (intense) activity over the northwest section of the airport. By 2340:28, the 0.4° base reflectivity image depicted a large area of activity over the airport with reflectivities of 45 dBz, or level 4 (very strong) activity, and greater. The two strongest areas of activity were located approximately 5 miles west-northwest and northeast at this time. Another area of activity located approximately 3 miles southwest of Little Rock was beginning to move toward the east-southeast with reflectivities reaching 54 dBz, or level 6 (extreme) activity. Figures 7 and 8 show the base reflectivity products for 2334:27 and 2340:28, respectively.

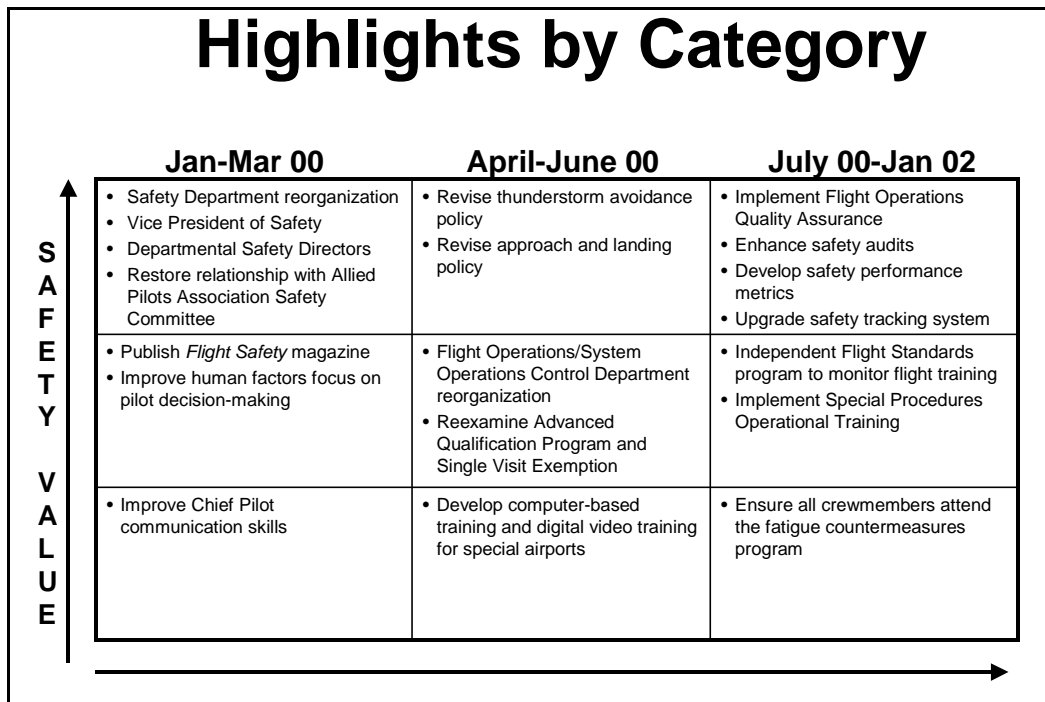
Figure 17. Categories of the Postaccident Audit Recommendations According to Expected Completion Date and Safety Value

The three phases of the evaluation produced 85 recommendations.¹³⁶ American and the Allied Pilots Association prioritized the recommendations according to importance or safety impact and created a timeline in which to accomplish the recommendations.¹³⁷ At the public hearing, the AMR Vice Chairman indicated that the list of recommendations had been reviewed by the FAA’s Certificate Management Office for AMR Corporation and presented to the Flight Standards Group at FAA headquarters. Figure 17 shows a table, presented by the AMR Vice Chairman, that highlights recommendation categories, their expected completion dates, and their safety impact.

On July 20, 2001, American Airlines provided the Safety Board with an update on actions to address the issues that had been identified during the three postaccident safety and operational audits. In addition to the actions involving the reorganization of the company that were previously discussed at the beginning of section 1.17 and the changes to the go-around policy previously stated in section 1.17.3.7, American made changes to its checklist philosophy to require challenges by the nonflying pilot and responses by the flying pilot for all mechanical checklist items (section 1.17.5.1 for the changes to the Before Landing checklist items) and expanded its stabilized approach guidance (see section 1.17.5.2).

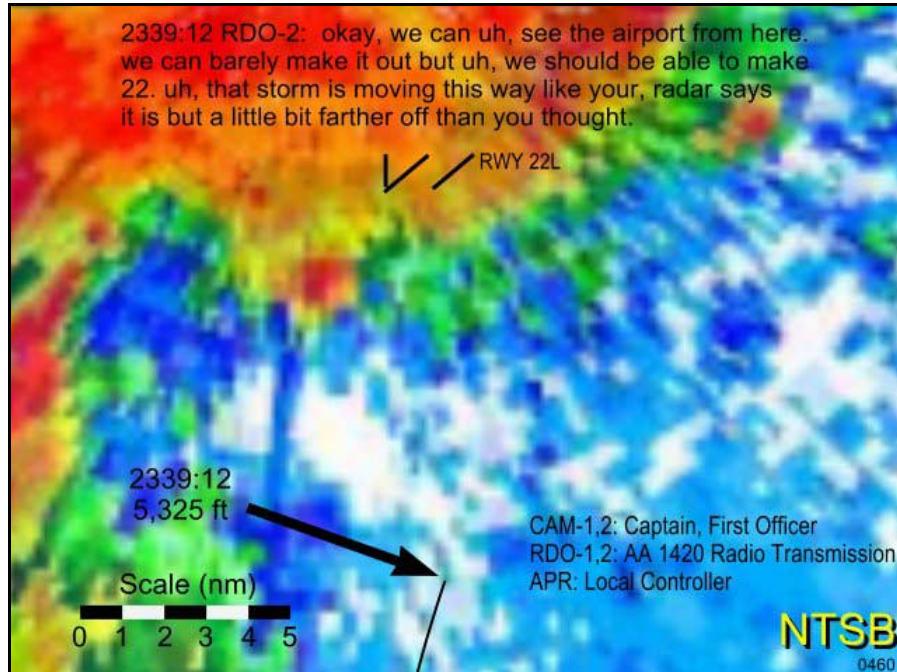
Figure 18. Weather and Flight Information for 2339:12

At 2334:11, the local controller told the flight crew, upon initial contact, that a thunderstorm located northwest of the airport was “moving through the area now” and that the winds were from 280° at 28 knots gusting to 44 knots. Even though the flight crewmembers had previously discussed the need to expedite the approach because of the weather, the CVR indicated that they had not discussed the possibility that the thunderstorm might reach the airport before the flight landed. In a postaccident interview, the first officer stated that, during the descent, the weather appeared to be about 15 miles away from the airport and that he and the captain thought that there was “some time” to make the approach. At 2339:12, the first officer told the controller, “that storm is moving this way like your radar says it is but a little bit farther off than you thought.” At that point, flight 1420 was about 11 miles south of the airport. Figure 18 shows a map of the weather conditions at 2339:12 and flight 1420’s location. After receiving the controller’s next wind report (330° at 11 knots), the first officer indicated that the winds were “a little bit better” than they had been earlier.

American’s policy did not prohibit flight crews from continuing an approach with thunderstorms in the terminal area as long as the crews ensured that their intended route was clear of the thunderstorms. During the descent into the terminal area, there was no evidence to indicate that the route was not clear. In public hearing testimony, the first officer stated that, during the descent, the weather was to the left and moving off to the right and that the airport looked clear. Thus, the Safety Board concludes that, during the

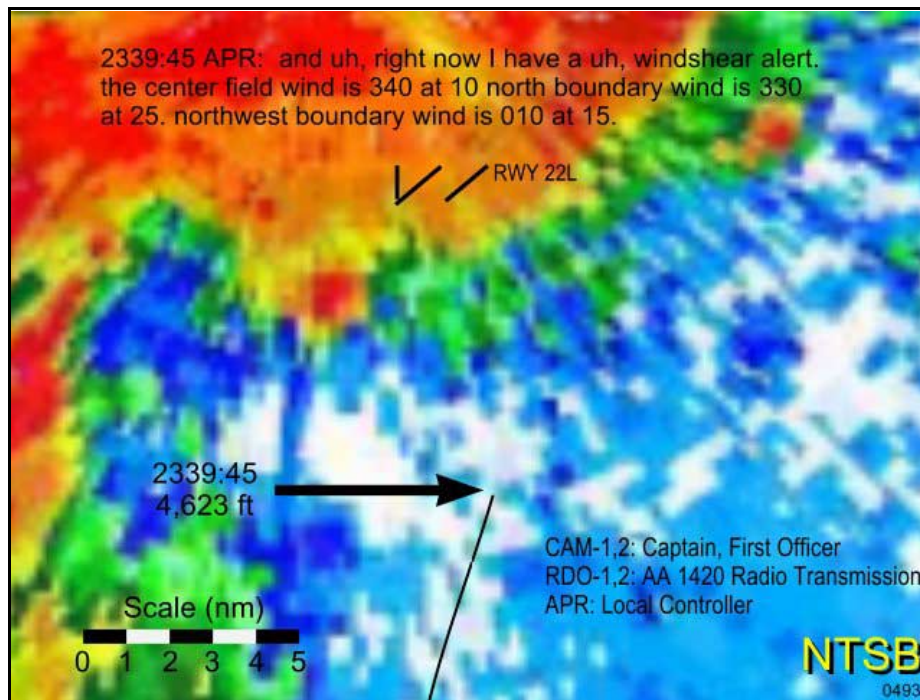
Figure 19. Weather and Flight Information for 2339:45

The flight crewmembers had been previously told by the controller to expect an instrument landing system (ILS) approach to runway 22L. At 2339:45, the local controller broadcast the first of two windshear alerts, reporting that the centerfield wind was 340° at 10 knots.¹⁷⁸ At this point, the airplane was about 8 miles from the airport. Afterward, the flight crew requested a change in runways from 22L to 4R because the winds had shifted to the northwest. The use of runway 22L could have resulted in a tailwind at the time of landing, so runway 4R was a more appropriate choice because of the expectation of a headwind. (NWS radar data indicated that the leading edge of a line of thunderstorms was over the airport at this time with the heaviest activity located northwest through northeast 5 miles from the runway.)¹⁷⁹ Figure 19 shows a map of the weather conditions at 2339:45 and flight 1420's location.

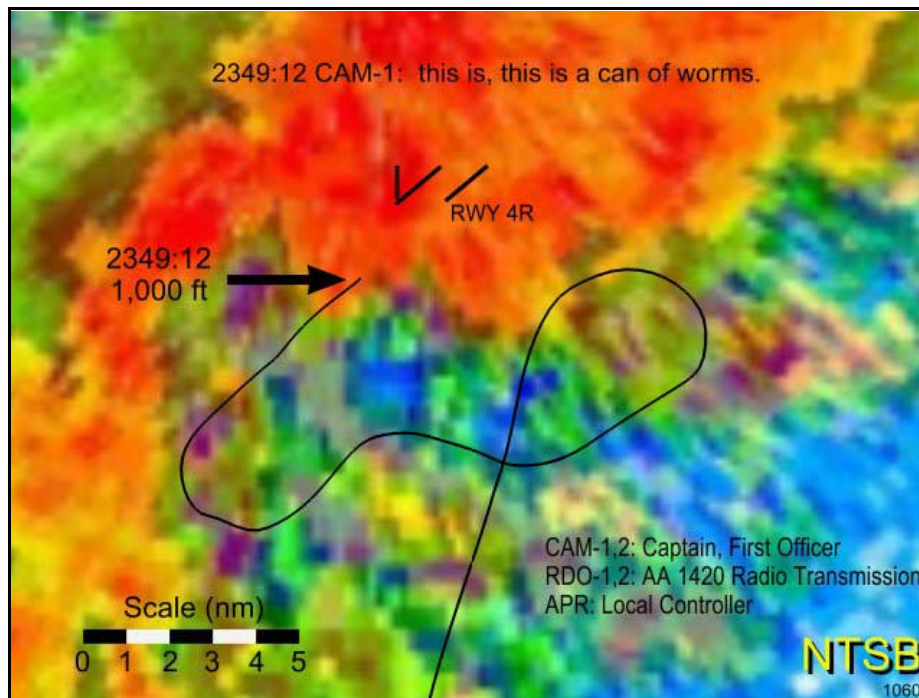
Figure 25. Weather and Flight Information for 2349:12

At 2349:10, the controller indicated that the winds were 330° at 28 knots. About 2 seconds later, the captain stated, “...this is a can of worms.” FDR data indicated that the airplane was about 1,140 feet msl (880 feet afl) at this time and that the captain was making active control inputs to keep the airplane on the localizer and glideslope. Also, the FDR data showing fluctuating airspeed (± 5 knots, with one excursion to +8 knots and one to -10 knots) and vertical acceleration (± 0.2 G with occasional excursions to ± 0.25 G)¹⁸⁶ were consistent with the presence of gusty and turbulent winds. Figure 25 shows a map of the weather conditions at 2349:12 and flight 1420’s location.
