Runway Overrun During Landing
Shuttle America, Inc.
Doing Business as Delta Connection Flight 6448
Embraer ERJ-170, N862RW
Cleveland, Ohio
February 18, 2007

NTSB/AAR-08/01
PB2008-910401

Aircraft Accident Report

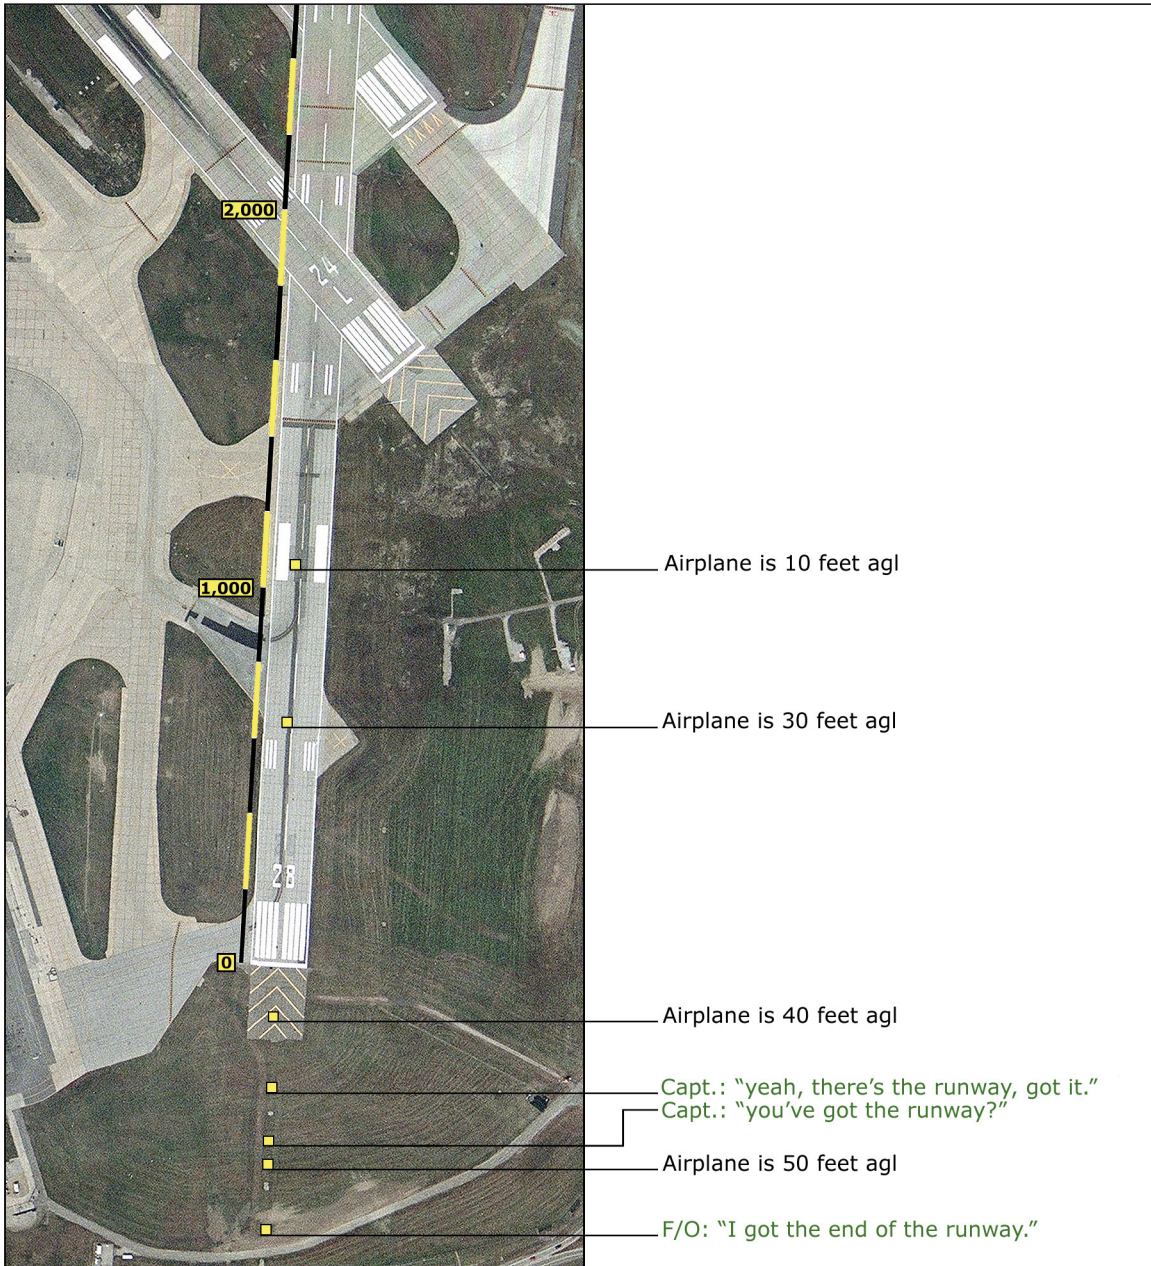
Figure 1. Location of Airplane Before Touchdown

The CVR recorded the sound of numerous impacts starting about 1505:50 and a sound similar to the airplane coming to a stop about 1505:57. The airplane came to rest on a snow-covered grass surface located southwest of the extended runway 28 centerline. Figure 1 shows the location of the airplane at the time of the captain’s go-around callout and as it passed the runway threshold. Figure 1a shows the pertinent events from the airplane’s touchdown to its overrun. Figure 2 shows the airplane in its final resting location.
