**NATIONAL  
TRANSPORTATION  
SAFETY  
BOARD**

**AIRCRAFT ACCIDENT REPORT**

**AIR CANADA FLIGHT 797  
McDONNELL DOUGLAS DC-9-32, C-FTLL  
GREATER CINCINNATI  
INTERNATIONAL AIRPORT  
COVINGTON, KENTUCKY  
JUNE 2, 1983**

**NTSB/AAR-86/02**

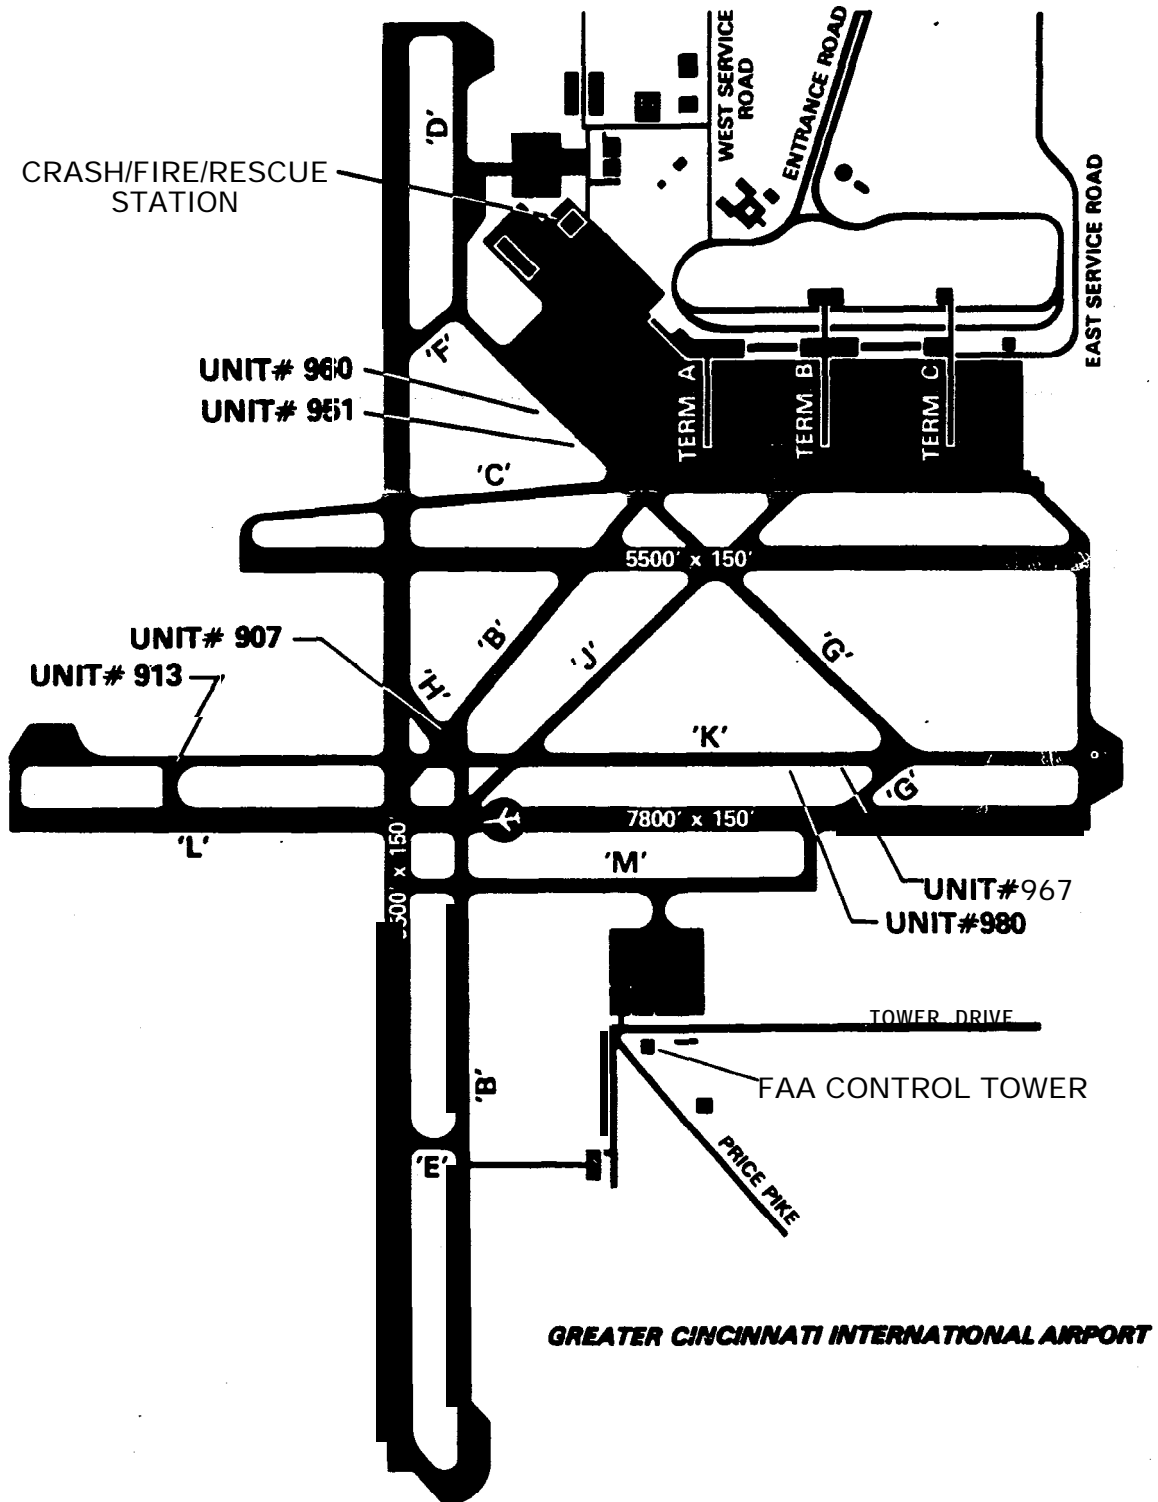
Figure 1.—Standby Positions of Crash/Fire/Rescue Units.

At 1913:38, after Flight 797 was unable to tell him its heading because its heading instruments were inoperative, the approach controller asked the flight to turn left. The controller said that this was an identification turn and that it was also designed to place the airplane closer to the airport. At 1914:03, after observing the target in a left turn, *the* approach controller said that Flight 797's primary target was now \*\*fully identified." He then told the flight that this was a "no gyro" 5/ radar approach for runway two seven left. . ." and cleared it to descend to 3,500 feet. He then told the flight that it was 12 nmi southeast of the Cincinnati Airport, cleared it to land on runway 27L, and informed it that the surface wind was 220° at 4 knots. He informed the tower of the change of landing runways and the tower directed *the* fire department to position its vehicles along runway 27L. (See figure 1.)

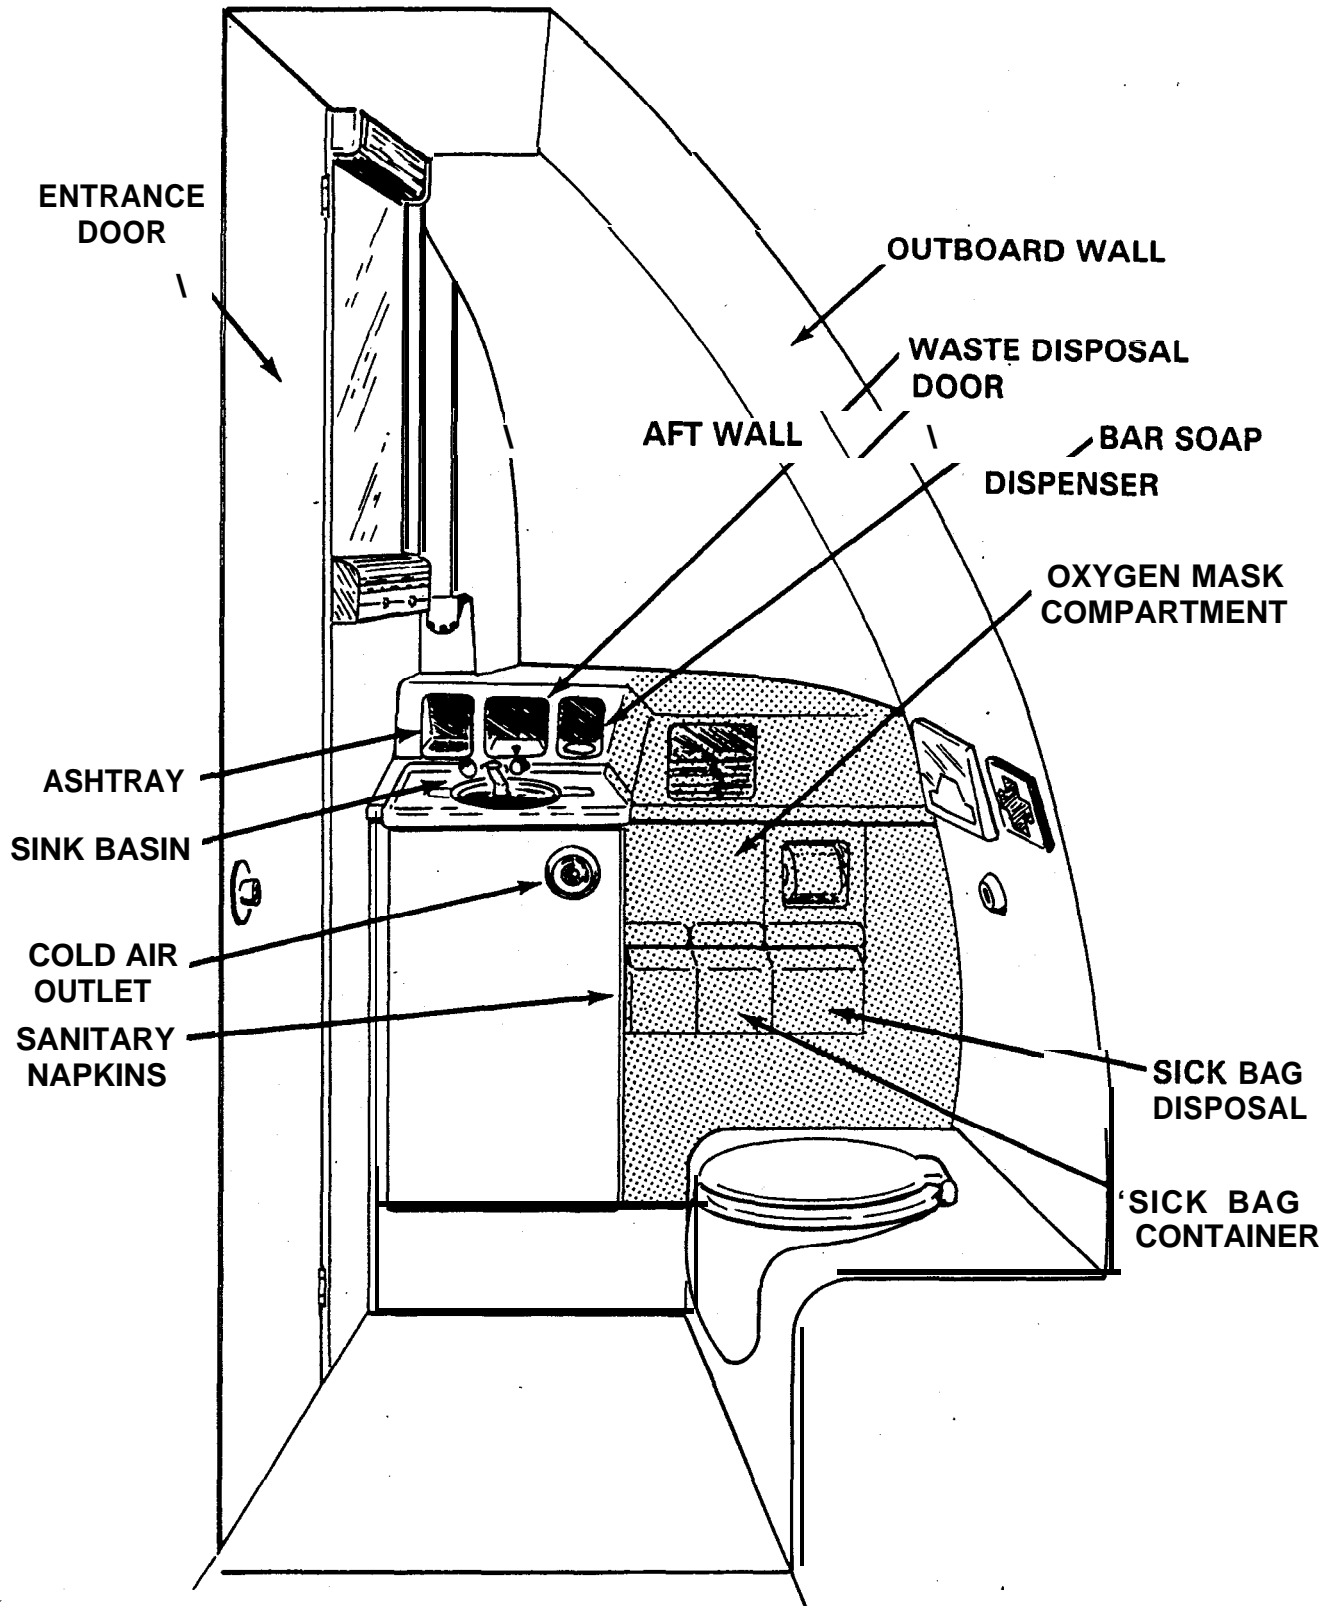
Figure 9.—Diagram of aft lavatory, viewed aft.

The aft lavatory was on the left side of the cabin, and began at FS 965 and extended aft to FS 1019, or just forward of the aft pressure bulkhead. The lavatory's outboard wall conformed essentially to the shape of the airplane's fuselage. There was a vanity section containing a stainless steel sink and amenities located along and extending forward from the aft wall. The commode containing a flushing motor was located along the lavatory's outboard wall. A trash chute and container were located below and behind the sink, and a fresh air supply outlet was positioned below the sink in the door of the vanity. Also, below the trash container, an aluminum shelf was installed. In addition, there was an oxygen outlet located in the oxygen mask compartment in the amenities section. (See figures 9 and 10.)

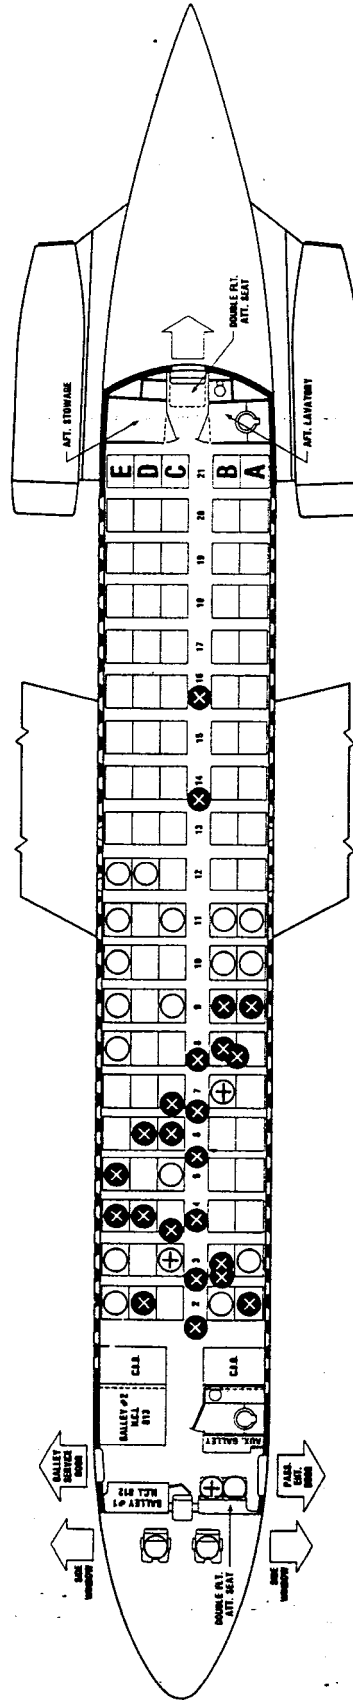
Figure 12.—Diagram of passenger seat locations.

Publication 356 also states, in part, that if excessive smoke and fumes are present in the cabin, the flight attendants should "relocate passengers away from the area of severe smoke and fumes if possible." The passengers had been moved forward in the cabin, and no passenger was seated farther aft than row 12. The two passengers in seats Nos. 12D and 12E refused to move forward because their seats were next to the right forward **overwing** exit window. (See figure 12.)

Except for two fatalities found in the aisle at rows 14 and 16, the majority of the fatalities were found either in the aisle or seated in rows 2 through 9. (See figure 12.) The fatalities at rows 14 and 16 had been seated in seats 8-B and 9-B, respectively.

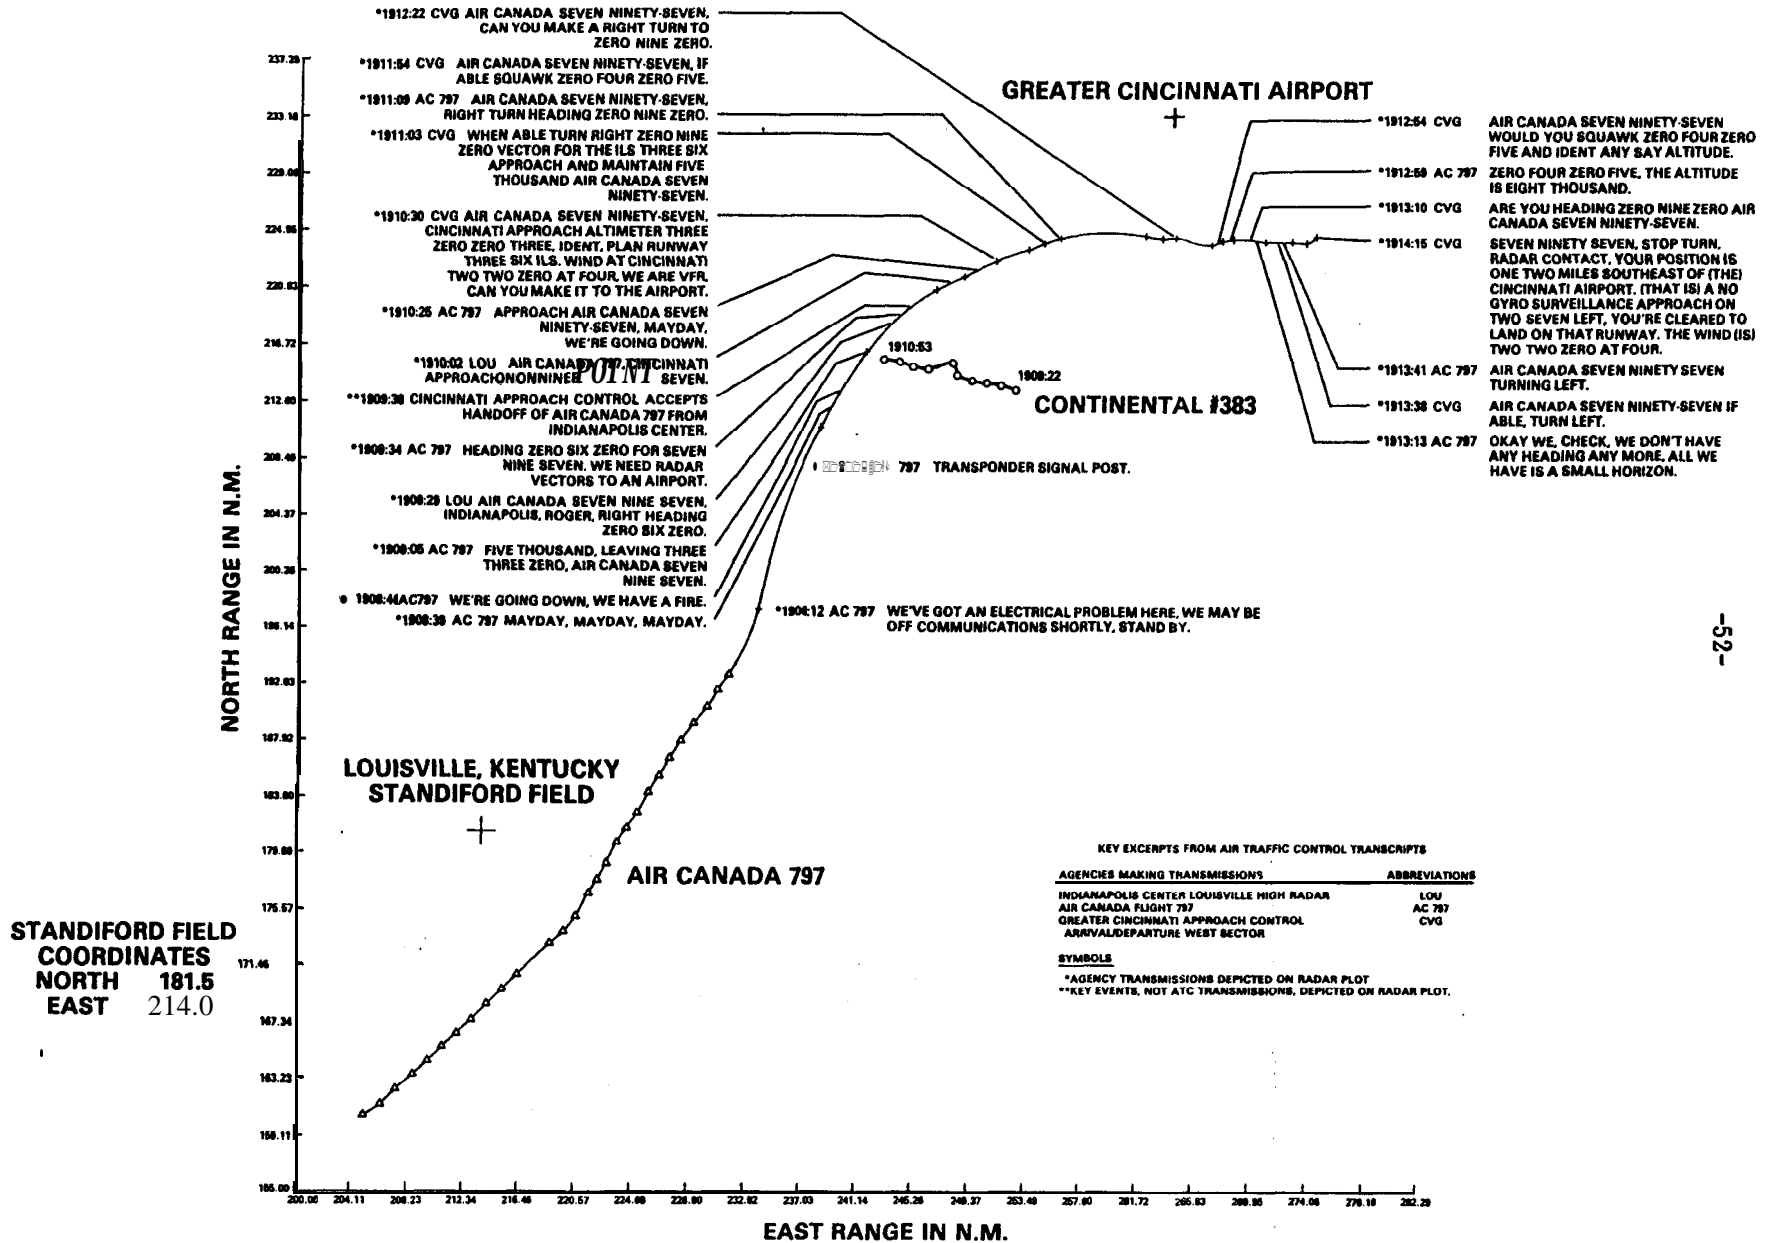
Figure 13.-Ground radar tracks for Flights 797 and 383.

18-36 of the Greater Cincinnati Airport were digitized and plotted with the ground tracks. Times of key transmissions and selected key events were included along Flight 797's radar ground track. The last radar fix retrieved from the DART's data occurred at **1914:15**, and the last transponder information from Flight 797 was received at **1906:12**. (See figure 13.)
