NATIONAL TRANSPORTATION SAFETY BOARD

AIRCRAFT ACCIDENT REPORT

**AIR CANADA FLIGHT 797
McDONNELL DOUGLAS DC-9-32, C-FTLL
GREATER CINCINNATI
INTERNATIONAL AIRPORT
COVINGTON, KENTUCKY
JUNE 2, 1983**

**NTSB/AAR-86/02
(SUPERSEDES - - NTSB/AAR-84/09)**

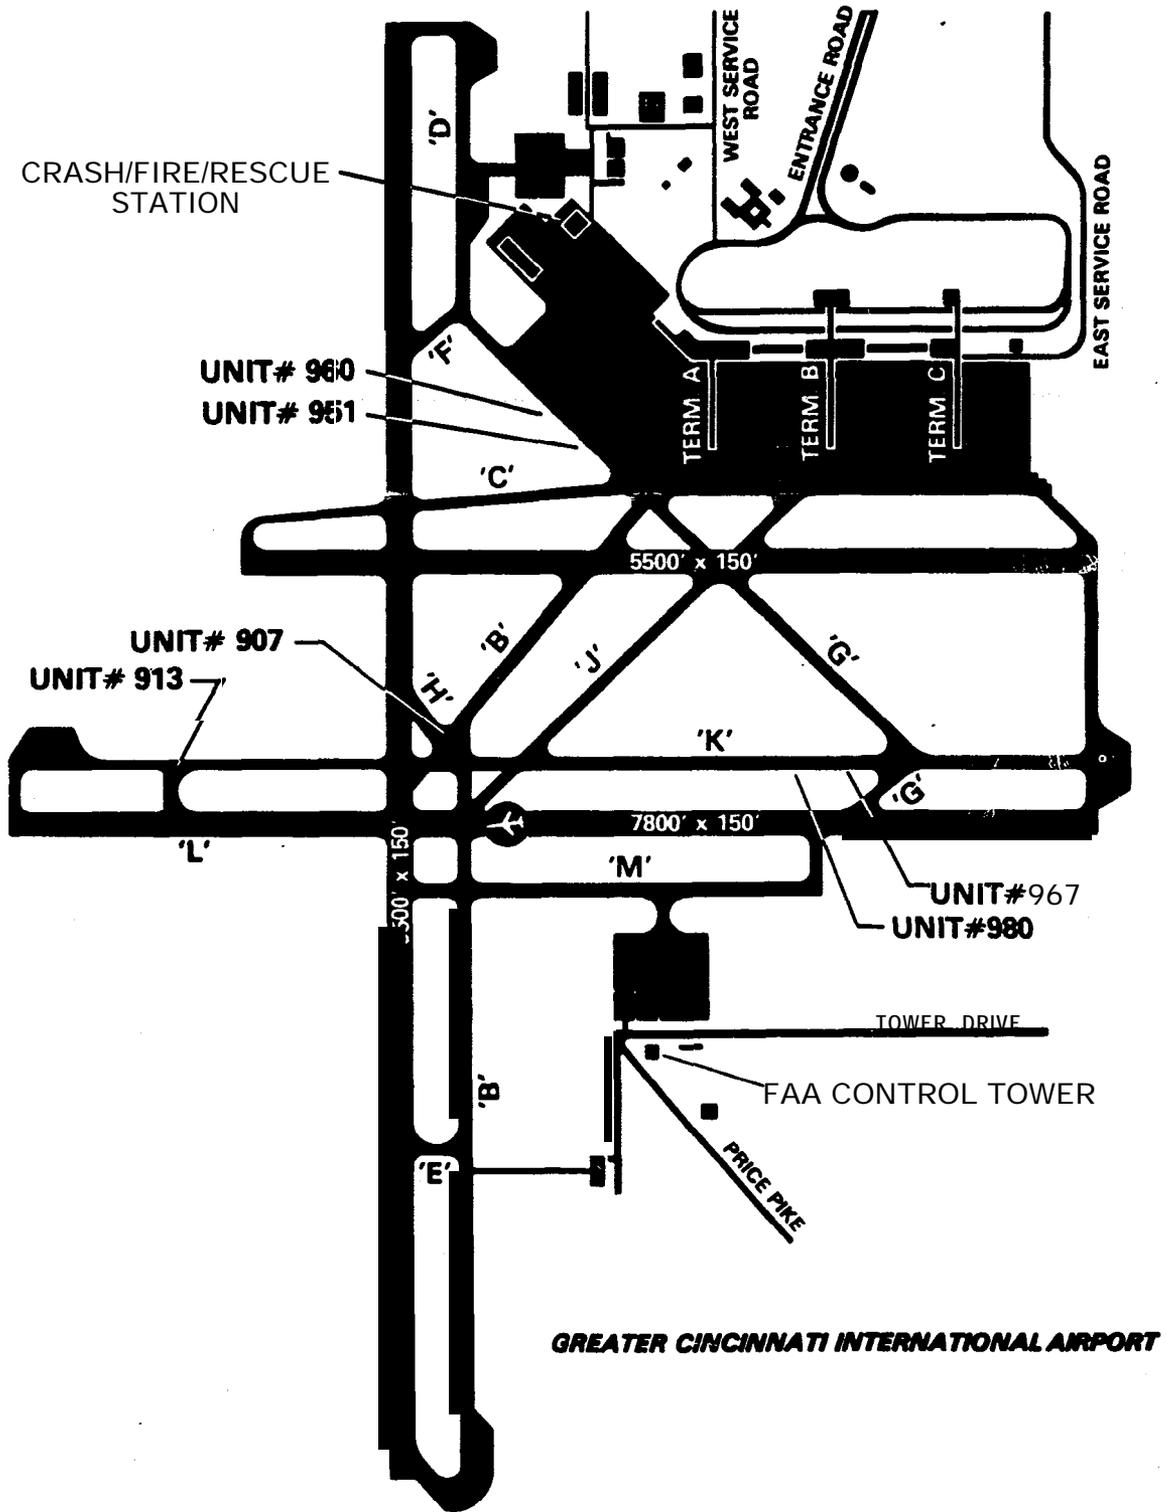
Figure 1.—Standby Positions of Crash/Fire/Rescue Units.

At 1913:38, after Flight 797 was unable to tell him its heading because its heading instruments were inoperative, the approach controller asked the flight to turn left. The controller said that this was an identification turn and that it was also designed to place the airplane closer to the airport. At 1914:03, after observing the target in a left turn, *the* approach controller said that Flight 797's primary target was now **fully identified." He then told the flight that this was a "no gyro" 5/ radar approach for runway two seven left. . ." and cleared it to descend to 3,500 feet. He then told the flight that it was 12 nmi southeast of the Cincinnati Airport, cleared it to land on runway 27L, and informed it that the surface wind was 220° at 4 knots. He informed the tower of the change of landing runways and the tower directed *the* fire department to position its vehicles along runway 27L. (See figure 1.)

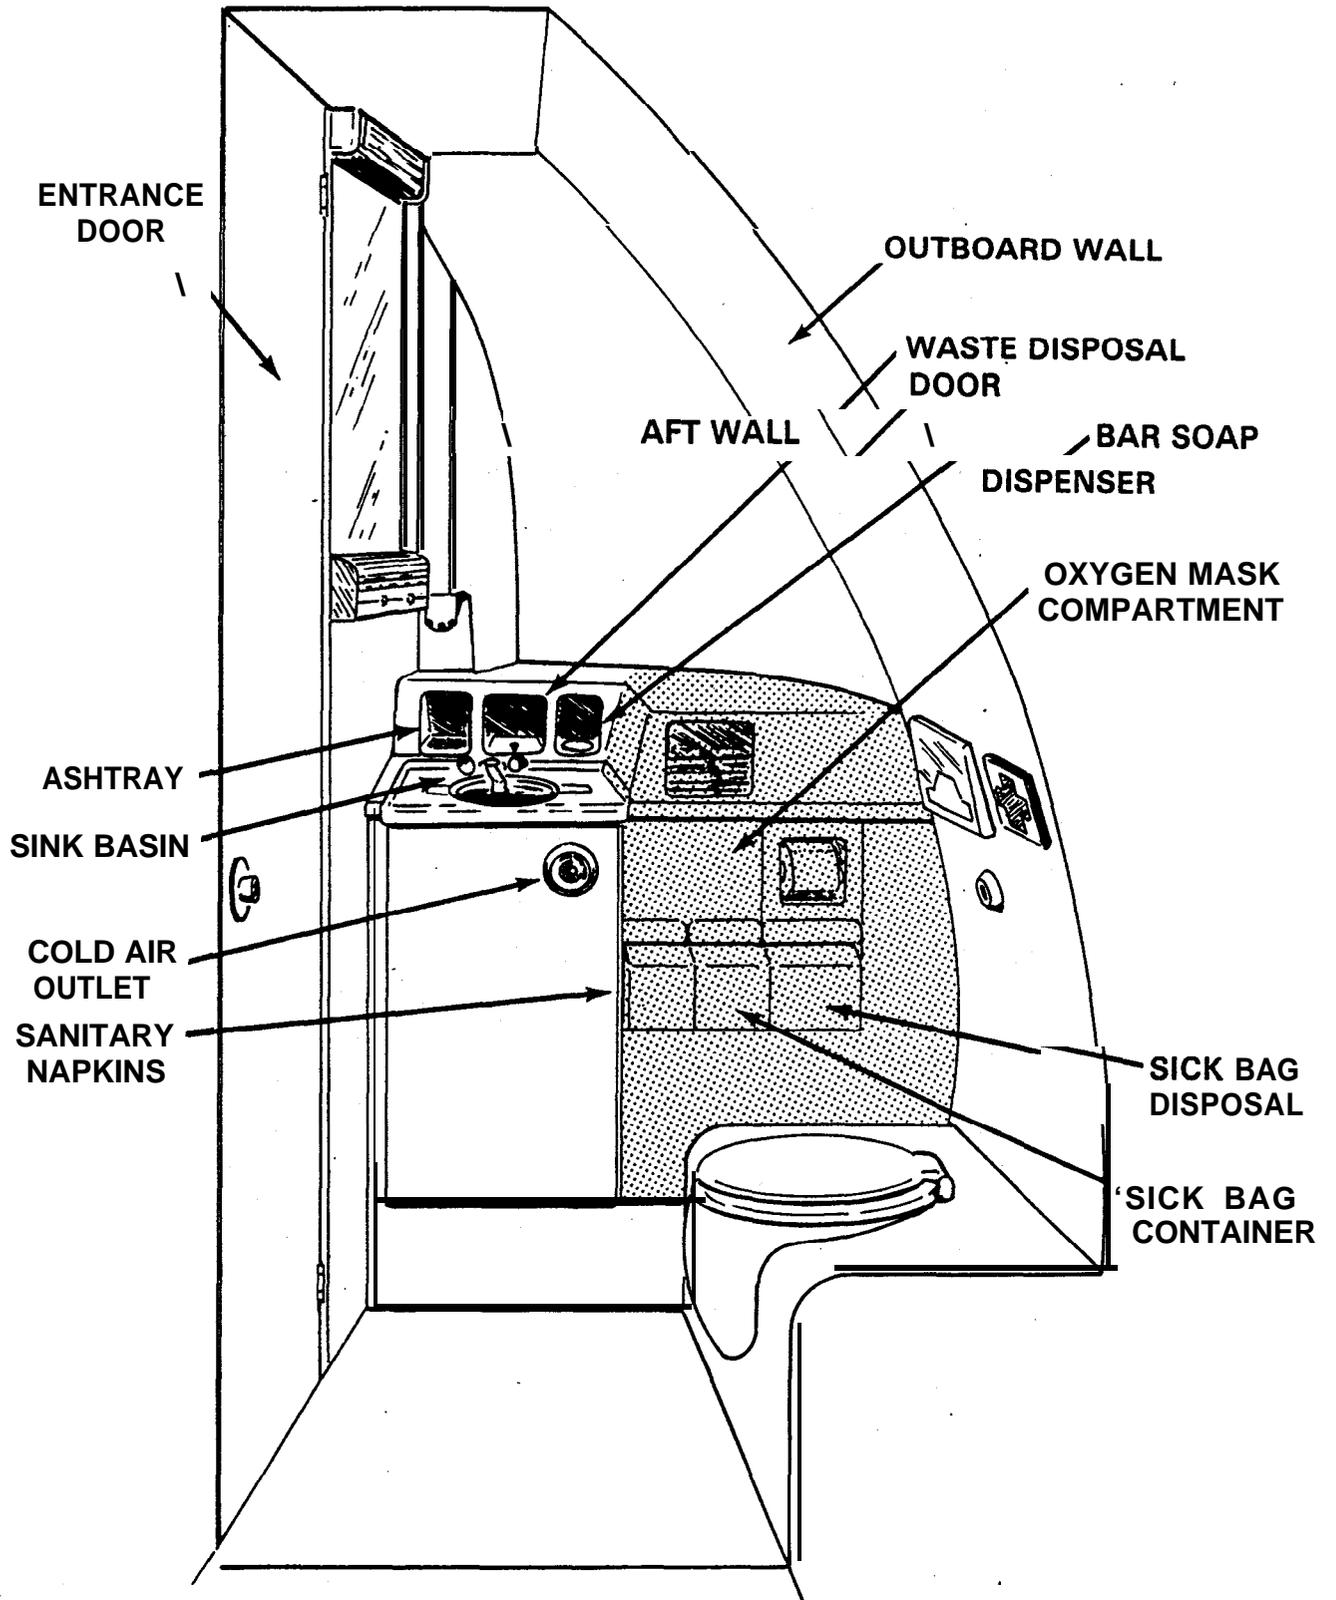
Figure 9.—Diagram of aft lavatory, viewed aft.

The aft lavatory was on the left side of the cabin, and began at FS 965 and extended aft to FS 1019, or just forward of the aft pressure bulkhead. The lavatory's outboard wall conformed essentially to the shape of the airplane's fuselage. There was a vanity section containing a stainless steel sink and amenities located along and extending forward from the aft wall. The commode containing a flushing motor was located along the lavatory's outboard wall. A trash chute and container were located below and behind the sink, and a fresh air supply outlet was positioned below the sink in the door of the vanity. Also, below the trash container, an aluminum shelf was installed. In addition, there was an oxygen outlet located in the oxygen mask compartment in the amenities section. (See figures 9 and 10.)

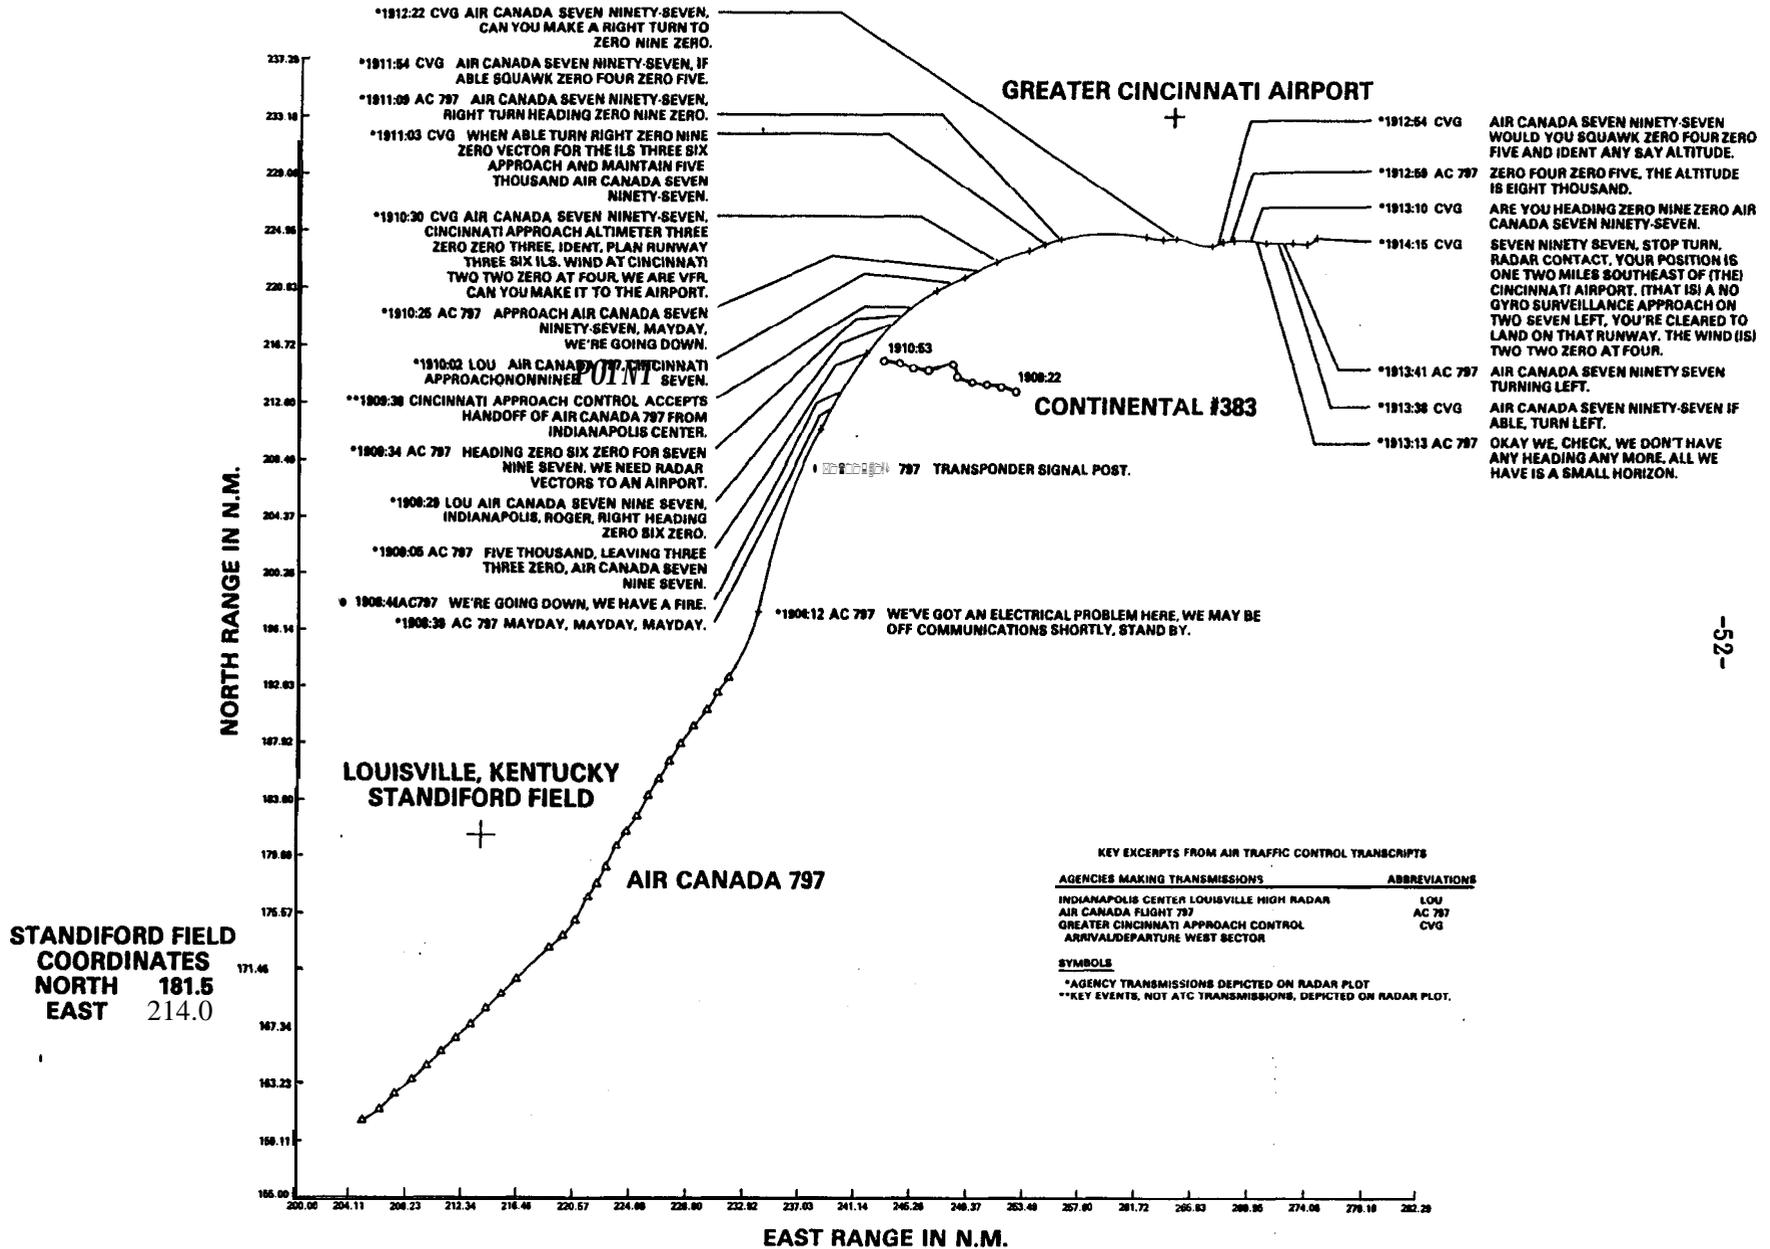
Figure 13.-Ground radar tracks for Flights 797 and 383.

18-36 of the Greater Cincinnati Airport were digitized and plotted with the ground tracks. Times of key transmissions and selected key events were included along Flight 797's radar ground track. The last radar fix retrieved from the DART's data occurred at **1914:15**, and the last transponder information from Flight 797 was received at **1906:12**. (See figure 13.)
