AIRCRAFT ACCIDENT REPORT

EXPLOSIVE DECOMPRESSION--
LOSS OF CARGO DOOR IN FLIGHT
UNITED AIRLINES FLIGHT 811
BOEING 747-122, N4713U
HONOLULU, HAWAII
FEBRUARY 24, 1989

**Adopted: March 18, 1992
Notation 5059C**

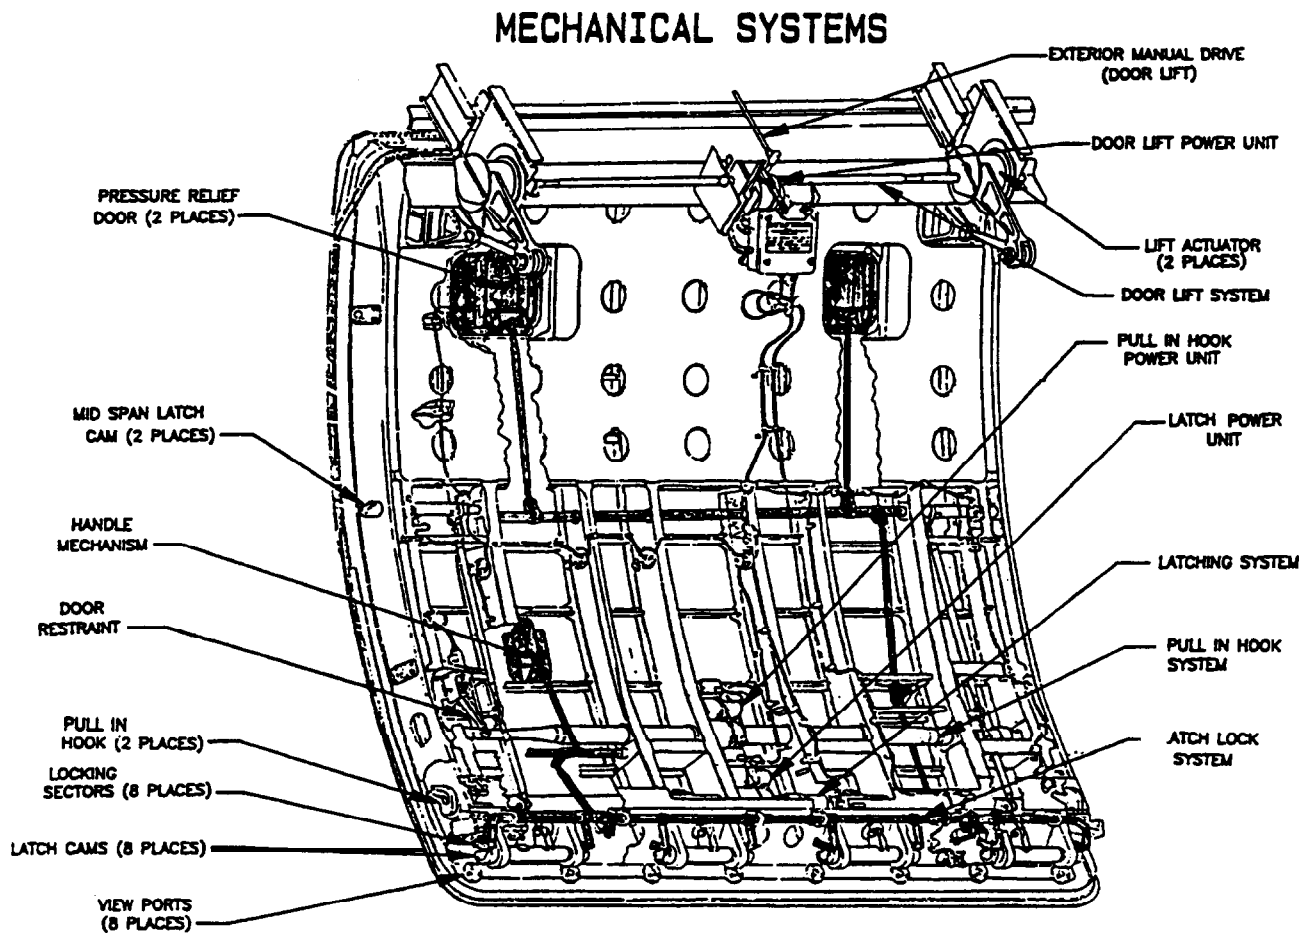
Figure 4.--Boeing 747 lower lobe forward cargo door.

The cargo door and its associated hardware are designed to carry circumferential (hoop) loads arising from pressurization of the airplane. These loads are transmitted from the piano hinge at the top of the door, through the door itself, and into the eight latches located along the bottom of the door. The eight latches consist of eight latch pins attached to the lower door sill and eight latch cams attached to the bottom of the door. The cargo door also has two **midspan** latches located along the fore and aft sides of the door. These **midspan** latches primarily serve to keep the sides of the door aligned with the fuselage. There are also four door stops which limit inward movement of the door. There are two **pull-in** hooks located on the fore and aft lower portion of the door, with pull-in hook pins on the sides of the door frame. (See figure 4 for cargo door components).

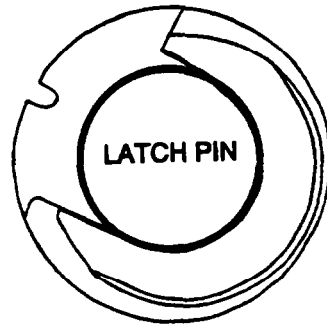
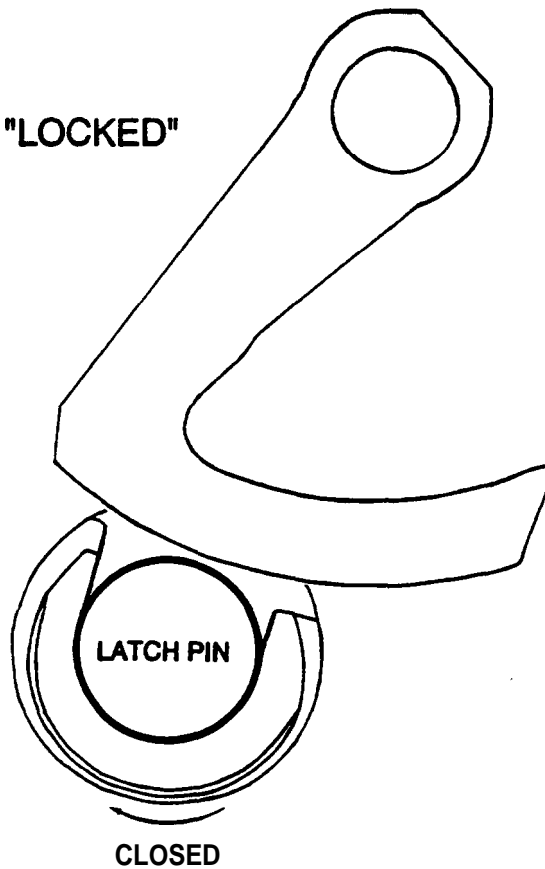
Figure 5.--Cargo door latch cam and lock sector in unlocked and locked positions.

The cargo doors on the B-747 have a master latch lock handle installed on the exterior of the door. The handle is opened and closed manually. The master latch lock handle simultaneously controls the operation of the latch lock sectors, which act as locks for the latch cams, and the two pressure relief doors located on the door. Figure 5 depicts a lock sector and latch cam in an unlocked and locked condition.

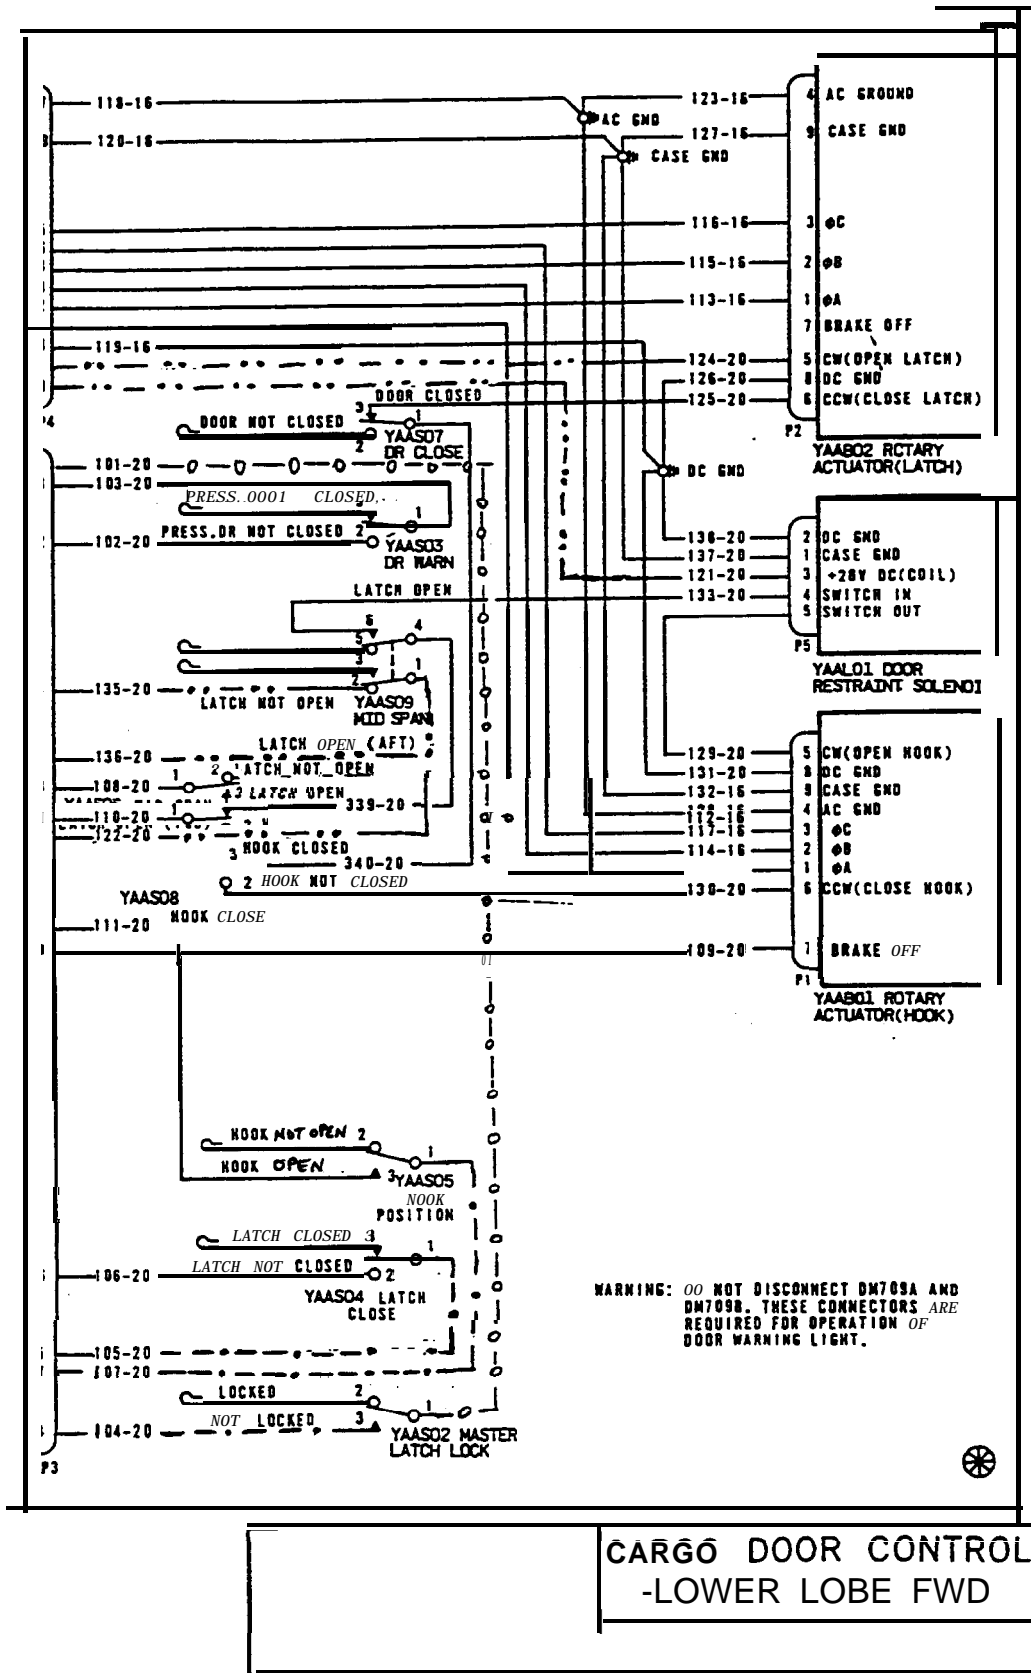
Figure 17.--Diagram of cargo door electrical circuitry.

Conductive contact of (-0-o-o-o) or (--...--.) coded wire with (-...-) coded wire could potentially result in providing a 28VDC circuit path to the latch actuator open circuit. Direct wire-to-wire paths are coded in Figure 17 as defined above. The two-wire short circuit paths are identified as wire pairs consisting of wire 101-20 shorting with any of the following wires; 108-20, 121-20, 122-20, 124-20, **135-20**, or 136-20.

If the S2 master latch lock switch fails in the “Not Locked” position, there are additional wire pairs that provide short circuit paths. These are coded in Figure 17 as (--...--.) to (-...-...) wire pairs.

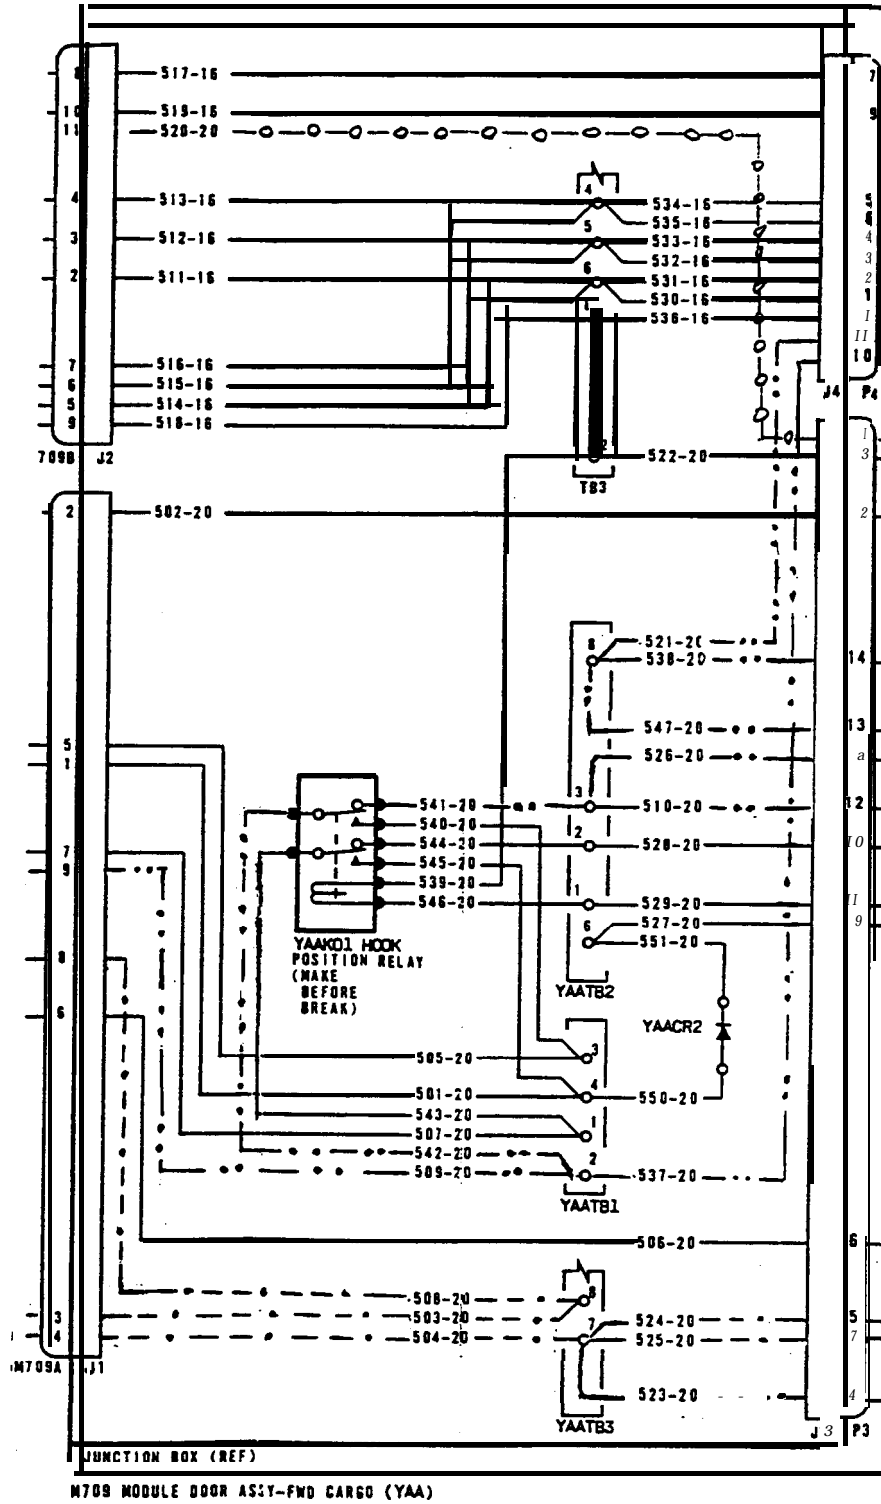
Figure 17a.--Diagram of cargo door electrical circuitry.

The cargo door was recovered with all of its position sensing switches installed in their proper locations. The electrical junction box was found attached to the door but damaged. The switches recovered and examined were: S2 Master Latch Lock; S3 Door Warning; S4 Latch Close; **S5** Hook Position; **S6** Fwd Mid-Span Latch Open; S7 Door Close; **S8** Hook Close; and **S9** Aft Mid-Span Latch Open. Figure 17 provides a diagram of the cargo door's electrical circuitry.

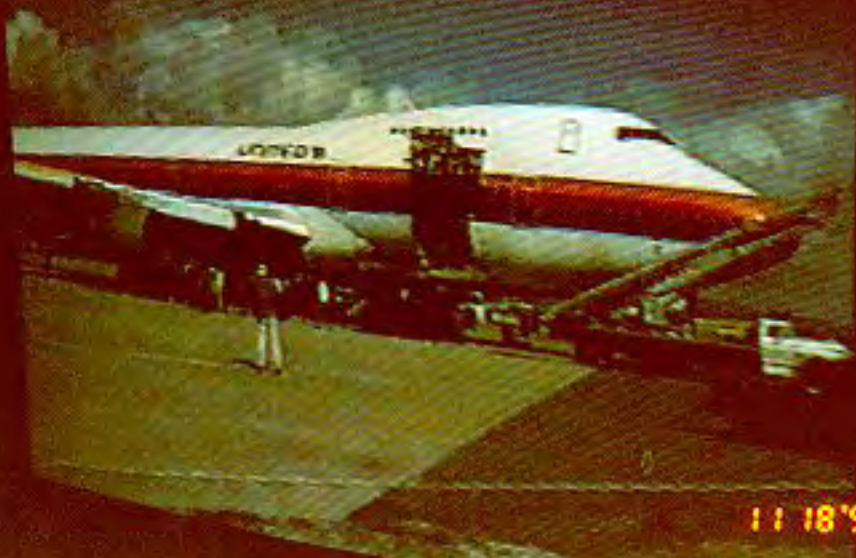
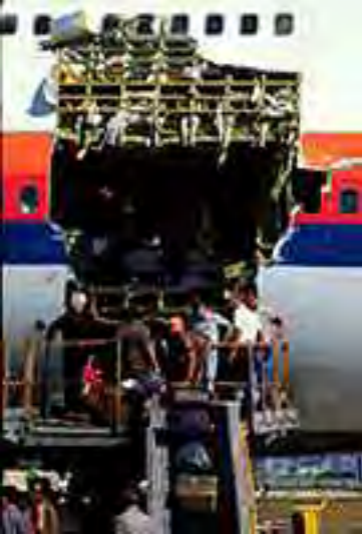
Examination of all structure around the area of primary damage disclosed no evidence of preexisting cracks or corrosion. All fractures were typical of fresh overstress breaks.

Figure 2.--Close-up view of hole and surrounding structure damage.
