Final Report

On the accident on **1st June 2009**
to the **Airbus A330-203**
registered **F-GZCP**
operated by **Air France**
flight AF 447 Rio de Janeiro - Paris

BEA

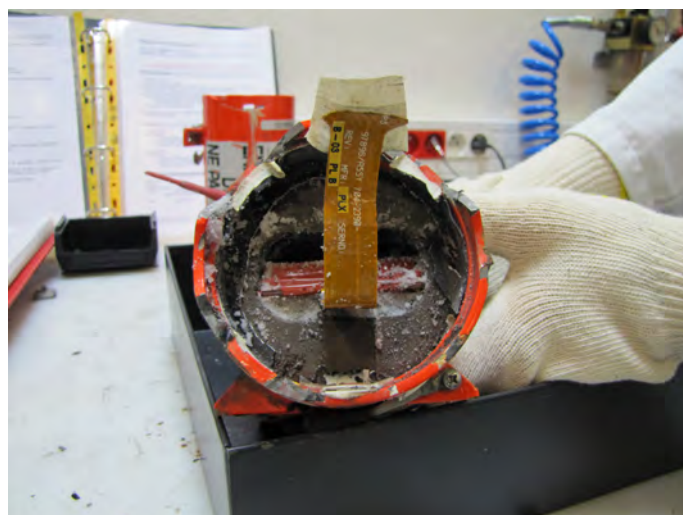
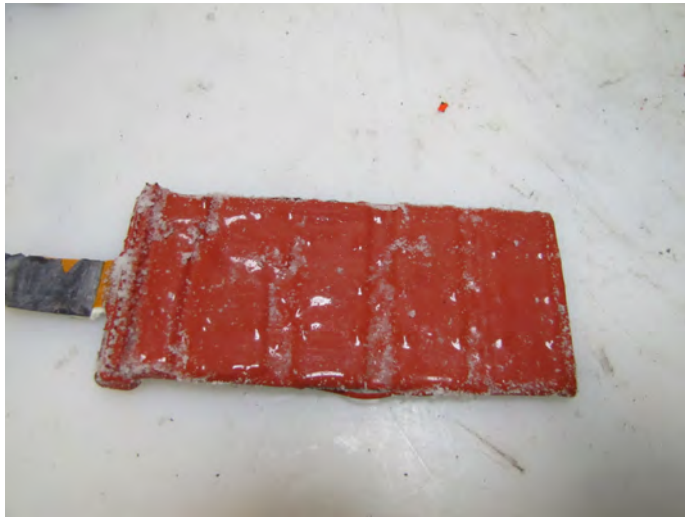
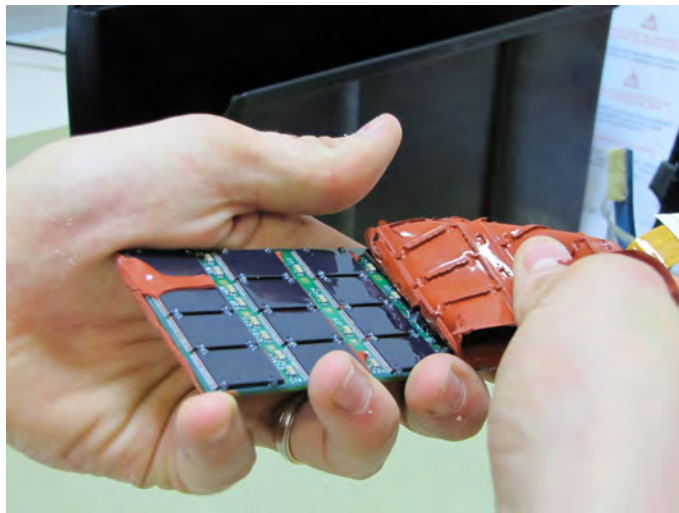
The memory board was cleaned. Visual inspection did not reveal any damage to the board. The board was placed in an oven for 36 hours in order to remove the moisture in the components and the printed circuit board. The impedance measurements that were then made on the input connector were in accordance with the measurements made on reference units.

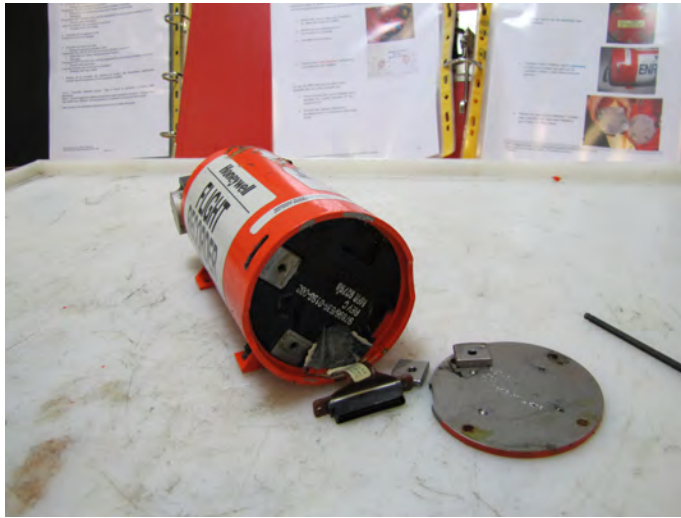
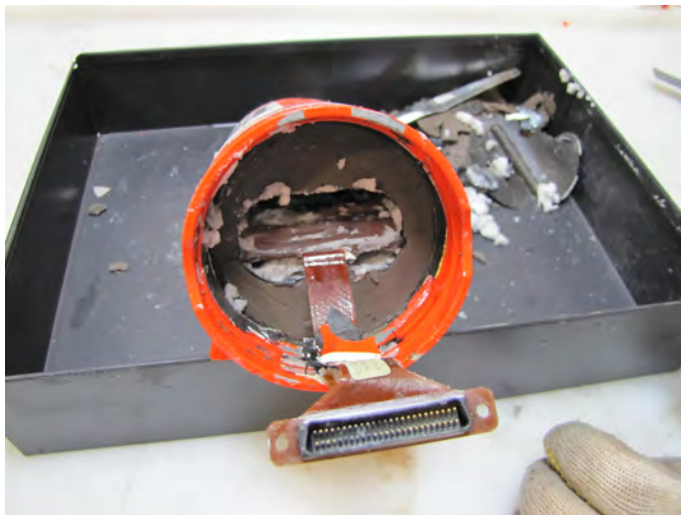
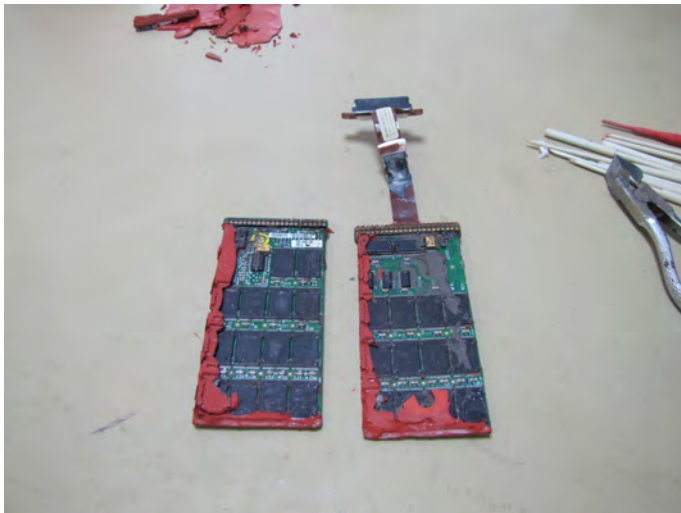
Visual inspection of the boards revealed damage: a capacitor and a resistor were cracked on one of the boards; two decoder-type components were damaged on the other board.

The boards were placed in an oven for 42 hours. The damaged components were unsoldered and replaced. The impedance value measured at the input connector complied with the measurements made on reference boards. The memory boards were then connected separately to the BEA's memory reader. A few memory components selected previously were addressed and read entirely. The consistency of the binary contents of each memory could then be checked using the manufacturer's hardware and software. The boards were then connected to the BEA's chassis and the data was extracted and decompressed using the manufacturer's official hardware.

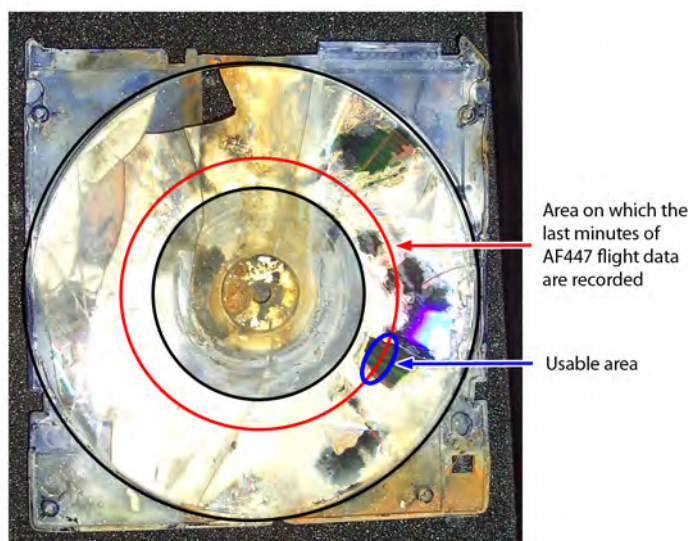
Figure 29: Optical disk showing the location of the readable zones

This computer is an unprotected parameter recorder used for flight analysis purposes by the operator. The data was recorded on a magneto-optical disk which was removed from the computer. The disk was so badly damaged that it was impossible to use traditional reading methods. It was therefore examined in collaboration with the solid-state physics laboratory at Paris-Sud University, and in conjunction with the manufacturer, Thales.

Readable zones were identified. The only zone likely to contain flight data was analysed. It relates to one second of information recorded every 100 seconds. Very little information could thus be recovered, and this data did not supplement the elements recovered by other means. The examination was therefore terminated after this feasibility study.

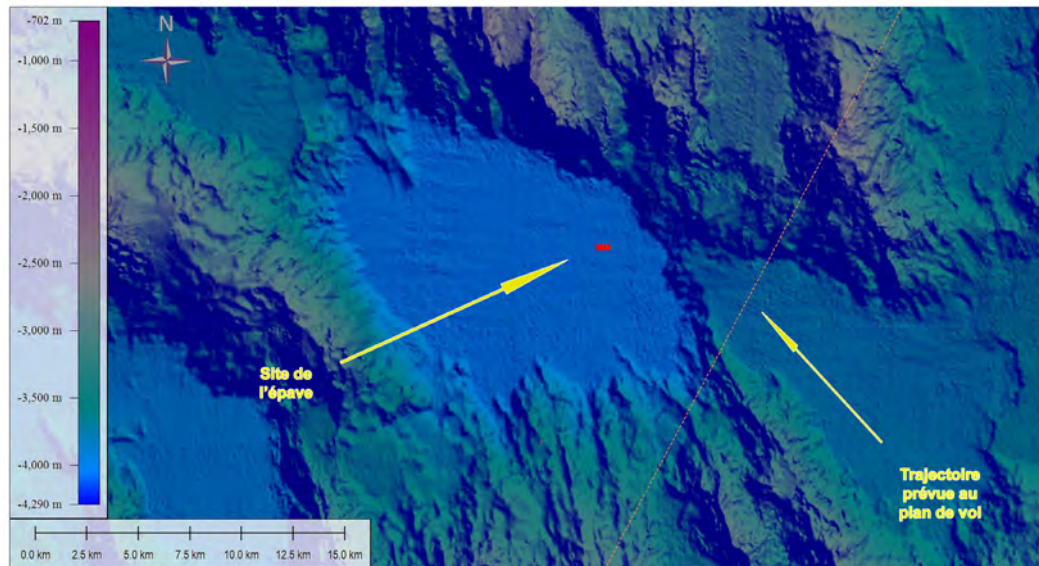
Figure 32: Wreckage localisation

The aeroplane wreckage was found about 6.5 NM on the radial 019 from the last known position, slightly to the left of the planned route. The wreckage rested on an abyssal plain at a depth of 3,900 metres. This plain, surrounded by terrain, made of clay type sediment, was around 15 km wide and was located west of the scheduled aeroplane flight path.

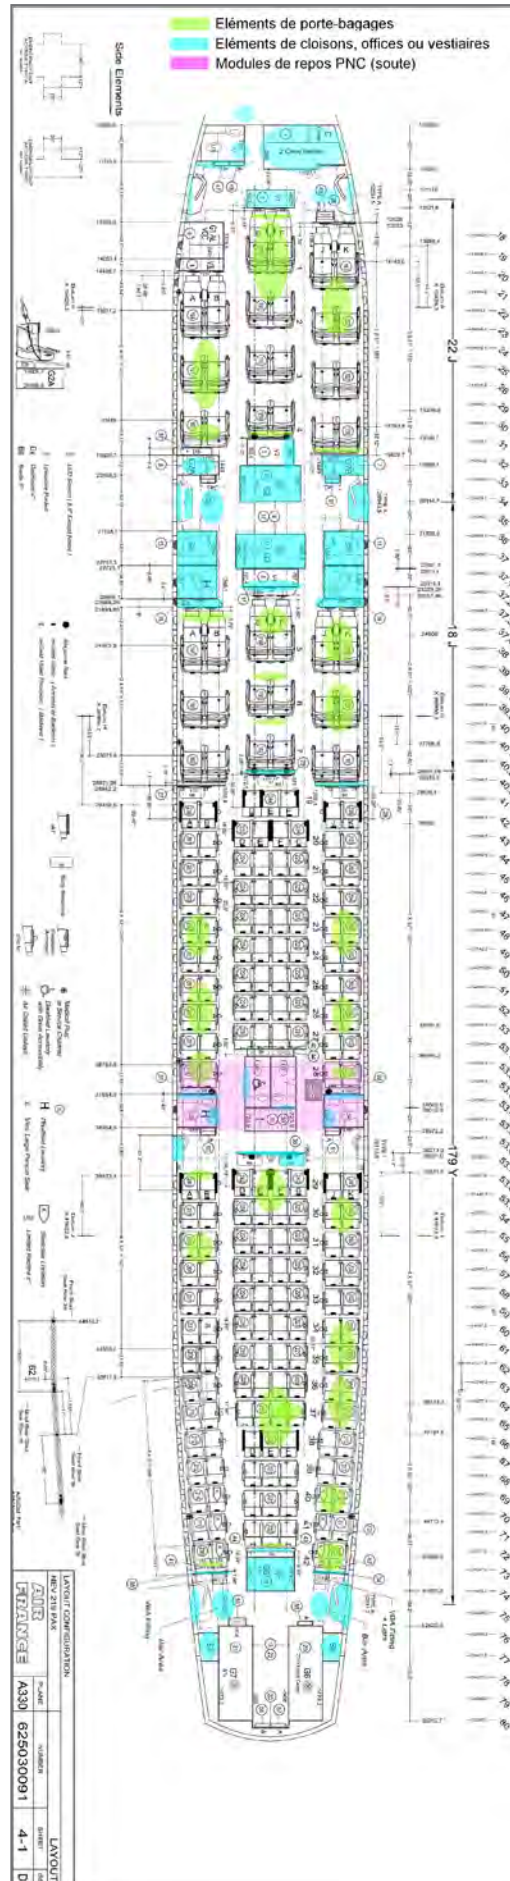
Figure 34: Position of the cabin part debris recovered in relation to the aircraft layout

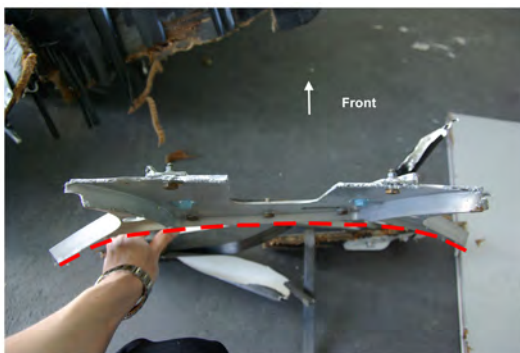
Figure 36: Luggage rack fitting deformed towards the front Toilet door (L54)

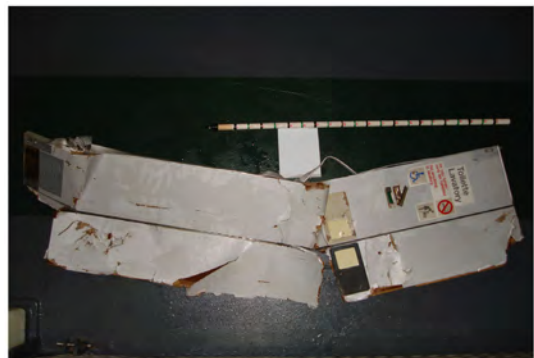
Figure 37: Metallic stiffeners deformed by buckling

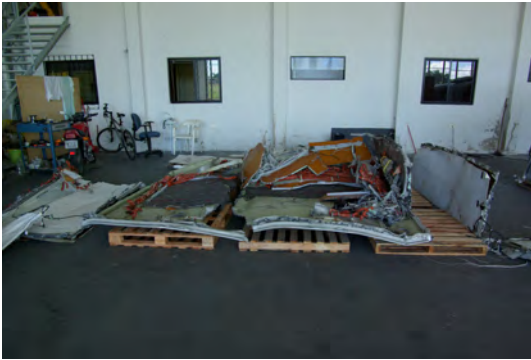
The wall fragments were crumpled. The reconstitution of the ceiling showed it was bent downwards and the floor bent upwards.

These deformations were symmetrical on the left and right sides with respect to the aircraft centreline.

Figure 38: Floor of the LDMCR:
with bottom-upwards deformation

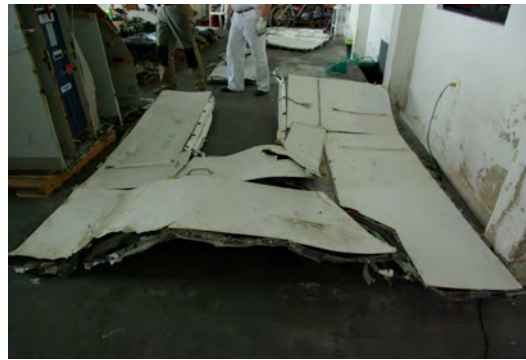
Figure 39: Ceiling of the LDMCR:
with top-downwards deformation

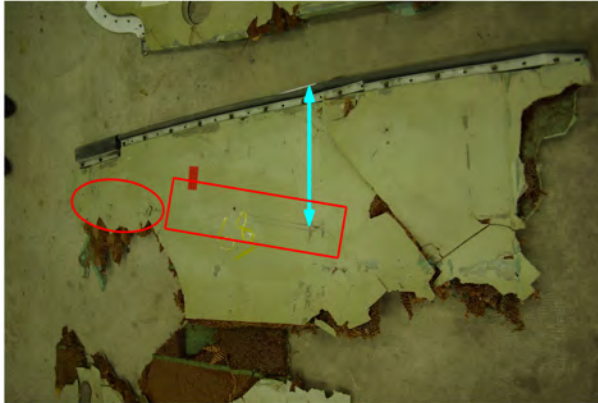
Several parts of the flap extension mechanism fairing were found. There were marks on two of them (positioned at the level of flap track N°3), made by the flap extension track on impact. Analysis of these marks (morphological and dimensional examinations) and comparison with an identical aeroplane made it possible to determine that the flaps were in the “retracted” position (see photo below) at the time of impact with the water (measurement of the distance between the track and the lower surface of the flap, position of the carriage on the track).

Figure 43: Part of the No. 3 flap track fairing on the left wing

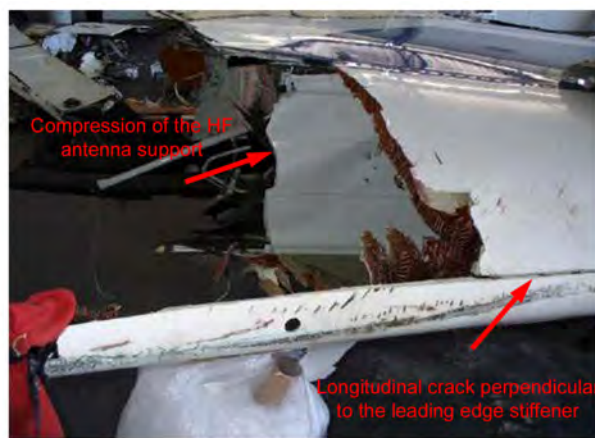
- ❑ Failure of the leading edge right- and left-hand panels
- ❑ Longitudinal cracking of the leading edge stiffener
- ❑ HF antenna support (attached to the forward spar): failure of the lower part, crumpling indicating bottom-upwards compression loads.

Figure 46: HF antenna support

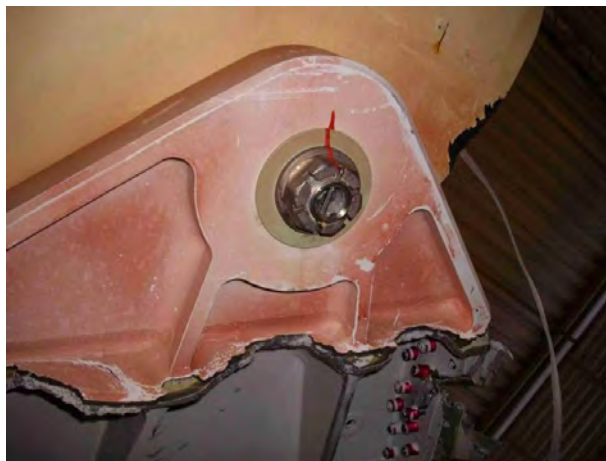
Figure 49: Right-hand aft lug: shearing of the fuselage along main frames 86-87

The part of frame 87 that can be seen had undergone S-shaped deformation: the left-hand side forwards, and the right-hand side backwards. The horizontal stabiliser actuator supports were deformed and broke in a backwards movement from the front. These observations indicate a backwards movement of the trimmable horizontal stabiliser.

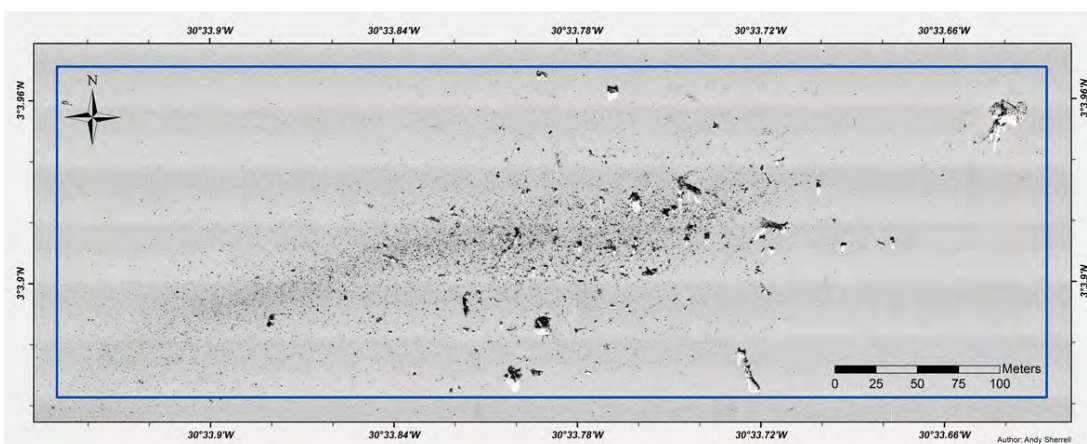
The densest debris (central section, engines, APU, landing gear) was found to the east of the site and the lighter debris to the west.

Outside the main area of 600 metres by 200 metres, a rear left fuselage panel containing eleven windows and around seven metres long was found approximately two kilometres south-west of the area. Part of the lower surface of the trimmable horizontal stabiliser was also found slightly to the south-west of this area.

Figure 55: Sonar Images of the debris field

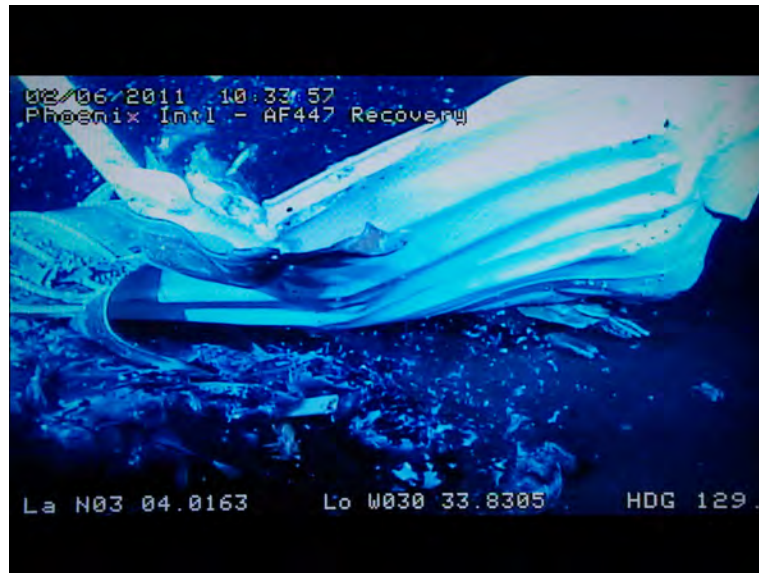
The lower elements of the fuselage were badly broken up and deformed. In these areas, crushing of the sheet-metal between the ribbing was noted, which indicates a vertical component at the time of impact.

Figure 56: Parts of the fuselage

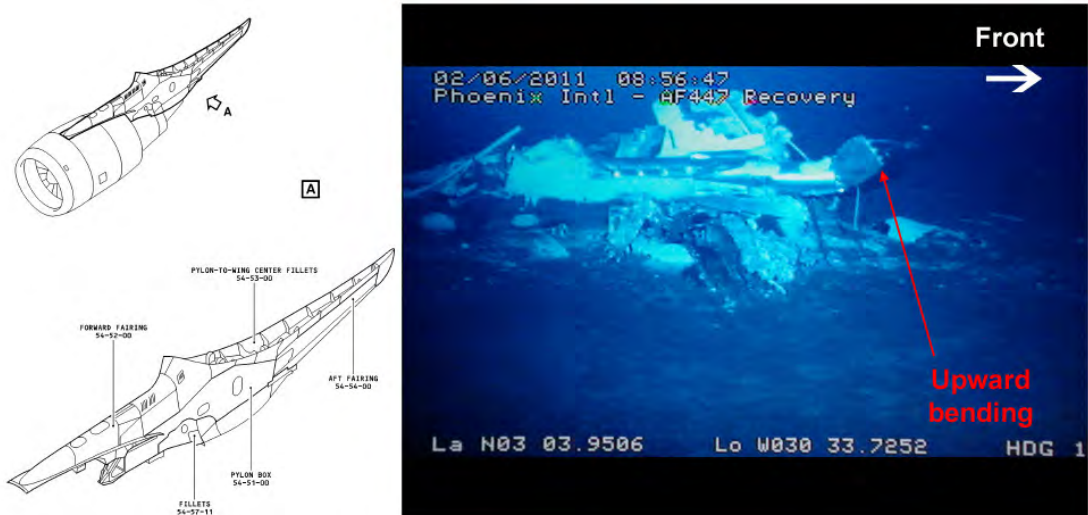
The engine pylons were found separated from the wings. They had deformations compatible with loads on the engines from below to above.

Figure 58: Engine pylon

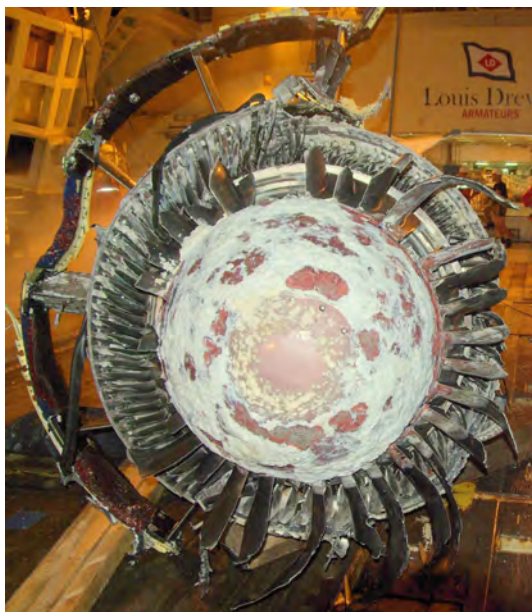
The visual examination of the two engines showed that they were at high RPM at the moment of impact with the sea.

Figure 60: Front view of engine

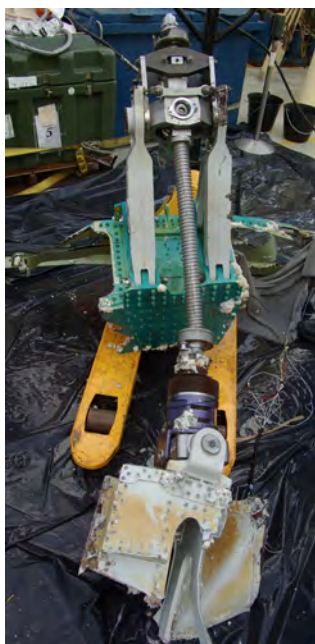
According to the manufacturer's technical documentation, the relative position of the actuator and the THS screwjack corresponded to a THS position of between 13° and 13.5° nose-up.

Figure 61: Trimmable horizontal stabiliser screwjack after being raised on board

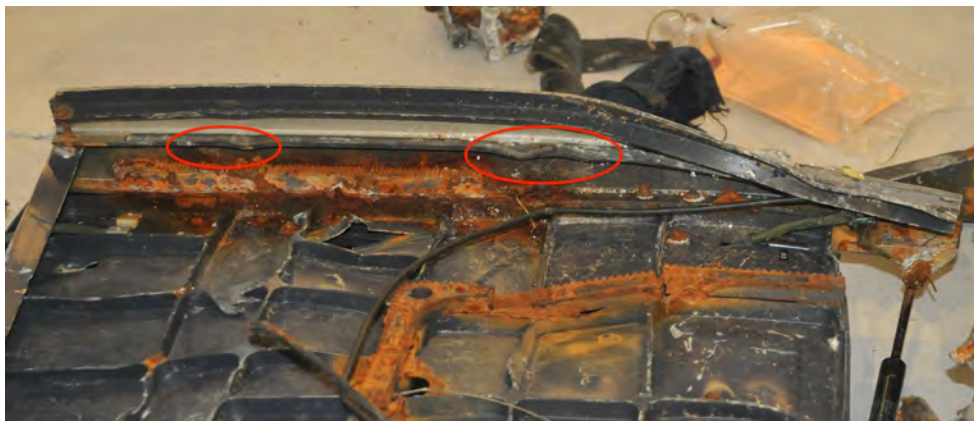
The marks left by the adjustment mechanism under the seat cushion enabled the horizontal position of the seat on impact to be determined: the seat was pushed back and moved to the left (in the "storage" position).

Figure 80: Roller marks on the guidance rail

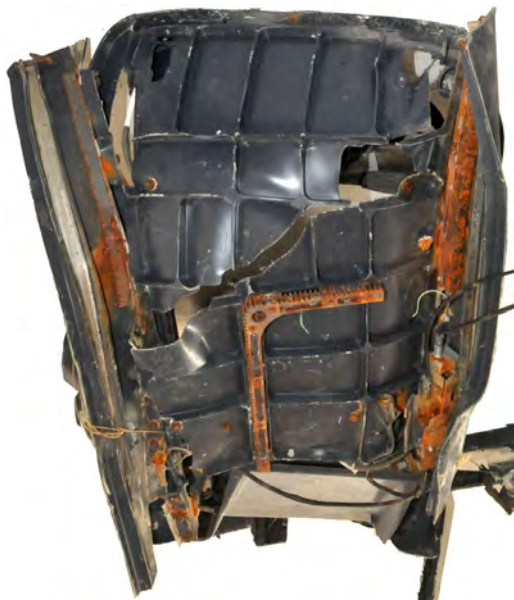
The marks left by the adjustment mechanism under the seat cushion enabled the horizontal position of the seat on impact to be determined. The seat was positioned 5.5 cm from the most forward position.

Figure 81: Right side seat cushion

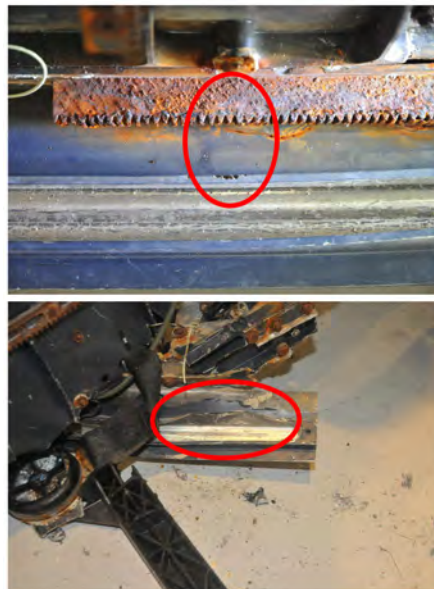
The threaded rods of the two tilt adjustment bolts were recovered almost completely drawn in, asymmetrically. For the same reasons as those explained for the left side seat, the positions deduced from observation of these bolts were not validated.

The seat's height adjustment mechanism was frozen at a height of 7.5 cm. The seat height may have been modified during impact. The height before impact may have been slightly higher (clutch slip).

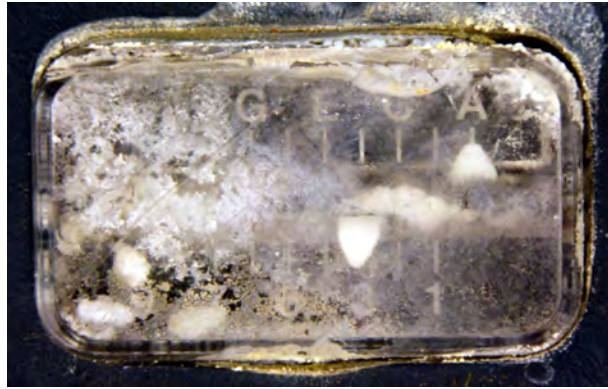
Figure 83: Dial indicating armrest position

The armrest was recovered in the up position, a probable consequence of the impact. The armrest position was indicated on the dial dedicated to this function. The needles were positioned on A values (adjustment from A to K for height) and 3 (adjustment from 1 to 9 for tilt angle). The armrest cladding was dismantled in order to check mechanism integrity and validate the needle positions. The mechanisms were demonstrated to be irreversible during certification tests, that is to say that leaning on the armrest did not modify the adjustments made with the knobs.

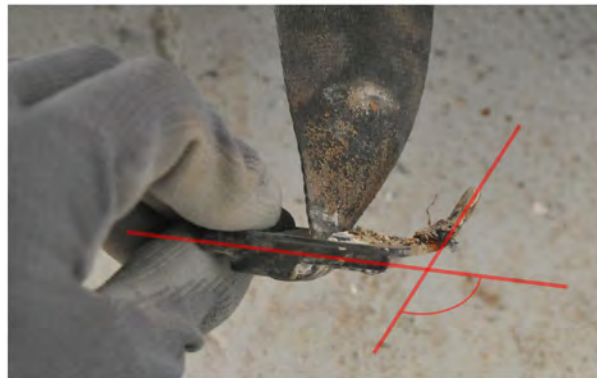
Figure 84: Malformation of the crotch belt fastening

The shoulder straps, the left lap belt and crotch belt were recovered detached. Examinations showed that on impact the left lap belt and crotch belt were locked and that the shoulder straps were not.

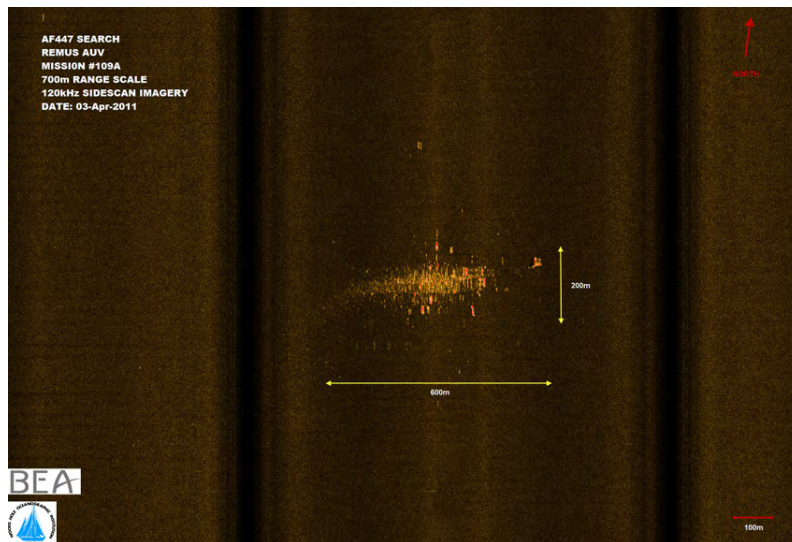
Figure 92: General view using sonar imaging: 120 kHz, range of 700 m

The first passage brought to light a concentration of backscattered data over an area of around 600 metres by 200 metres.

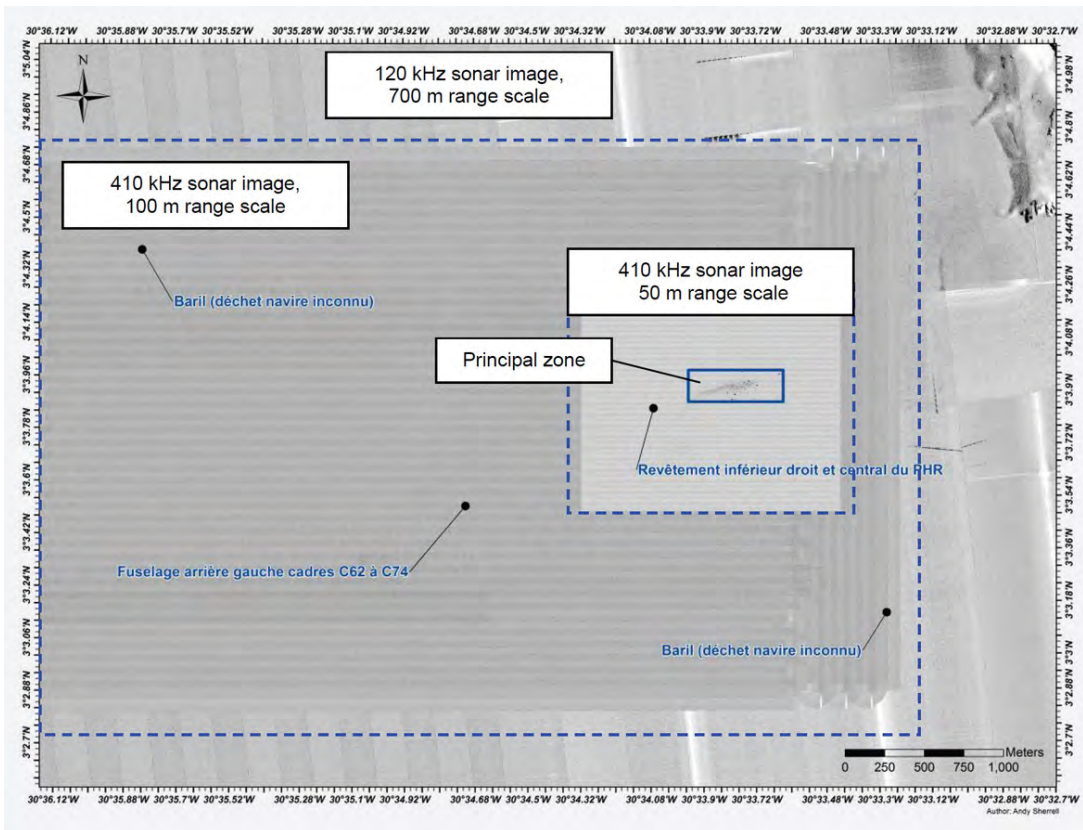
During phase 4, the area was scoured several times by the REMUS AUVs with different sonar settings to make sure that no possible debris, located beyond the main zone, was forgotten. This exploration made it possible to localize a part of the fuselage about two kilometres from this zone as well as objects such as oil drums that did not come from the aircraft (see the following figure). The initial imagery was subsequently enhanced by high resolution 410 kHz sonar images at various range scales.

Figure 97: Overlay of sonar images taken with various settings:
120 kHz, 700 m range scale - 410 kHz, 100 m range scale - 410 kHz, 50 m range scale

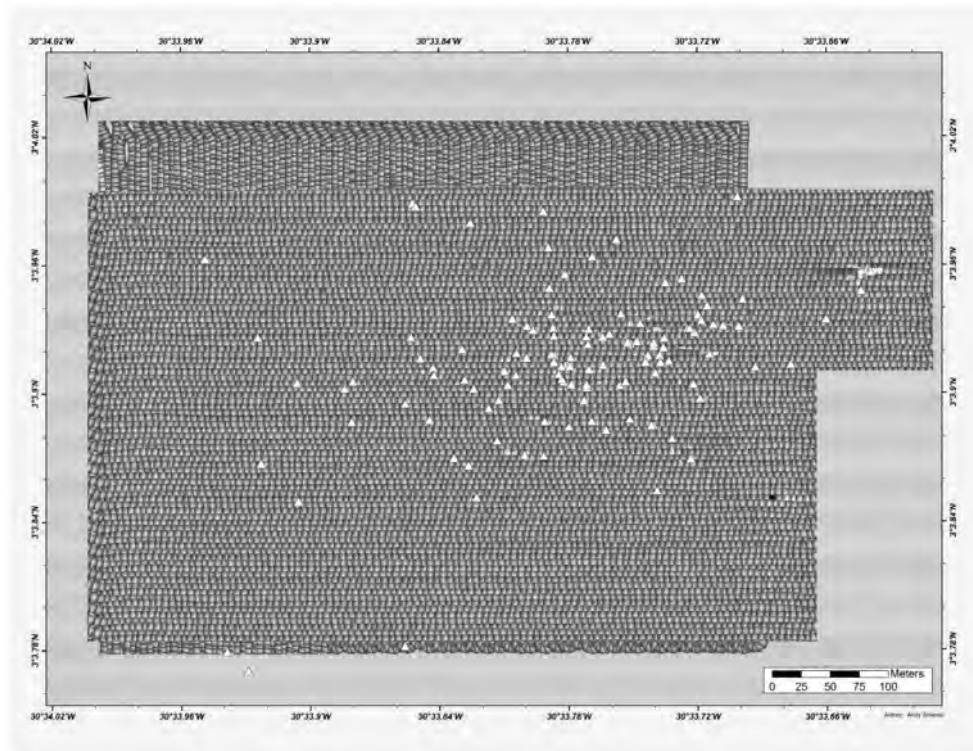
Figure 98: Visualisation of the photo mosaic obtained with REMUS AUV images and the aeroplane debris identified by using the REMORA ROV
