HAZARDS of ERRONEOUS GLIDESLOPE INDICATIONS

All airplanes equipped with instrument landing systems are vulnerable to capturing erroneous glideslope signals. Boeing, the International Civil Aviation Organization, and the U.S. Federal Aviation Administration are working together to improve awareness and prevent such errors. Flight crews can help manage the risk by understanding the problem and performing glideslope confidence checks.

SAFETY

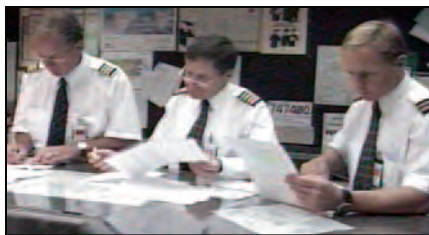
Human factors were very important in the successful outcome of the Air New Zealand incident. Crewmembers were alert to possible ILS problems because

notice to airmen (NOTAM) bulletins had informed them that the ILS was unmonitored, and they discussed this during their approach briefings. They also paid attention to subtle cues that something might be wrong, even though the automatic flight system was indicating normally. Last, the crewmembers were willing to execute a go-around to give them more time to sort through the conflicting information (fig. 3).
