**NATIONAL
TRANSPORTATION
SAFETY
BOARD**

AIRCRAFT ACCIDENT REPORT

**DELTA AIR LINES, INC.,
LOCKHEED L-101 1-385-1, N726DA
DALLAS/FORT WORTH -
INTERNATIONAL AIRPORT, TEXAS
AUGUST 2, 1985**

NTSB/AAR-86/05

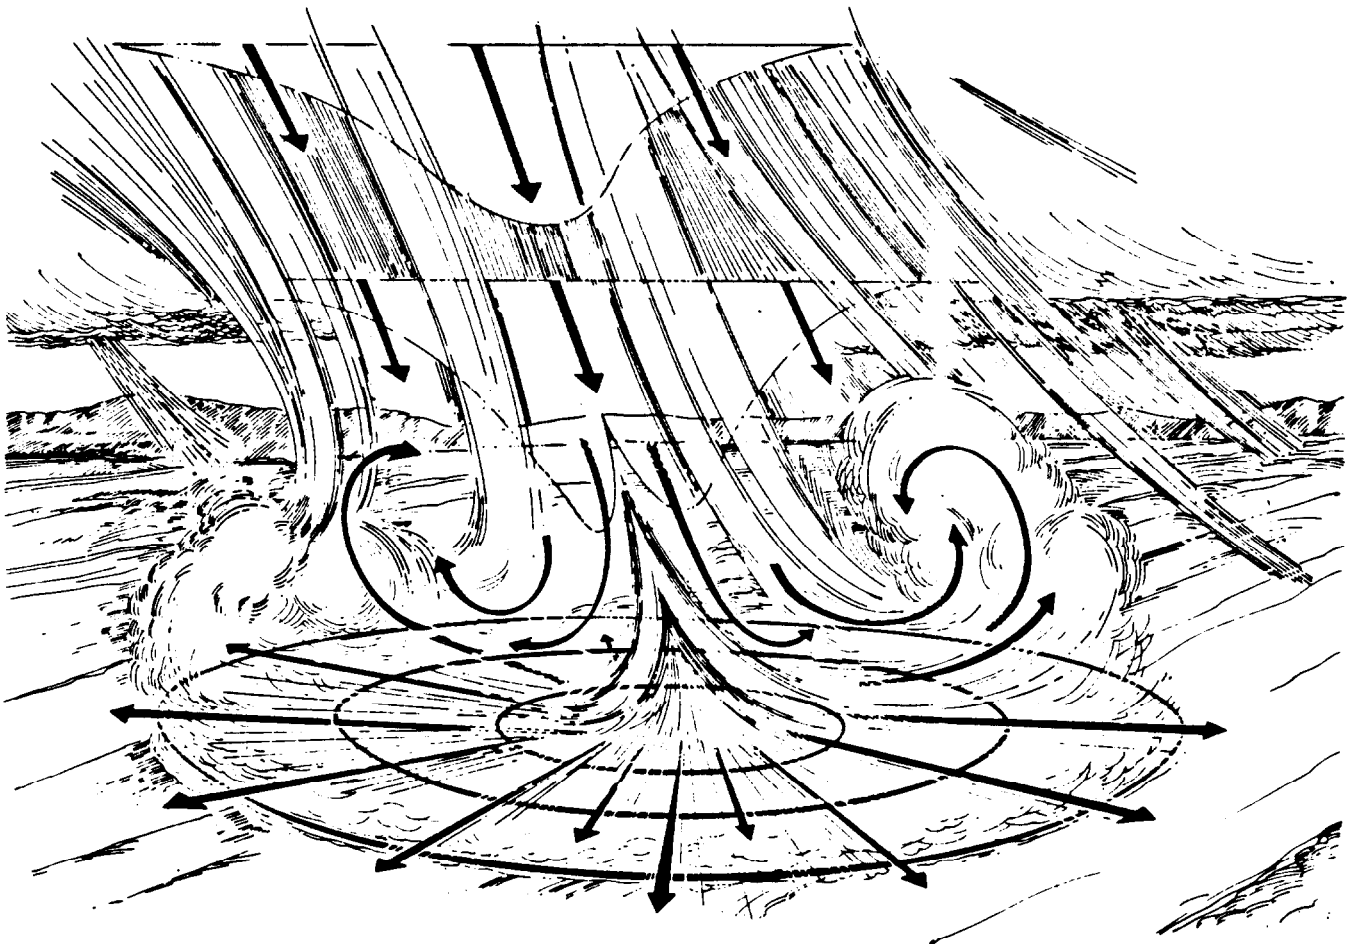
Figure 4.--Typical microburst wind field.

A downburst **20/** is a strong downdraft which induces an outburst of highly divergent damaging **winds** on or near the ground. Downbursts vary from less than 1 kilometer (**0.62** mile) to tens of kilometers in diameter. Downbursts are subdivided into macrobursts and microbursts according to their horizontal scale of damaging winds. A **macroburst's** horizontal wind field extends in excess of 4 kilometers (2.5 miles) in diameter, whereas the microburst's horizontal wind field extends less than 4 kilometers (2.5 miles) in diameter. (See figure 4.)
