PB2002-910401
NTSB/AAB-02/01
DCA00MA006

Aircraft Accident Brief

**EgyptAir Flight 990
Boeing 767-366ER, SU-GAP
60 Miles South of Nantucket, Massachusetts
October 31, 1999**

**NTSB/AAB-02/01
PB2002-910401
Adopted March 13, 2002**

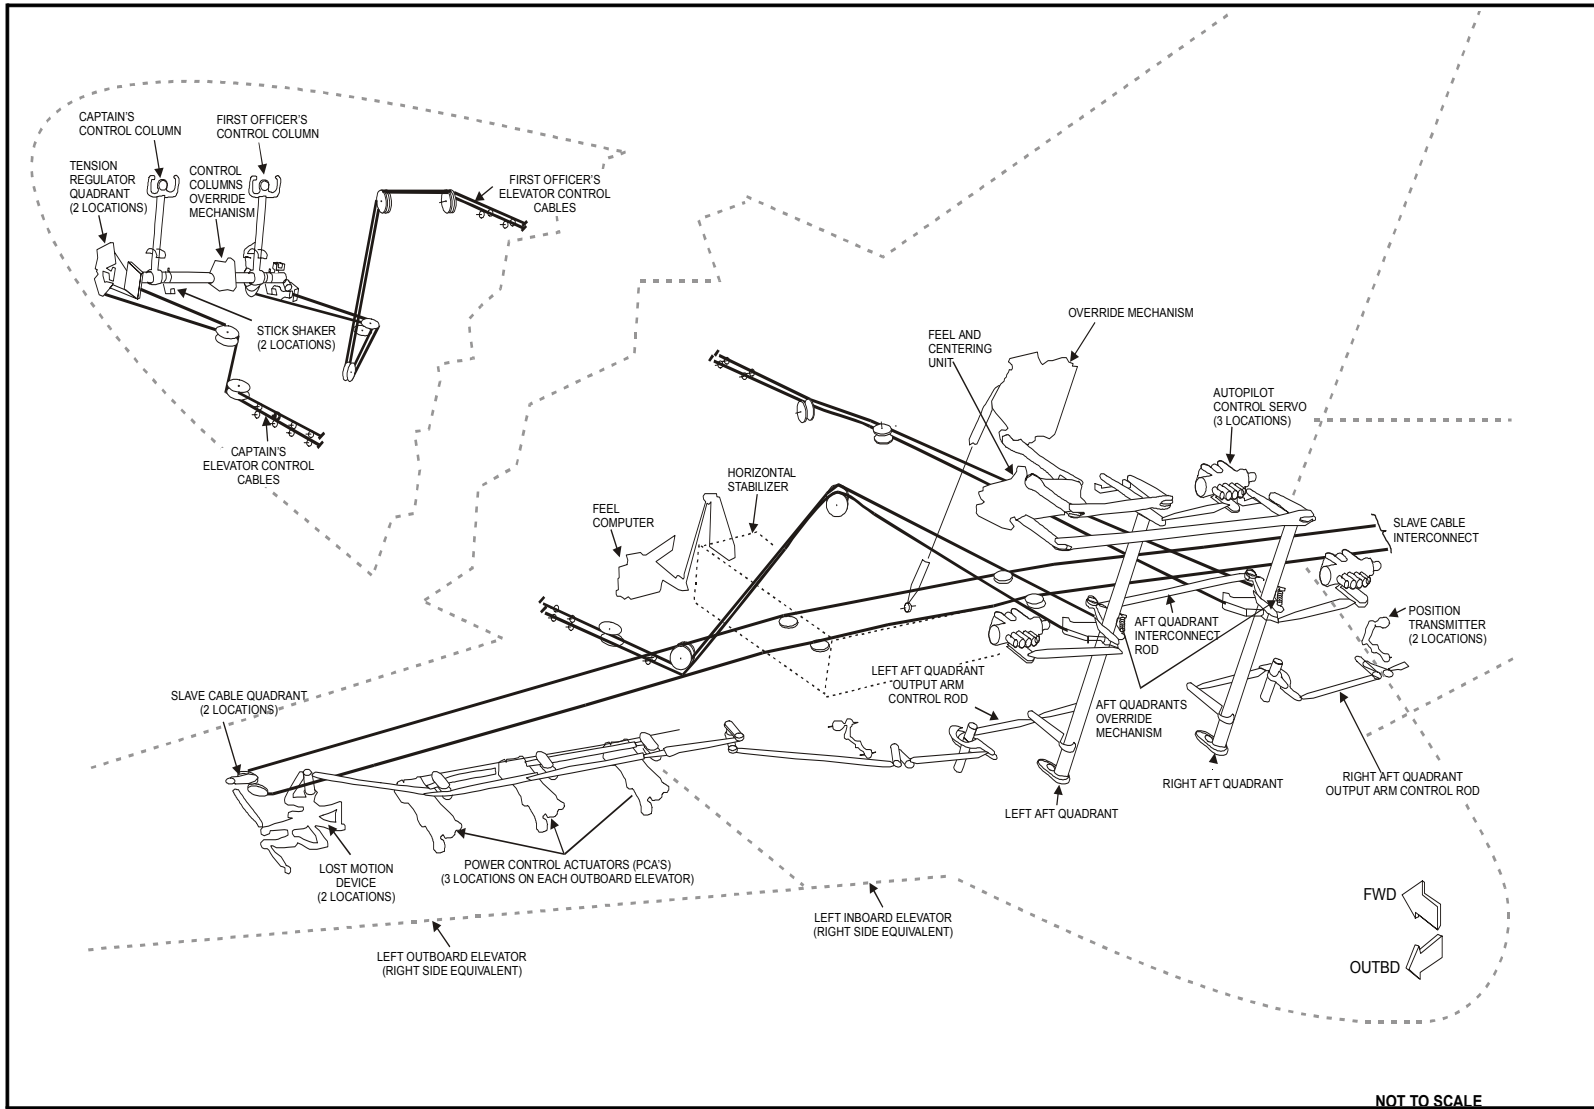
Figure 1a. Diagram of the components in the entire 767 elevator control system.

Because the accident sequence involved a sustained unusual motion about the airplane's pitch axis, the Safety Board examined the 767's longitudinal flight control system. According to the Boeing 767 Maintenance Manual, the 767's longitudinal flight control system includes two (left and right) sets of linked elevator surfaces (inboard and outboard), which are attached to the rear spar of the movable horizontal stabilizer by hinges. Each outboard elevator surface is driven by three power control actuators (PCA). Because the outboard and inboard surfaces are linked, the inboard elevator surfaces move when the outboard elevator surfaces are driven. Hydraulic power for elevator PCA movement is provided by the 767's three independent hydraulic systems—each hydraulic system powers one of each elevator surface's PCAs, which provides redundancy within the elevator control system. (Components in the elevator control system are shown in figures 1a and 1b.)

5. (Page 15, footnote 32) The routing of the cable in Figure 1a appears to be the opposite of the routing described in the footnote.

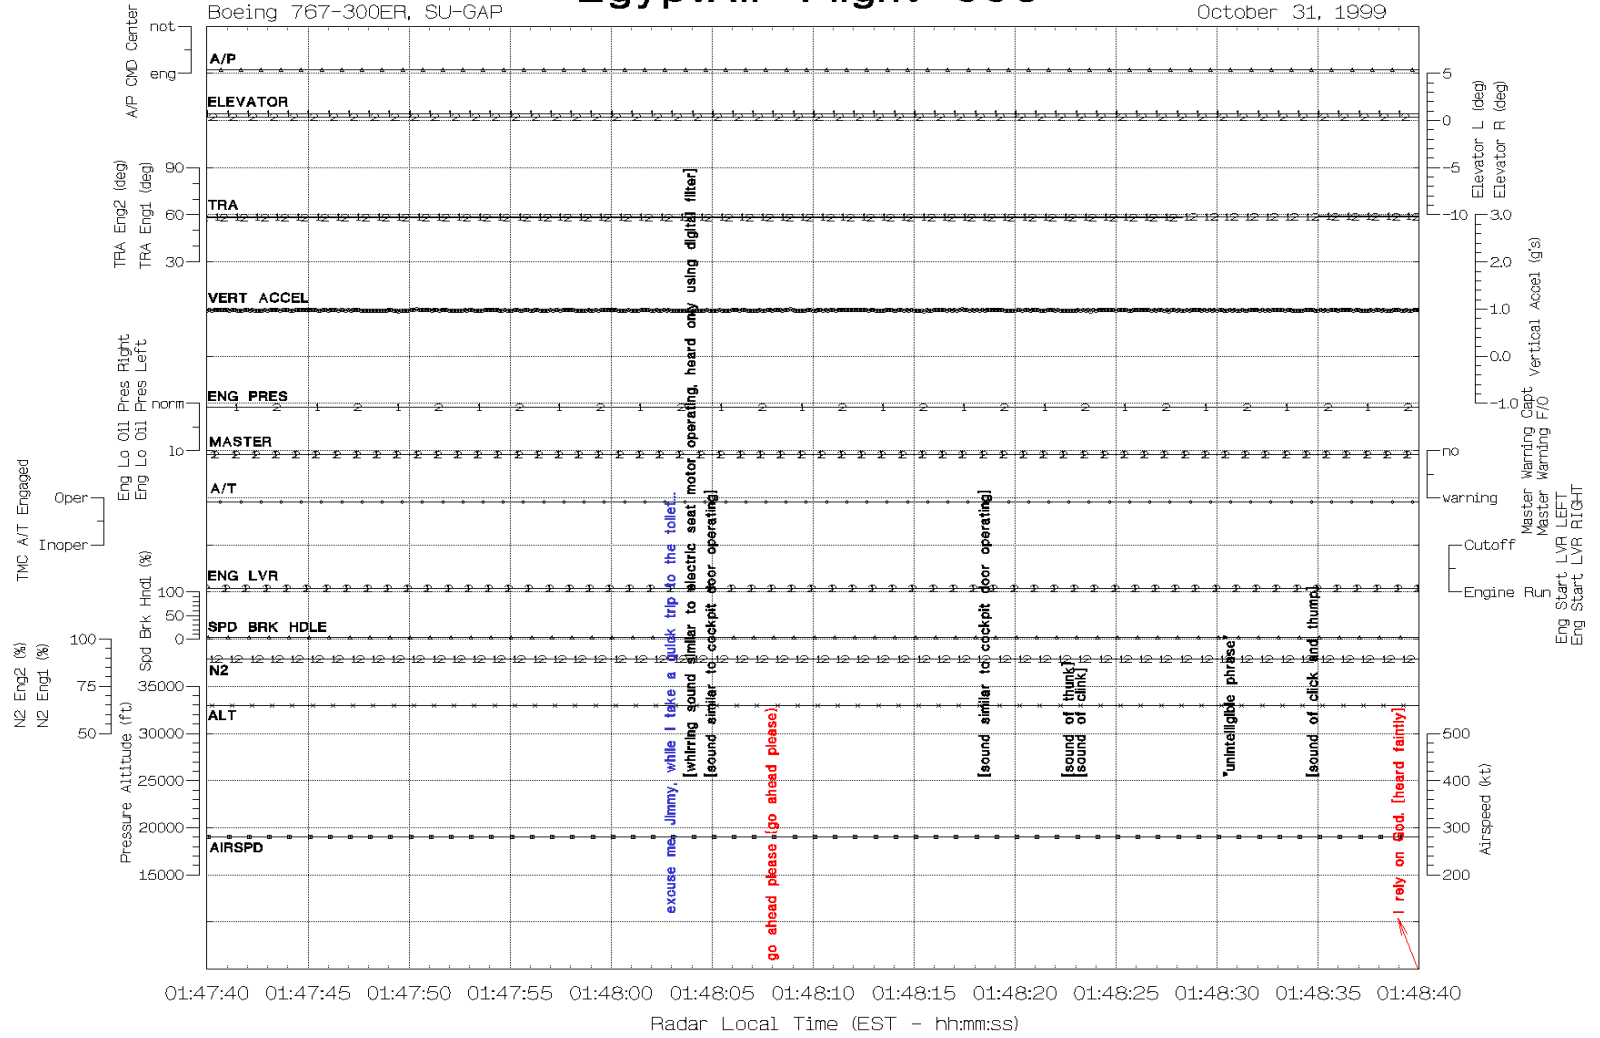
Figure 3a. A graph depicting selected FDR data from 1:47.40 to 1:48.40.

Flight performance parameters recorded by the FDR included the following: pressure altitude; airspeed (computed); engine rpm; pitch; roll; heading; angle of attack; normal (vertical), longitudinal, and lateral acceleration (load factors); left and right elevator positions; left and right inboard and outboard aileron positions; left and right trailing edge flap positions; rudder position; and horizontal stabilizer position. In addition, the FDR recorded speedbrake handle position, throttle resolver angle, autopilot engagement/disengagement, engine low oil pressure, and engine fuel cut signals. The FDR was not required to and did not record control wheel, control column, or spoiler positions nor did it record control wheel and column forces.⁵³ Excerpts from the FDR data plots and CVR transcript are shown in figures 3a through 3h.
