AIRCRAFT ACCIDENT REPORT

**CONTROLLED FLIGHT INTO TERRAIN
AIR CHINA INTERNATIONAL FLIGHT 129
B767-200ER, B2552
MOUNTAIN DOTDAE, GIMHAE
APRIL 15, 2002**

**KOREA MINISTRY OF CONSTRUCTION AND TRANSPORTATION
KOREA AVIATION-ACCIDENT INVESTIGATION BOARD**

KAIB/AAR F0201
Adopted March 4, 2005

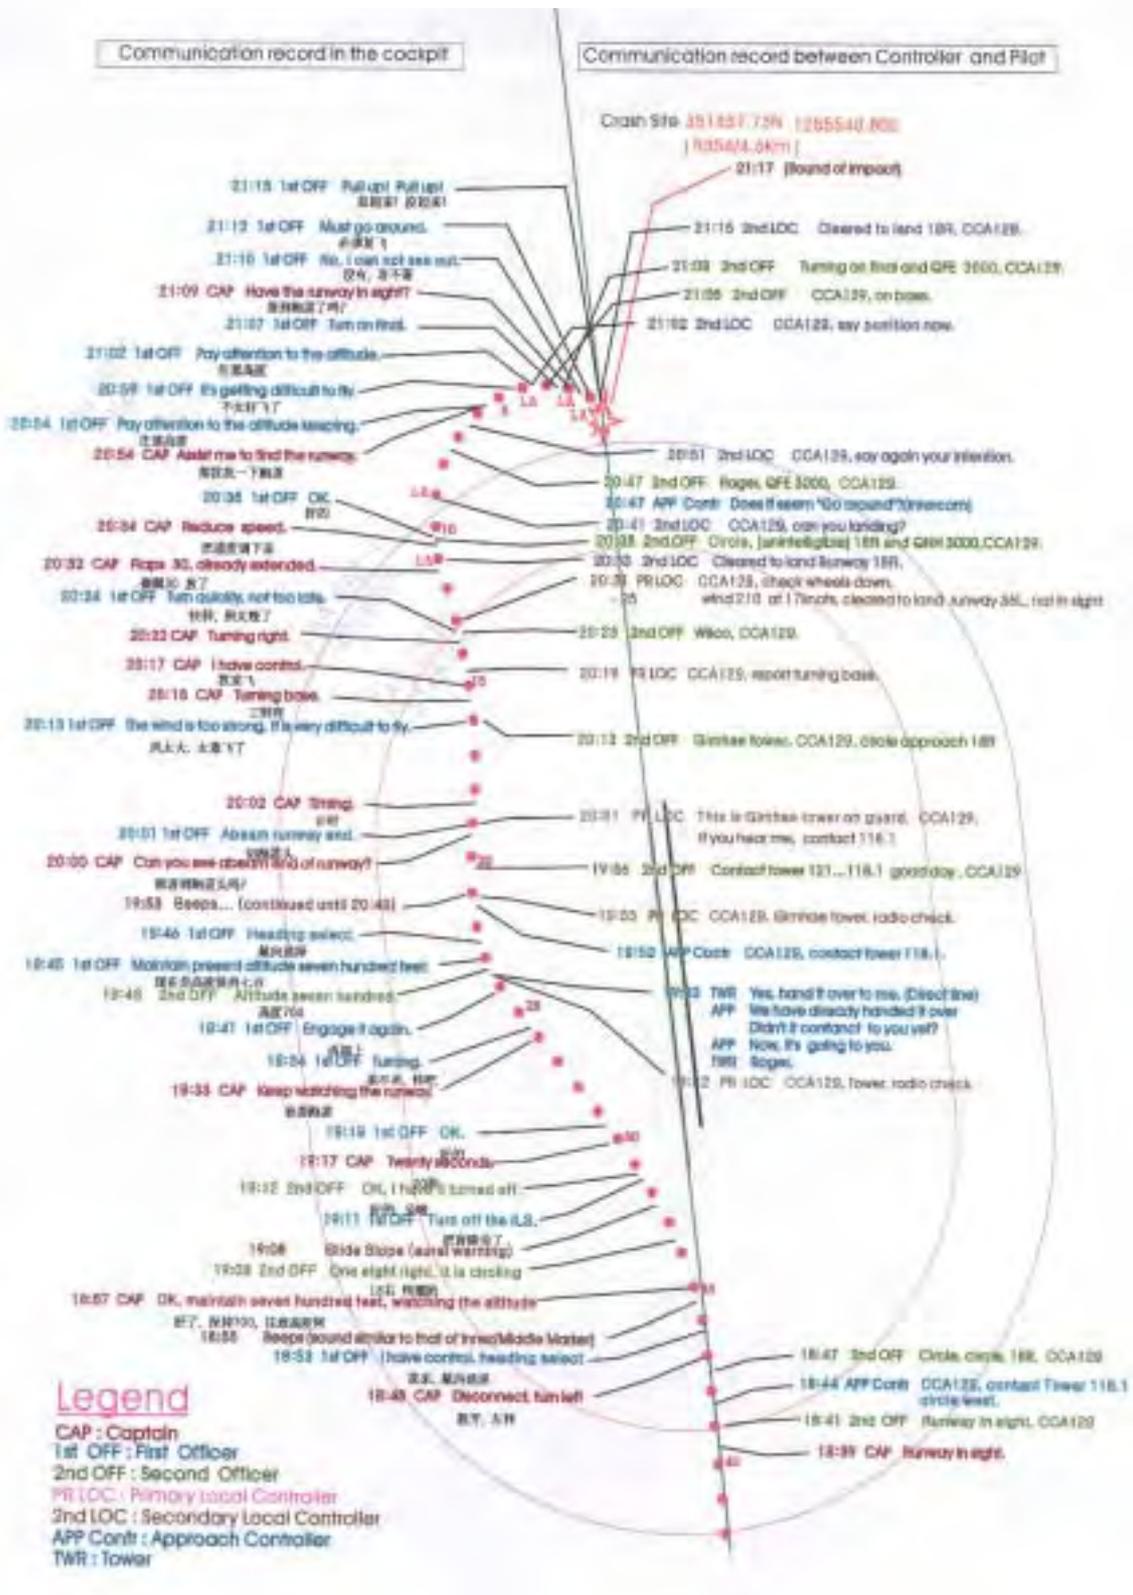
Figure 1-2 CVR & ATC Transcripts Plotted along the Flight Track from the FDR Data (English and Chinese Version)

Figure 1-1 (in Korean) and Figure 1-2 (in English) depict the flight track from the pertinent FDR data, with the communications of CVR and ATC tape recording transcripts, plotted on the chart, during the circling approach at Gimhae airport, until the time of accident.

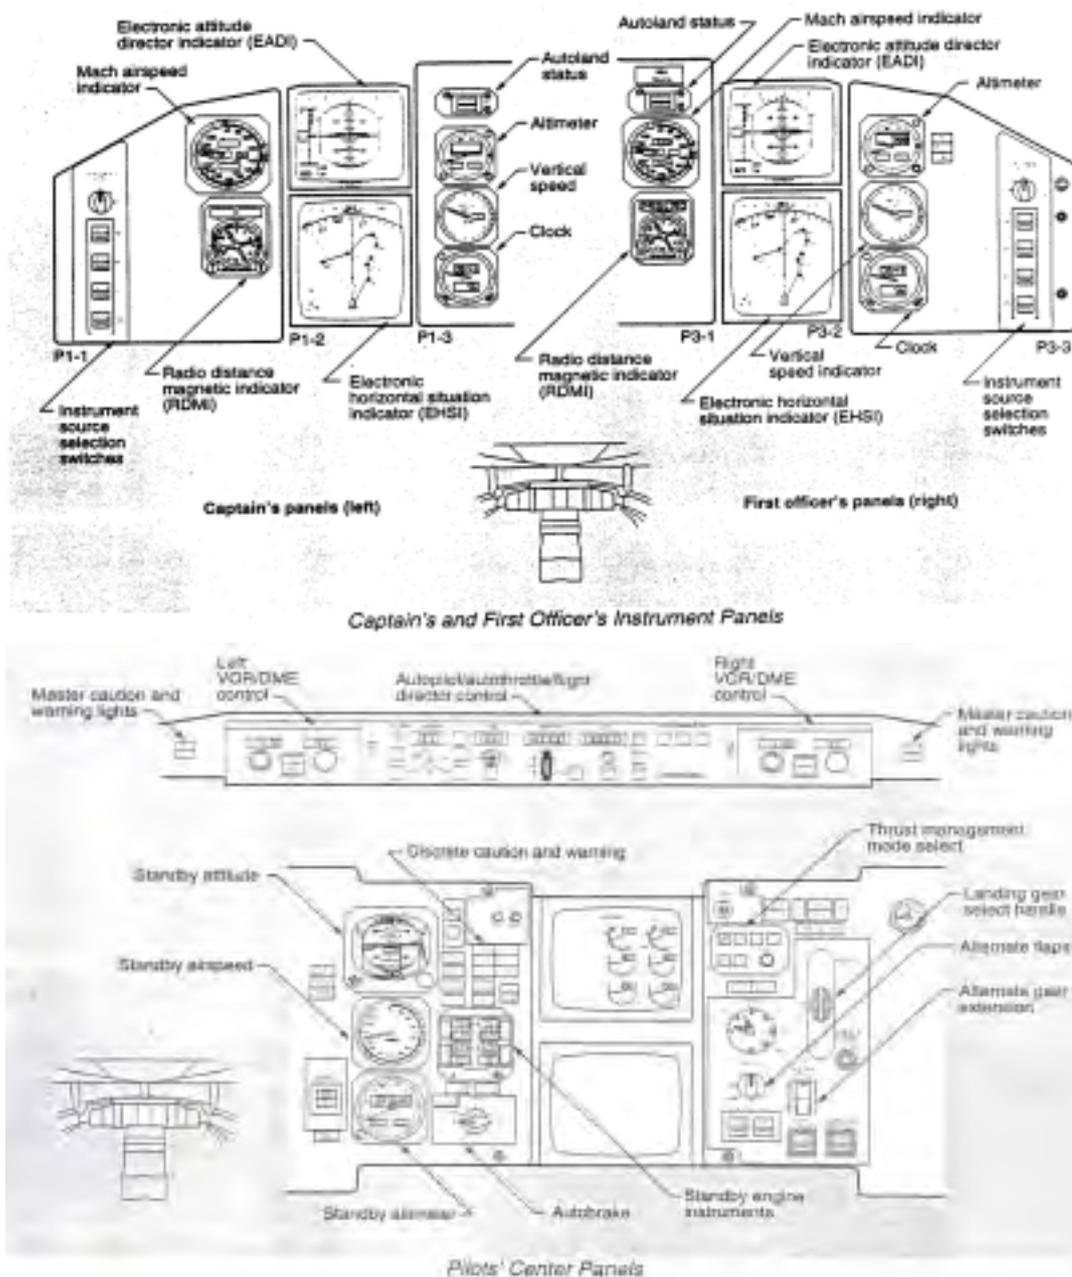
Figure 1-4 Captain's and First Officer's Front Instrument Panels

The flight deck and the forward electronics bay were completely destroyed by impact forces and a postcrash fire. One burnt airspeed indicator, with the needle indicating approximately 138 kt, was found at the accident site.

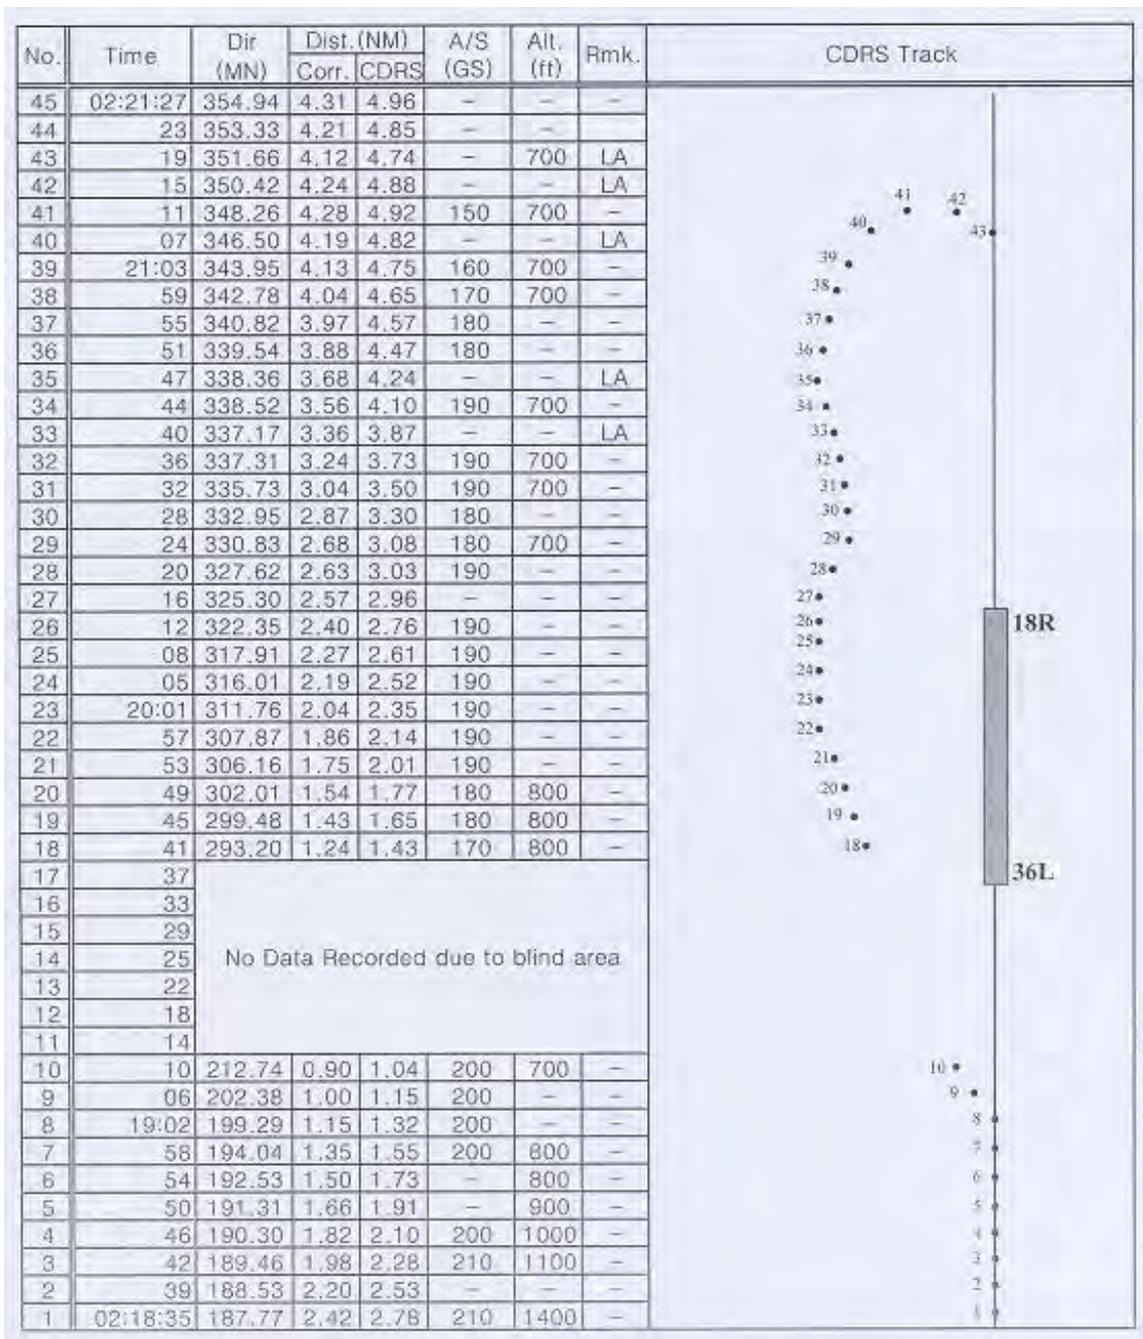
Figure 1-6 CDRS Data

Figures 1-6 and 1-7 illustrate respectively the radar track data and the circling approach area of flight 129 during the circling approach to runway 18R.

* Approximately 200 ~ 1,100 meters of difference existed from the final approach course to runway 36L to the crash point in the flight track on the drawing based on the CDRS data scaled one to 50,000, thus the CDRS data (distance) was multiplied by an invariable number 0.868976, and the revised the distance was calculated for the correction on the drawing. The flight track was composed on the basis of the revised data.

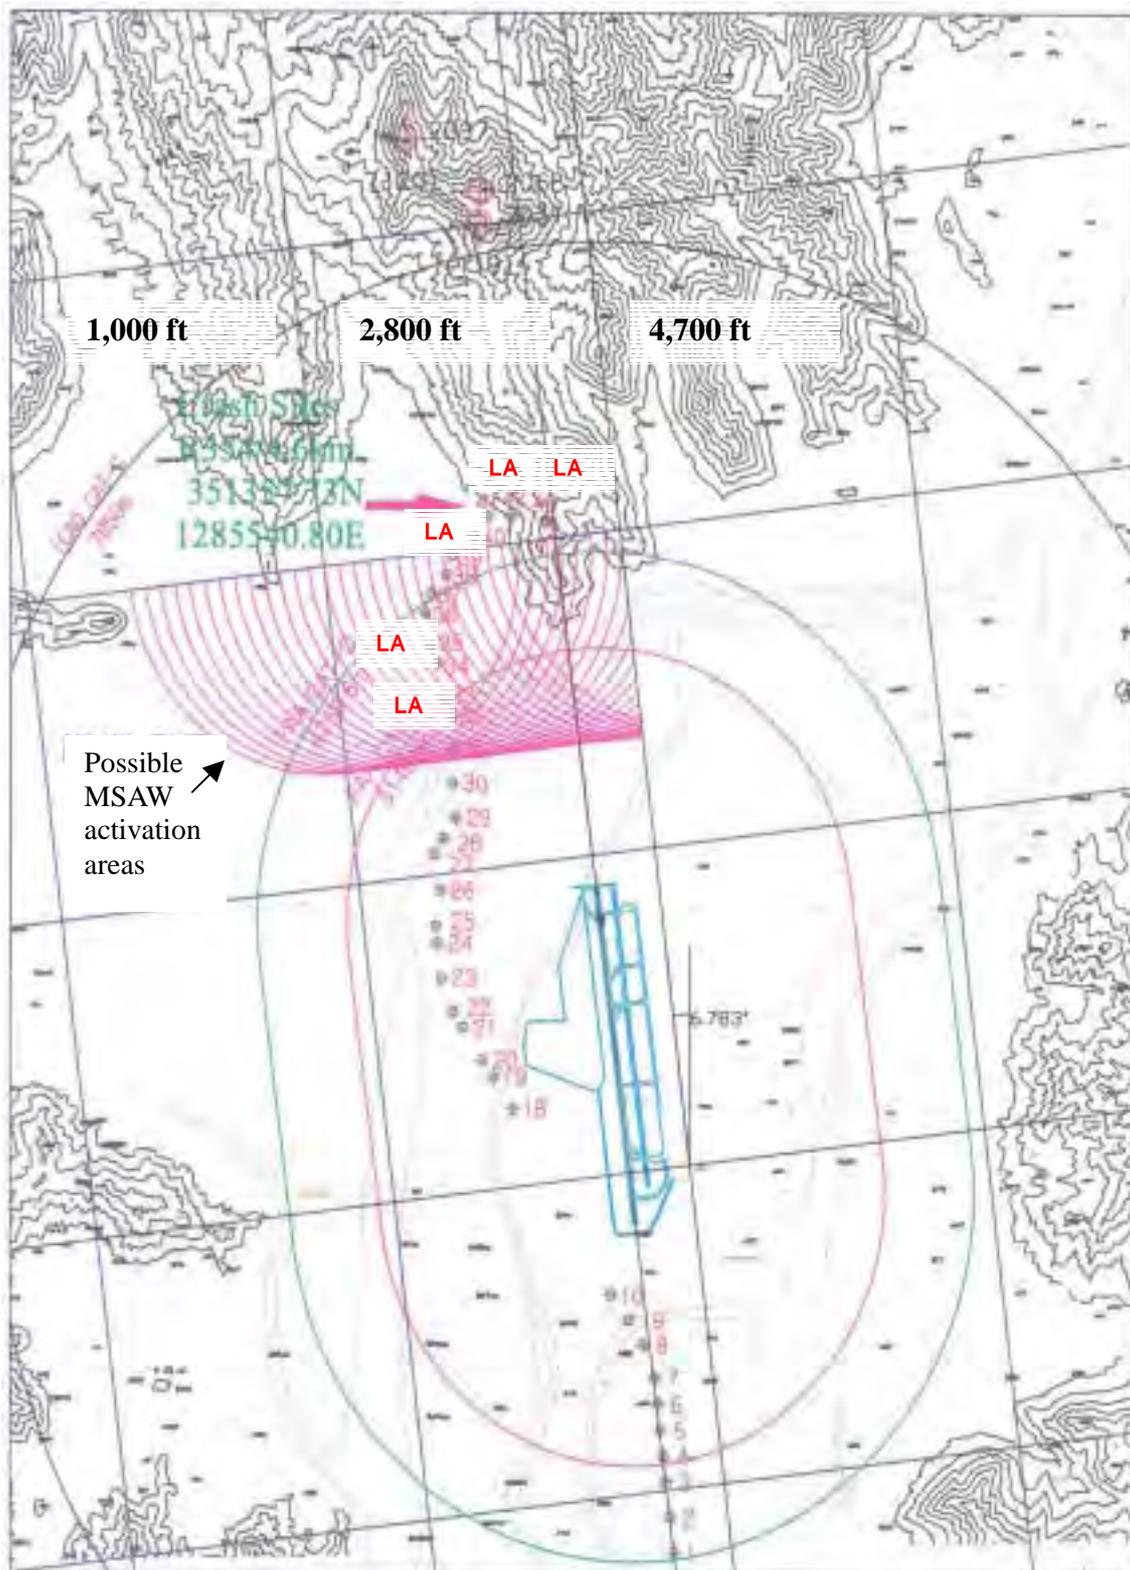
Figure 1-9 Possible MSAW Activation Areas and Circling Approach Area

The MSAW was programmed according to the standards described in the Airforce manual. The approach control area was divided into 2 NM square bins, for a total of 4,900 bins, where the minimum safe altitude of each bin was programmed with 700 ft above the highest obstacle. As shown on Figure 1-9, the minimum safe altitude of the airport's northern bin where Mt. Shinuh⁶⁰ is positioned was programmed to 2,800 ft in consideration of the height of that mountain (2,076 ft), and it was set to 1,000 ft for the west bin, and 4,700 ft for the east bin respectively.

Figure 1-9 illustrates possible MSAW activation areas⁶¹ along with circling approach area by the FAA and ICAO standards.

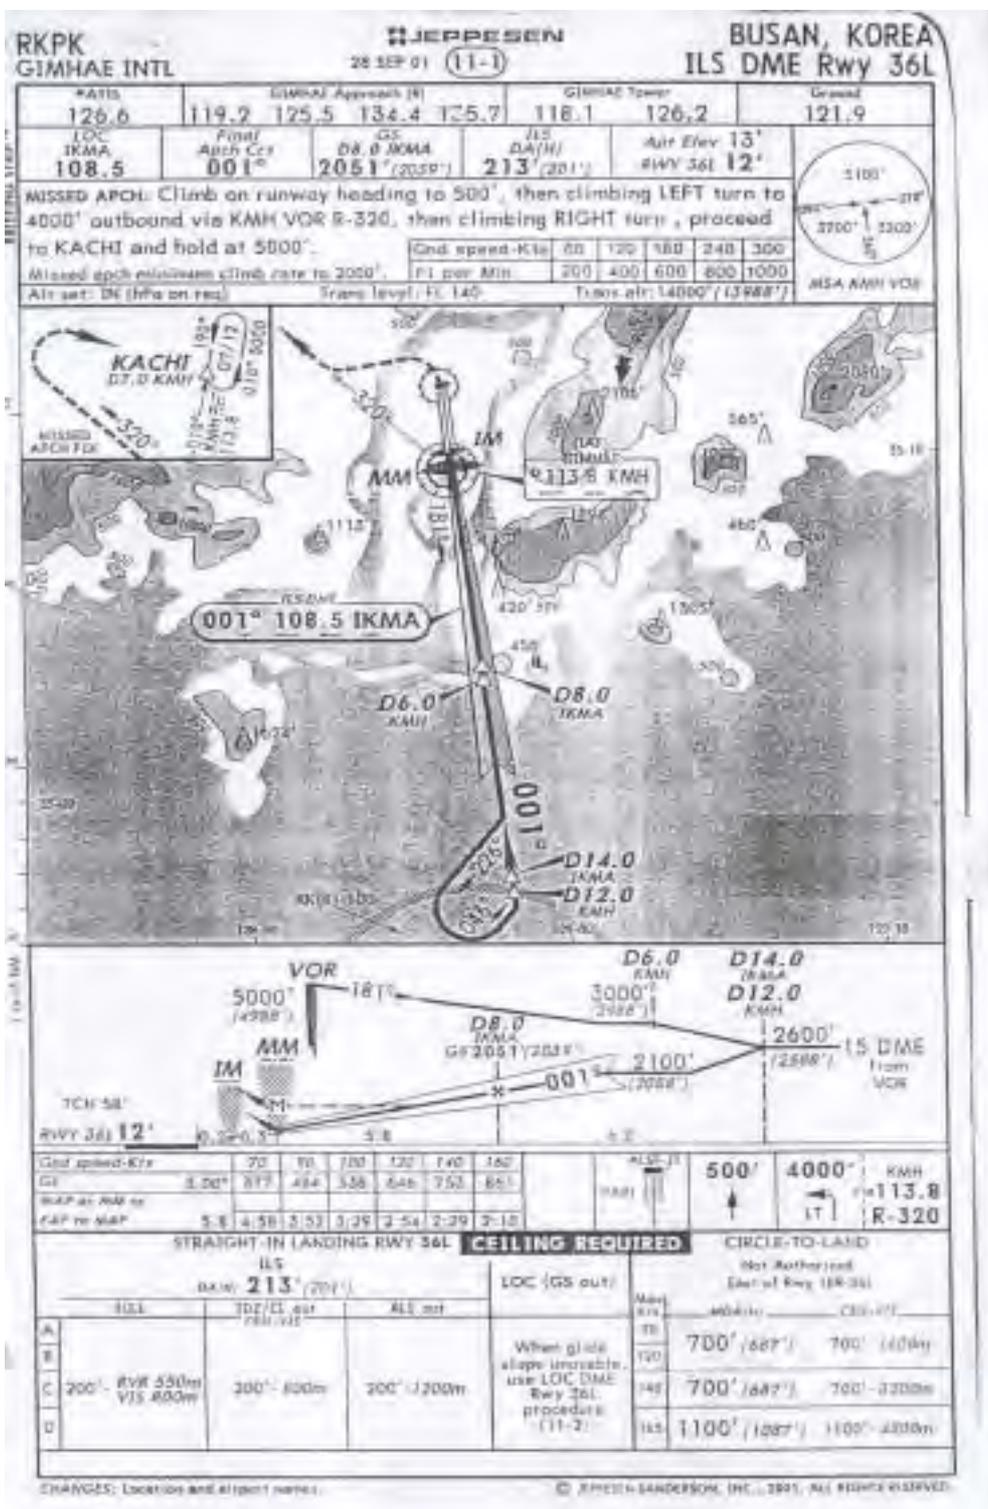
Figure 1-11A RWY 36L Instrument Approach Chart (Issued date: SEP 25, 01)

The instrument approach chart used⁶⁶ by the flight crew of flight 129 as shown on Figure 1-11A (ILS DME Rwy 36L, effective SEP 25, 01), displayed the plan view with contour lines and different shades of color to show heights of the terrain, and obstacle symbols marked with the elevations. The enlarged depiction of the missed approach holding precluded showing the obstacles to the north of the circling approach area. The Jeppesen chart of the Busan, Korea ILS DME or LOC DME Rwy 36L published Oct 25, 2002 was revised according to the amended ROK AIP. Jeppesen took the opportunity in this revision to improve the plan view depiction by changing the plan view scale to include a larger area, including the terrain and obstacles in the vicinity of the accident as shown on Figure 1-11B.

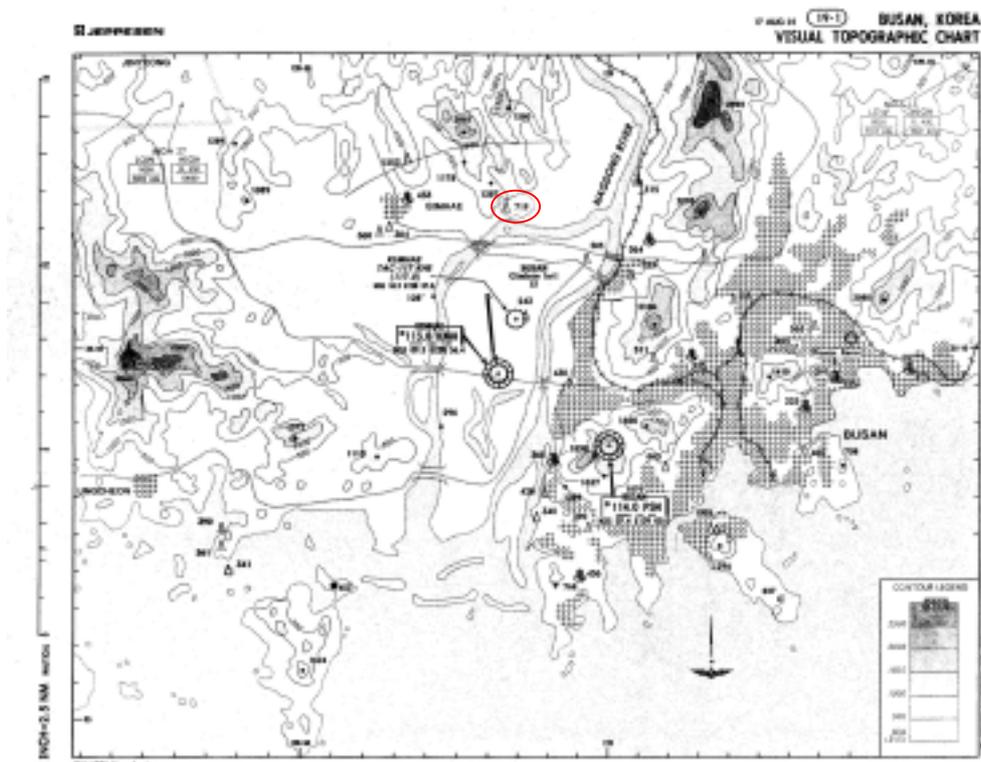
Figure 1-12 Visual Topographic Chart (Jeppesen RKP 19-1)

The Jeppesen manual, page 19-1 of Gimhae airport, a visual topographic chart as shown on Figure 1-12, did contain detailed obstacle and topographic information.

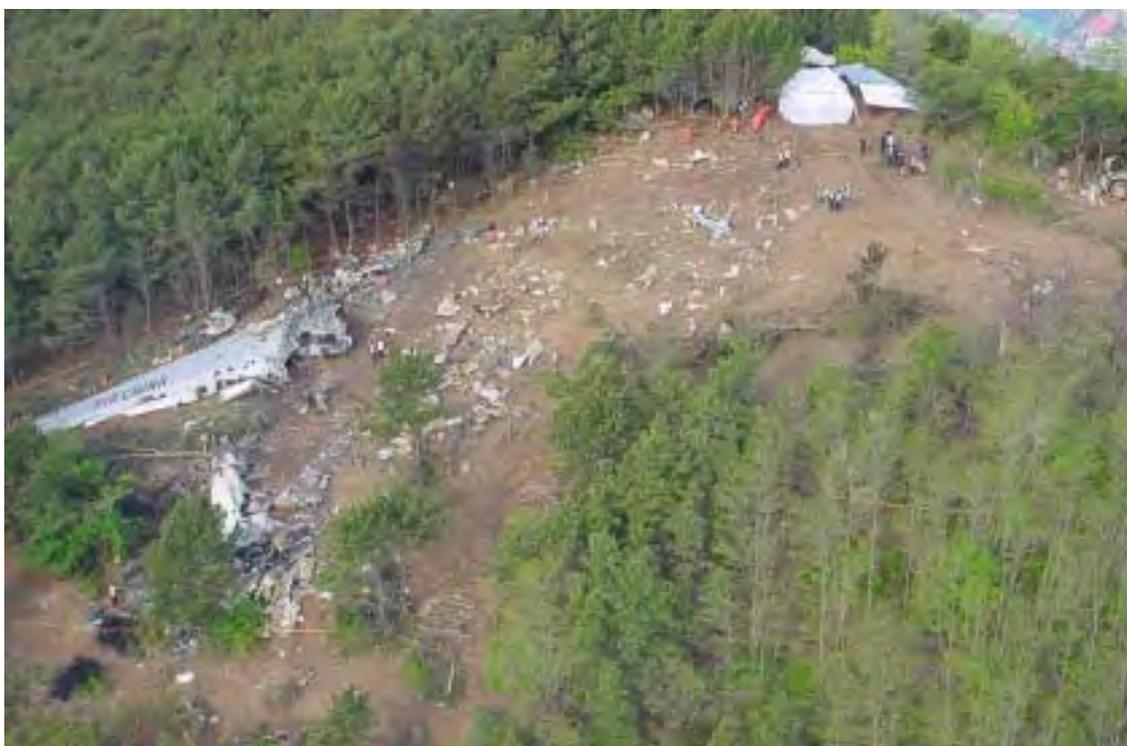
Figure 1-14 Photograph of the Accident Site

The investigation results on ground markings and the wreckage distribution pattern⁸² showed the initial contact with terrain of an elevation of 204m, where the right wing struck trees. As shown on the Figures 1-13 and 1-14, the wreckage was scattered in an area about 200 m long and 100 m wide.

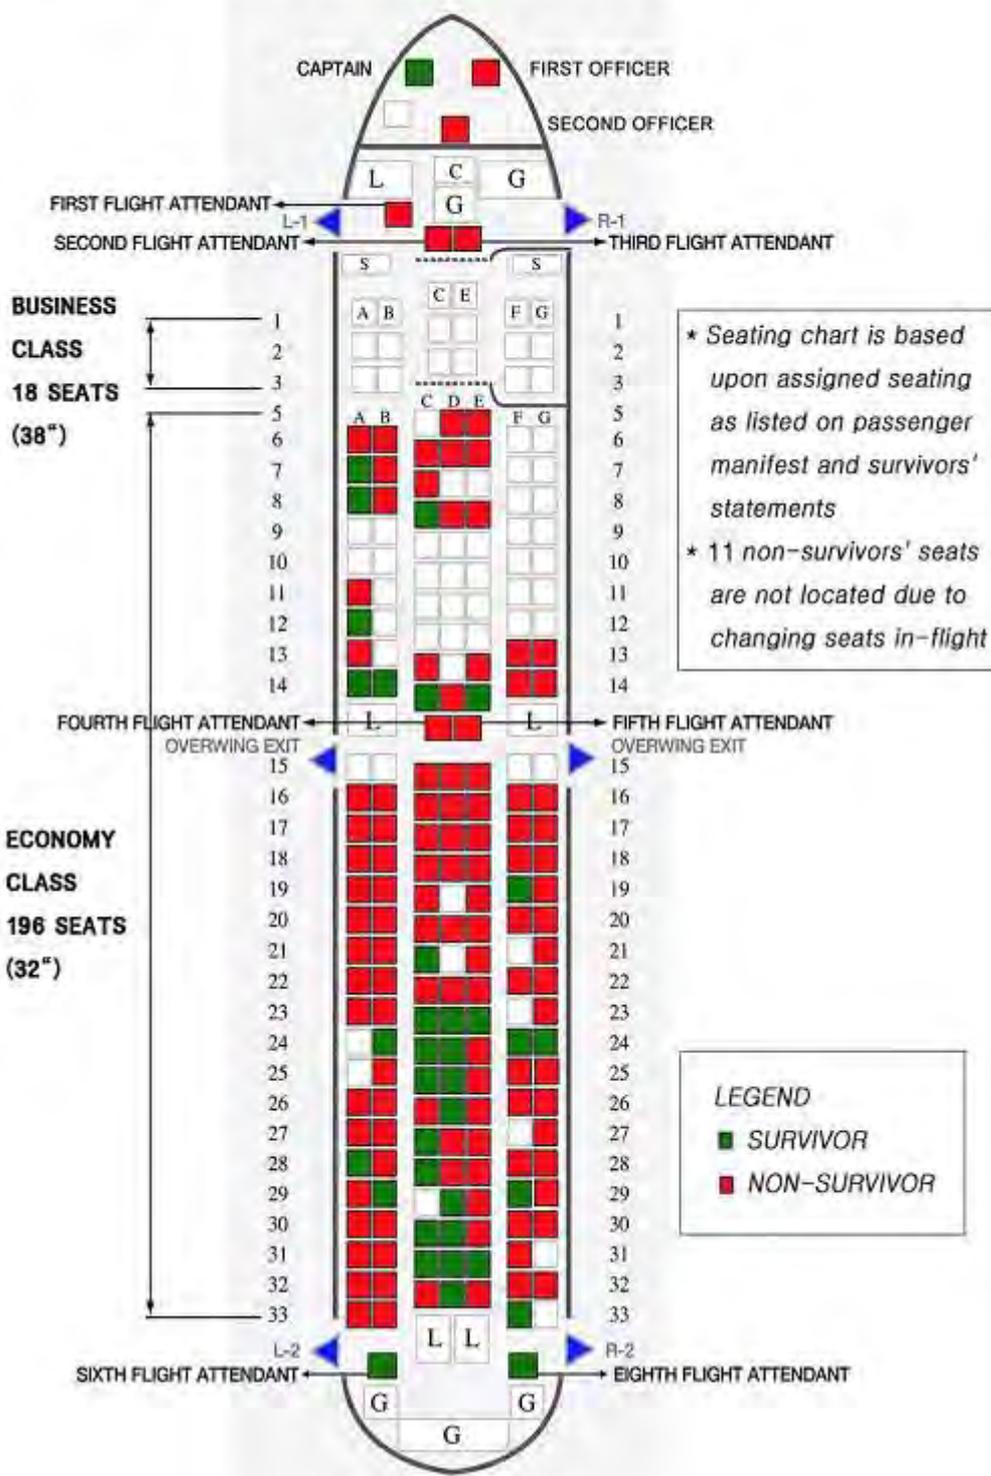
Figure 1-18 Seating Chart Showing the Location of the Occupants

Figure 1-18⁹³ shows that 8 of the 34 surviving passengers were seated in the economy class between rows 7 and 14, and out of these, 5 were seated on the left side and 3 in the middle seats. The seating for the other 26 surviving passengers was distributed from rows 19 to 33 in the back of the economy class, of which 3 were on the left side, 18 in the middle, and 5 on the right side.

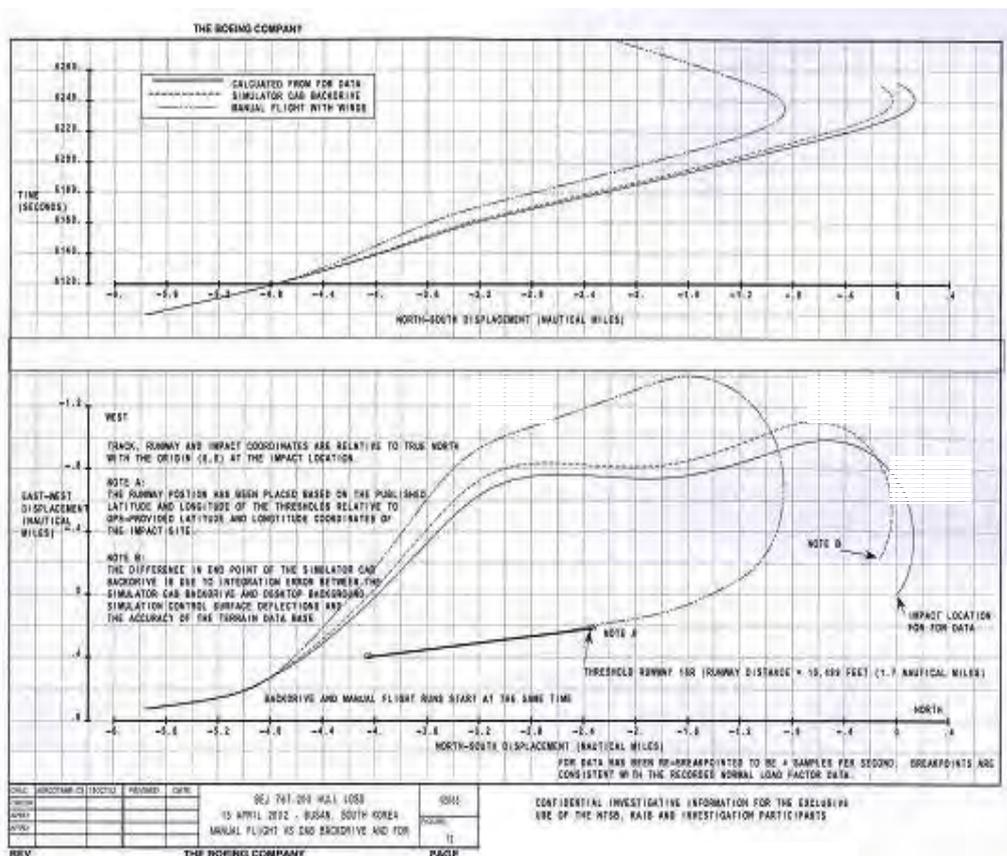
Figure 1-19 Flight Tracks from the Simulator Backdrive Session

The three tracks plotted on Figure 1-19 began from the same starting point, where: manual circling approach maneuvering track with wind corrected heading and 20 seconds time check; the backdrive cab track; and the FDR track are shown.

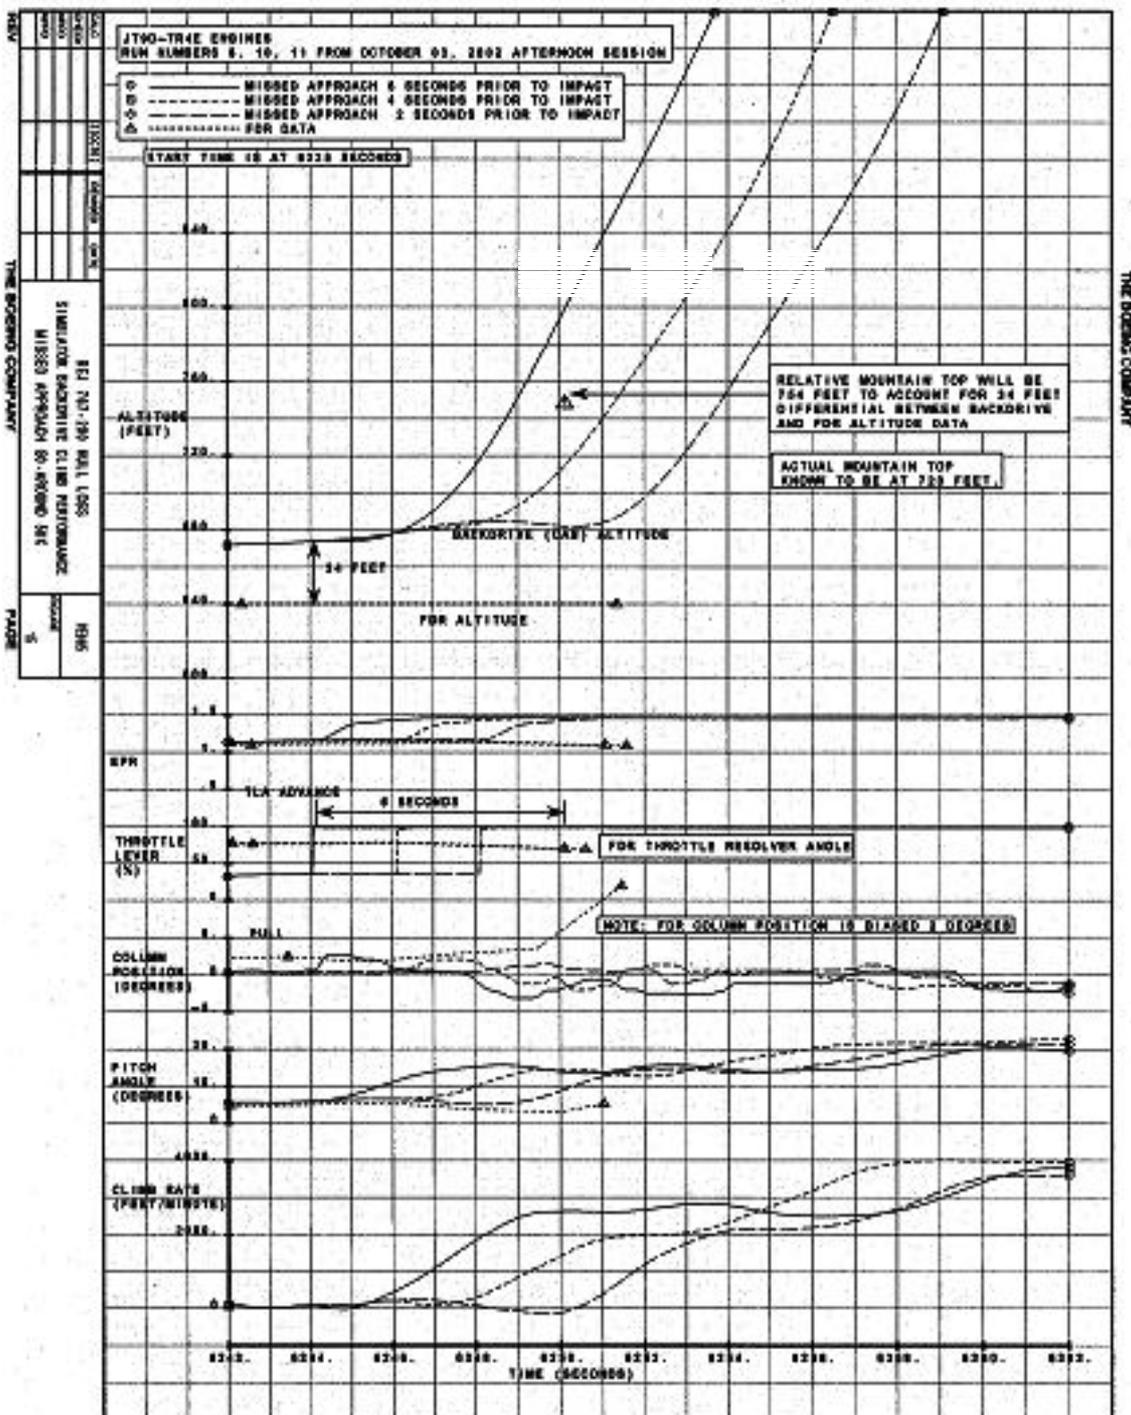
Figure 1-20 Climb Performance Data, Missed Approach Maneuver

The go around maneuvers were flown by advancing the throttles to the forward stop, transitioning flaps from 30 to 20, and pitching the aircraft to 15°nose up, while maintaining the turn to the airport.

Both go around and terrain avoidance maneuvers showed the aircraft clearing the mountain when either maneuver was performed 6 seconds prior to impact.

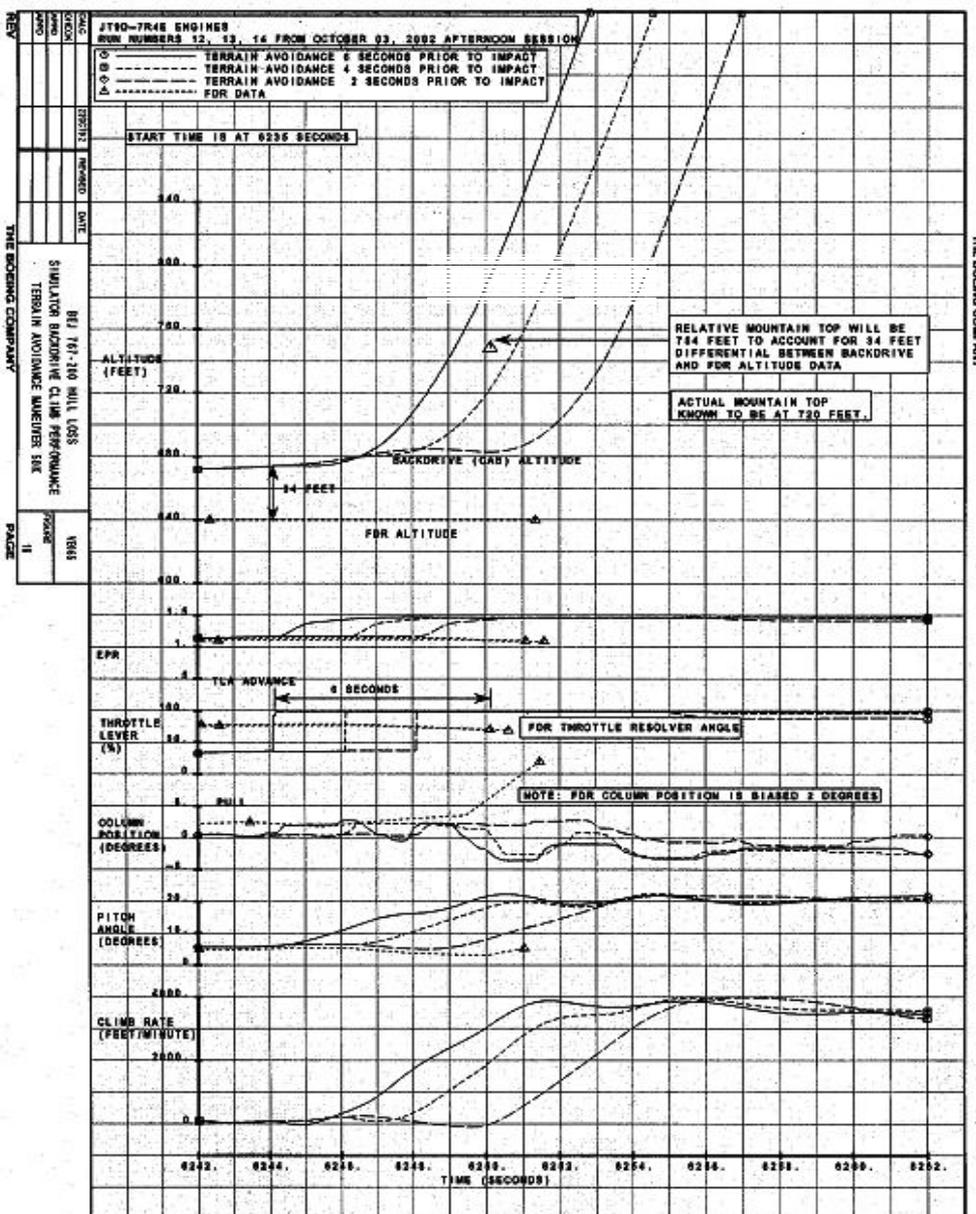
Figure 1-21 Climb Performance Data, Terrain Avoidance Maneuver

Terrain avoidance maneuvers were flown by advancing the throttles to the forward stop, pitching to 20°nose up while maintaining the turn to the airport. The backdrive for these maneuvers started at time 6,235 seconds which was the starting time of the base turn, with the pilot interrupt, flying manually, occurring ① 6, ② 4 and ③ 2 seconds prior to the approximate time of impact. Figures 1-20 and 1-21 show the climb performance data, including climb margins, for the go around and terrain avoidance maneuvers respectively. The relative mountain peak is shown graphically.

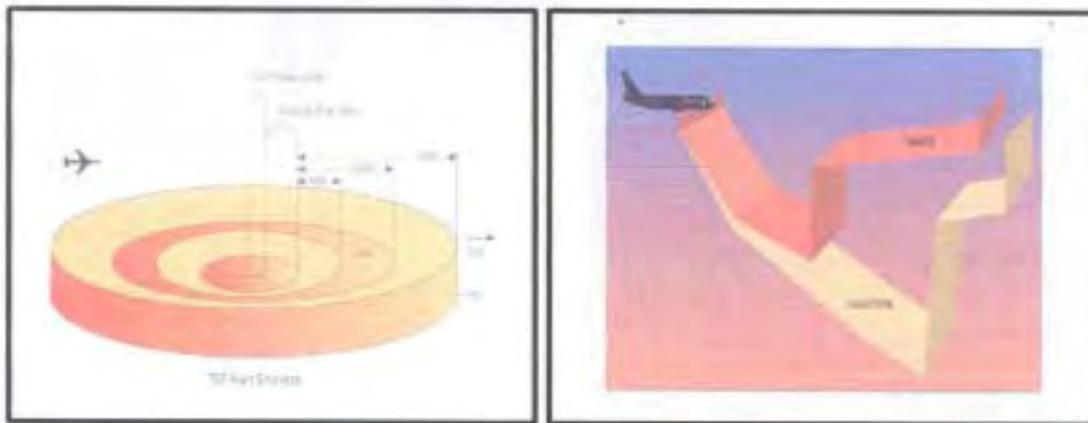
Figure 2-3: Terrain Clearance Floor Alert Envelope, Centered on the Runway

The traditional GPWS was susceptible to nuisance warnings and would provide little or no advance warning when the aircraft was configured for landing, due to design constraints of the technology available at the time of the design of the system. In order to improve upon the design, a Terrain Clearance Floor (TCF) was introduced into the EGPWS computer which creates an increasing terrain-clearance envelope around the intended destination airport runway directly related to the distance from the runway. TCF warnings are based on current aircraft location, nearest runway center point position and radio altitude. TCF is active during takeoff, cruise, and final approach. In the case of approaching this sector, Terrain Awareness and Warning System activates aural and visual warnings as shown in the Figure 2-3.

When an aircraft approaches an alert envelope, the EGPWS activates caution lights and generates an aural warning, “Too Low Terrain.” Both aural and visual warnings are generated 60 seconds prior to impact, and an aural “Pull Up” is generated 30 seconds before impact.
