Flight Safety

AUGUST 2004

Stabilized Approach And Flare Are Keys to Avoiding Hard Landings

Vol. 23 No. 8

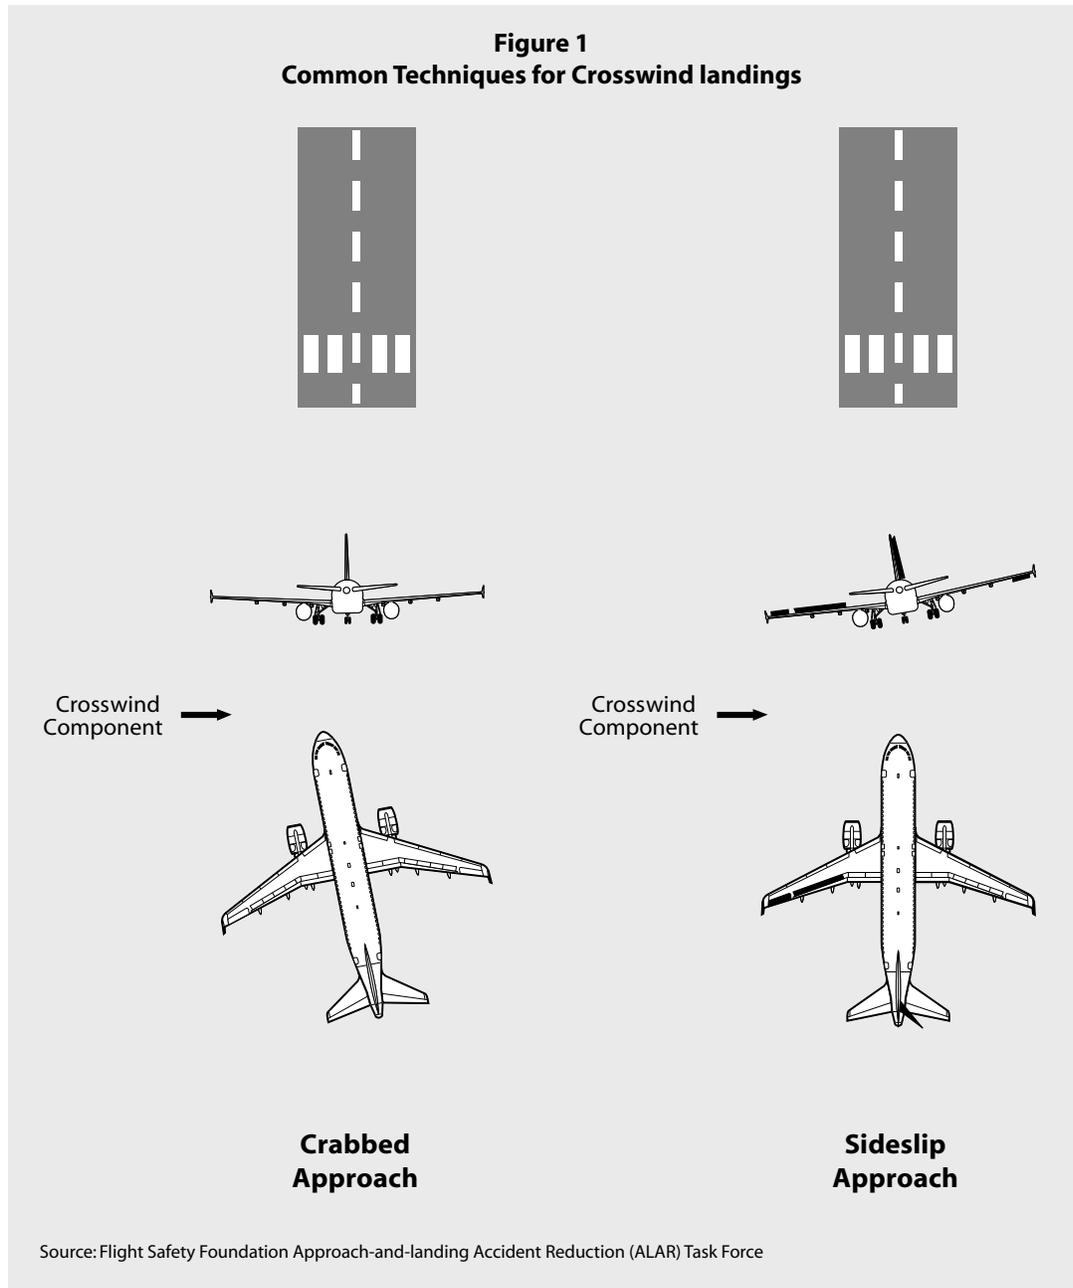
When the captain (the pilot flying) disengaged the autopilot about 100 feet AGL, the airplane yawed five degrees right and began to drift left. The captain made control inputs to correct the drift. Just before touchdown, a gust caused an increase in indicated airspeed and nose-up pitch

attitude; the captain applied nose-down pitch control and reduced power. The airplane had a crab angle of eight degrees when the left-main landing gear and the nose landing gear touched down hard. The nose landing gear collapsed, and the airplane slid about 3,000 meters (9,843 feet) before stopping off the side of the runway. Three of the 213 occupants received minor injuries while evacuating the airplane.
