# Investigation Report

5X004-0/01  
April 2003

Kind of occurrence: Serious Incident  
Date: 20. March 2001  
Location: Frankfurt / Main  
Type of aircraft: Transport category aeroplane  
Manufacturer / Model: Airbus Industrie / A 320-200  
Injuries to persons: no Injuries  
Damage to aircraft: A/C not damaged  
Other damage: none  
Source of Information: BFU Investigation

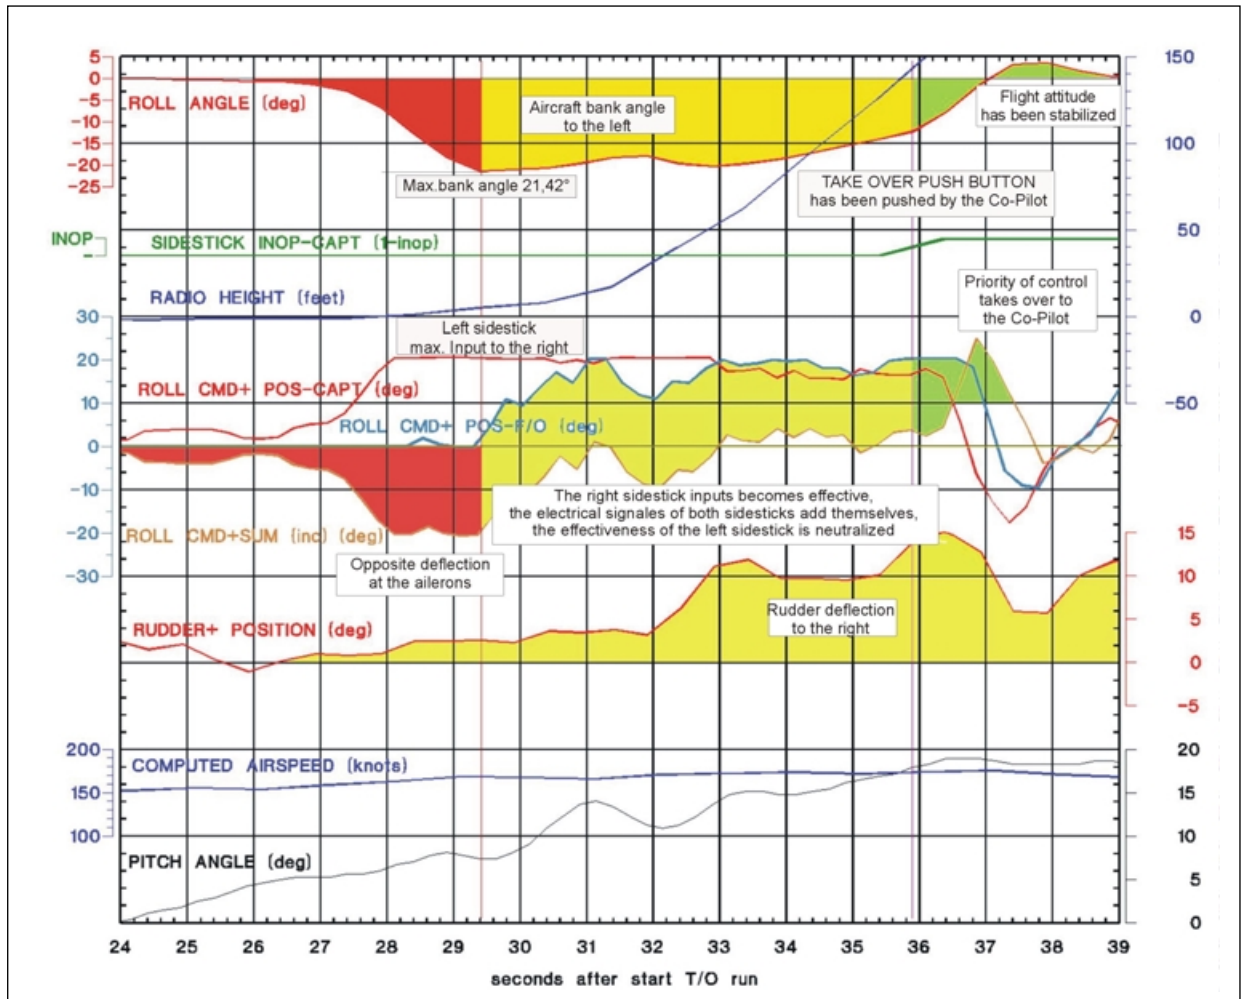
The flight data recorder concerned is a solid state flight data recorder (SSFDR) made by Loral-Aviation-Recorders in Sarasota/Florida. Approx. 470 parameters had been recorded. The flight data recordings were stored on a CD and sent to Braunschweig to the BFU for the purpose of evaluation.
