**AIRCRAFT SERIOUS INCIDENT REPORT
OCCURRENCE NUMBER 00/2518
B767-319ER
ZK-NCJ**

**NZ 60
'ERRONEOUS' GLIDESLOPE CAPTURE,
AUTOCOUPLED APPROACH,
AND GO-AROUND**

**FALEOLO AIRPORT, SAMOA
29 JULY 2000**

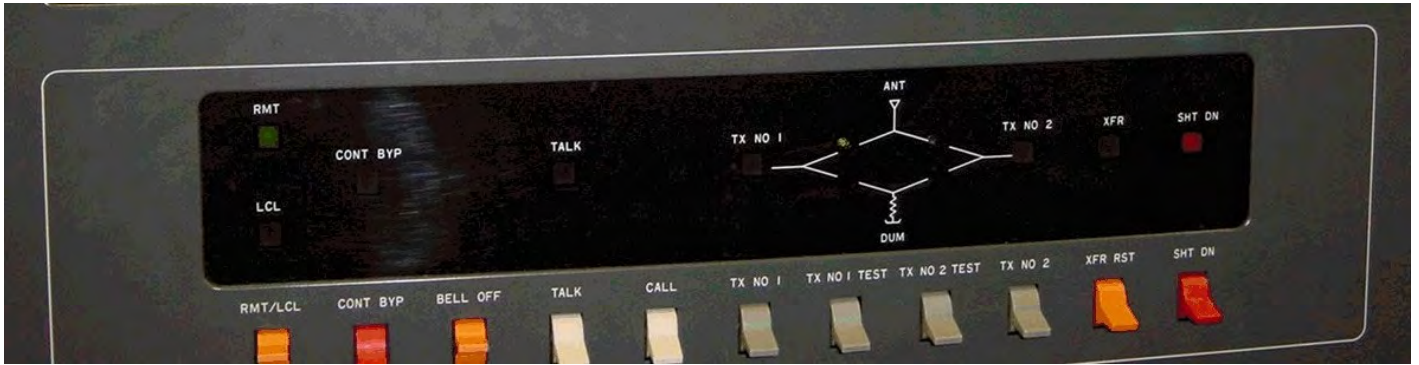
Close up of control panel

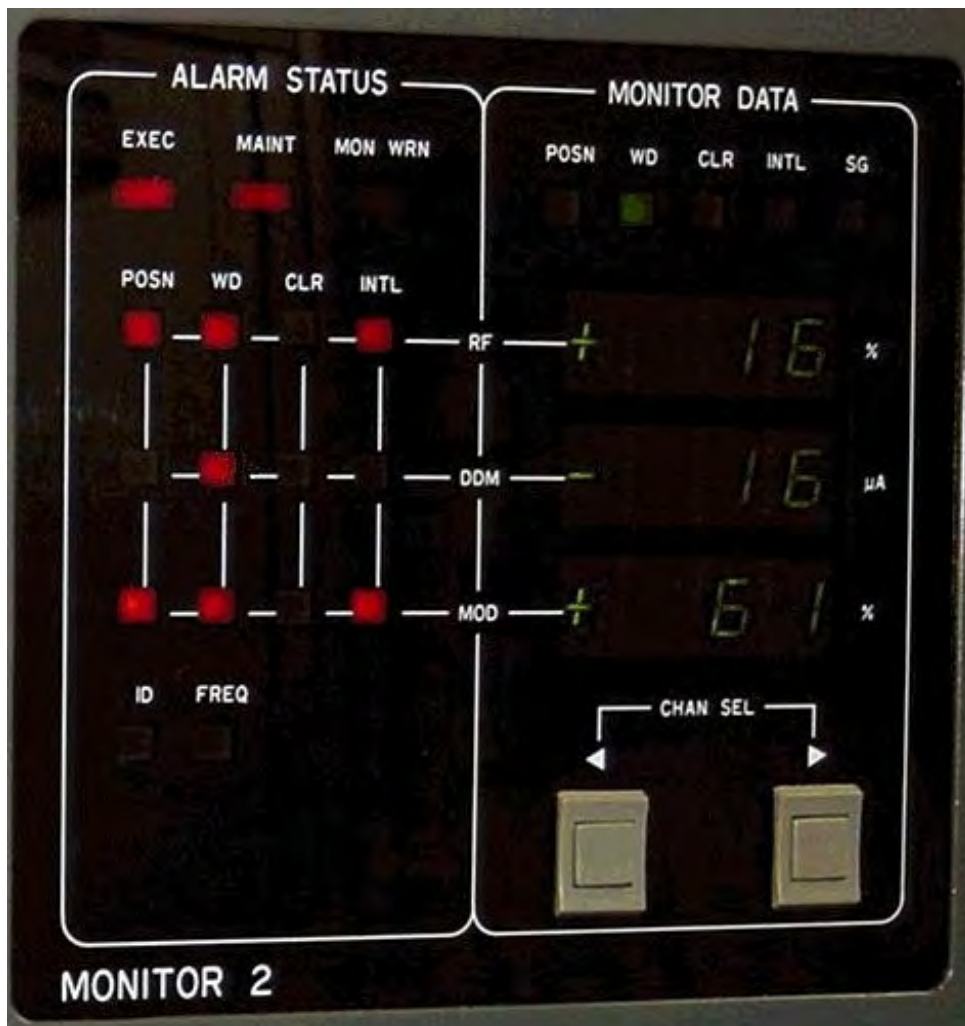
Close up of one monitor panel

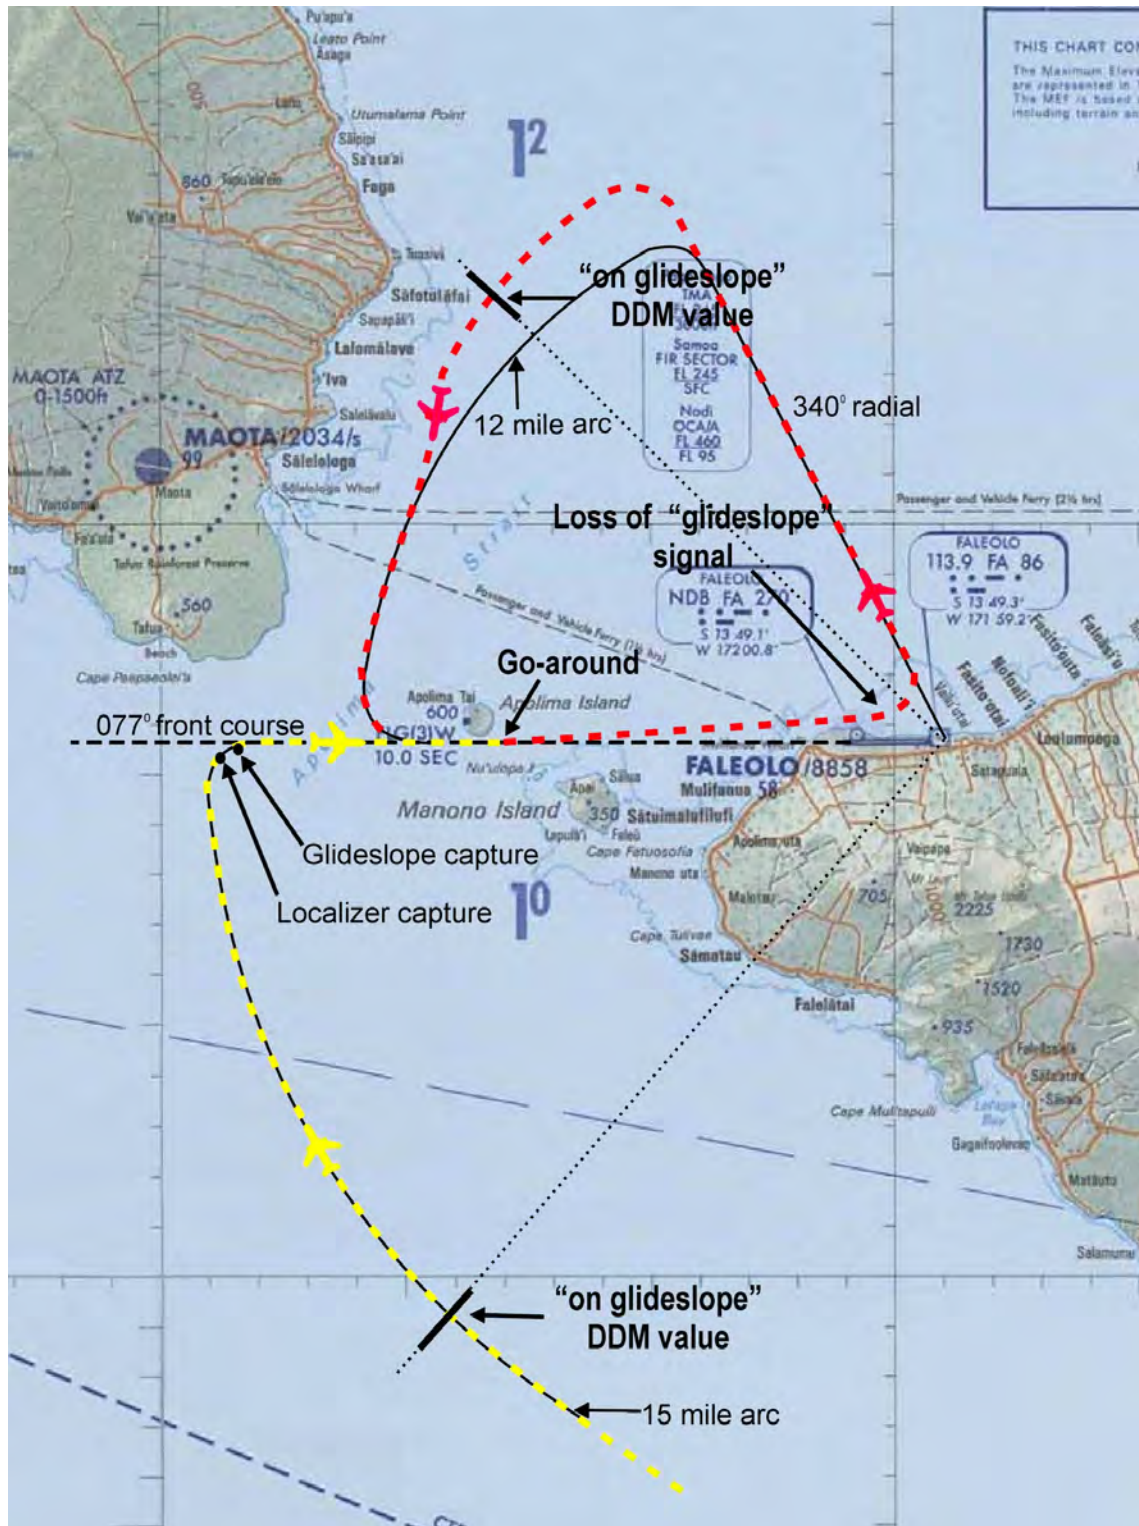
Flight Path of NZ 60

NZ 60 Profile - First Approach Apia

NOTE: Distances shown on the above profile are approximate. The FDR fitted to ZK-NCJ does not record DME. Distances were computed using IRS longitudinal information adjusted for latitude and corrected for the residual error.

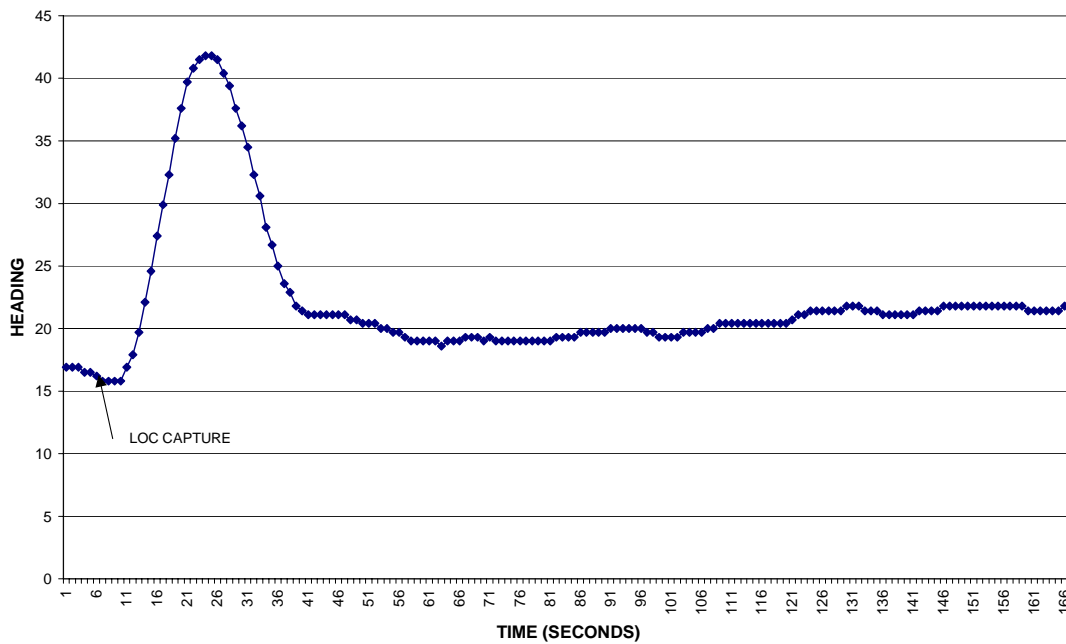
Proving Flight Two – Profile Six

On the second localizer profile, the localizer was armed and captured from a heading of 016°. A right turn onto a heading of 042° followed, with a subsequent left turn onto 021°, stabilising on 020° with a very slight bias towards further small turns to the left. With an on-track indication on the EADI, the aircraft flew through the centreline of Runway 05 towards the rising terrain to the Northwest of the airfield.

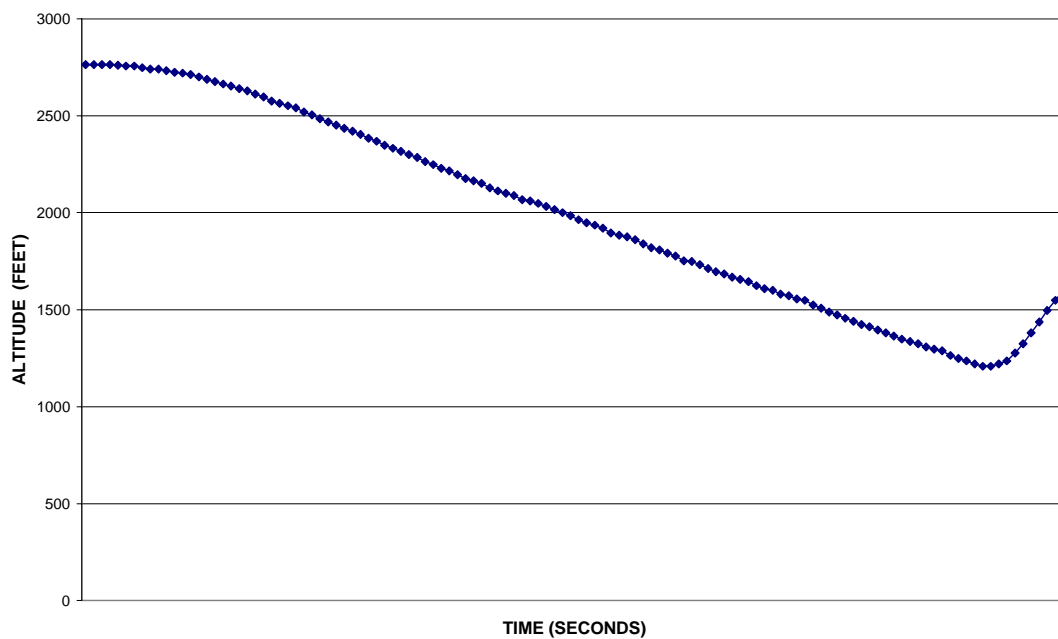
Proving Flight Two – Profile Seven

Profile 7 was flown with the ILS restored to normal operation. The aircraft positioned around the northern arc to observe ‘normal’ indications. As the aircraft travelled around the arc toward the localizer the Standby Attitude Indicator’s glideslope deviation indicator moved erratically as it caught the false slopes off other lobes. This was unlike the steady ‘on glideslope’ indication noted around the arc on the previous proving flight. As anticipated, no glideslope information appeared on the EADI until the track was within 90° of the selected front course. Once the EADI glideslope deviation indication was displayed, normal movement of the glideslope deviation indicator was observed as the aircraft approached the glideslope from below.

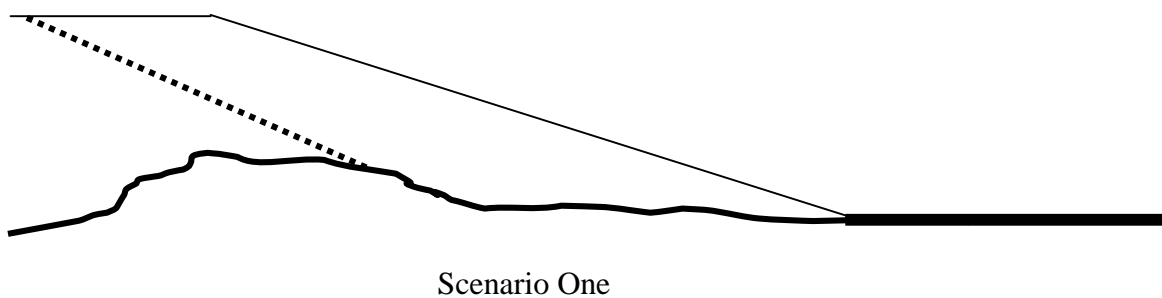
- Scenario one is where the aircraft captures the ‘glideslope’ prior to actual descent point and on a profile close to the expected 3°. If the erroneous glideslope is not detected, terrain/obstacles may be a factor prior to the briefed decision point.

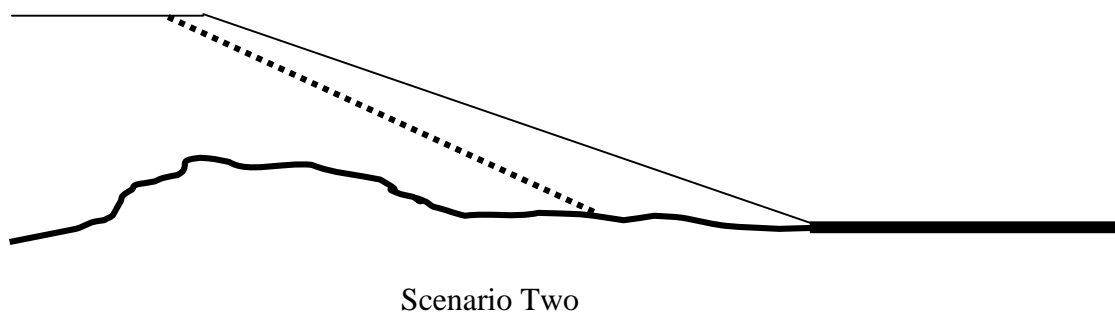
- Scenario two is where the aircraft captures the ‘glideslope’ slightly short of the true glideslope intercept point and flies a profile steeper than but close to the expected 3°. The crew may not identify the discrepancy with a glideslope intercept distance/altitude check. The resultant profile will take the aircraft to a point short of the true decision point.

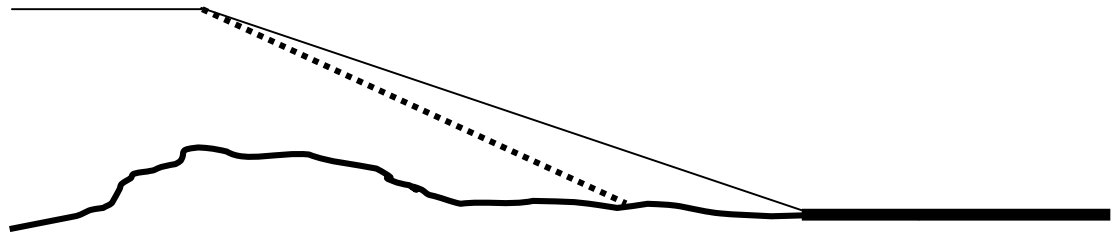
Scenario Three

- Scenario three is where the aircraft captures the 'glideslope' at the correct intercept point, but not on a true glidepath. The profile flown will not necessarily be a 3° glidepath and there is nothing to ensure the aircraft maintains the path. If the path is greater than 3°, the aircraft will still fall short of true decision point.

While the first scenario may be detected with a distance/altitude check at glideslope intercept provided that point is known, this statement does not hold true for the other two scenarios. Faced with a seemingly valid glideslope indication with no warnings present on the flight deck, the crew will inevitably accept the glideslope. On all the profiles the aircraft is not receiving glideslope guidance and therefore the flight path cannot be predicted.

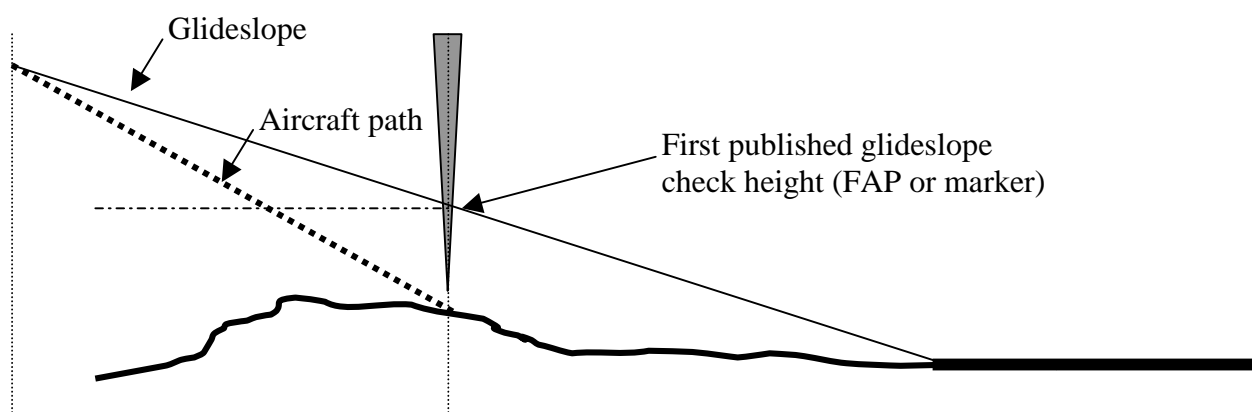
Therefore, unless the crew has a positive and accurate orientation of position relative to glideslope, the charted glideslope check height cannot be considered as a reliable method of detecting an erroneous glideslope in all cases and is only guaranteed to provide protection against an error in the on-board equipment – experience has taught us that incorrectly set altimeters are the most likely cause. A good glideslope will provide some protection against altimeter error, but until a reference point is reached the altimeter does not necessarily provide protection against an erroneous glideslope.

Crew must be aware of the potential for maintenance error to cause a glideslope (or localizer) to radiate erroneous information with no on-board warning due to systemic failure. Therefore they must maintain a ‘reasonableness’ check of the ILS and be prepared for a missed approach if they have an unresolved discrepancy by a defined point, but must also have confidence in the precision aspect of the approach.

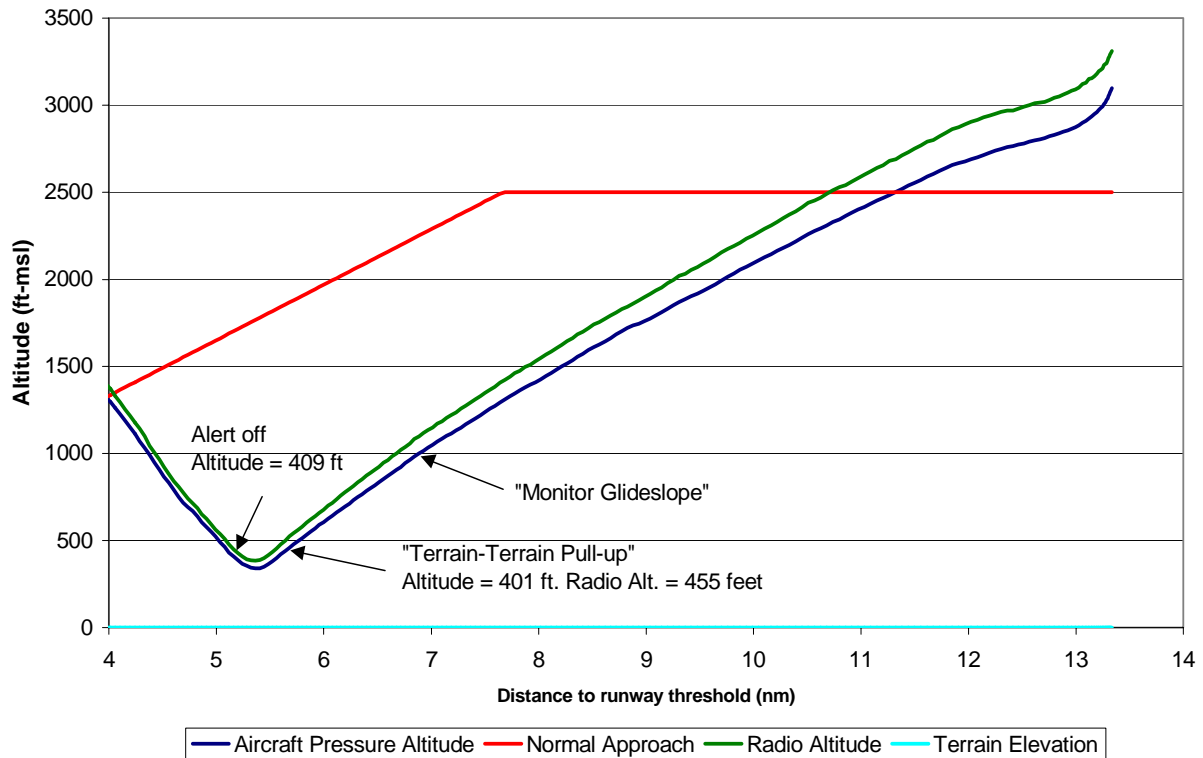
NZ 60 Profile Depicting Computed EGPWS Warning Altitude

Although not installed on ZK-NCJ the following chart traces the approach flight path of NZ 60 and indicates the altitude at which a current generation EGPWS would have provided a “TERRAIN, TERRAIN PULL-UP” warning.
