Lauda Air B767 Accident Report

**AIRCRAFT ACCIDENT INVESTIGATION COMMITTEE
MINISTRY OF TRANSPORT AND COMMUNICATIONS
THAILAND**

**LAUDA AIR LUFTFAHRT AKTIENGESELLSCHAFT
BOEING 767-300ER
REGISTRATION OE-LAV
DAN CHANG DISTRICT
SUPHAN BURI PROVINCE
THAILAND
26 MAY B.E. 2534 (A.D. 1991)**

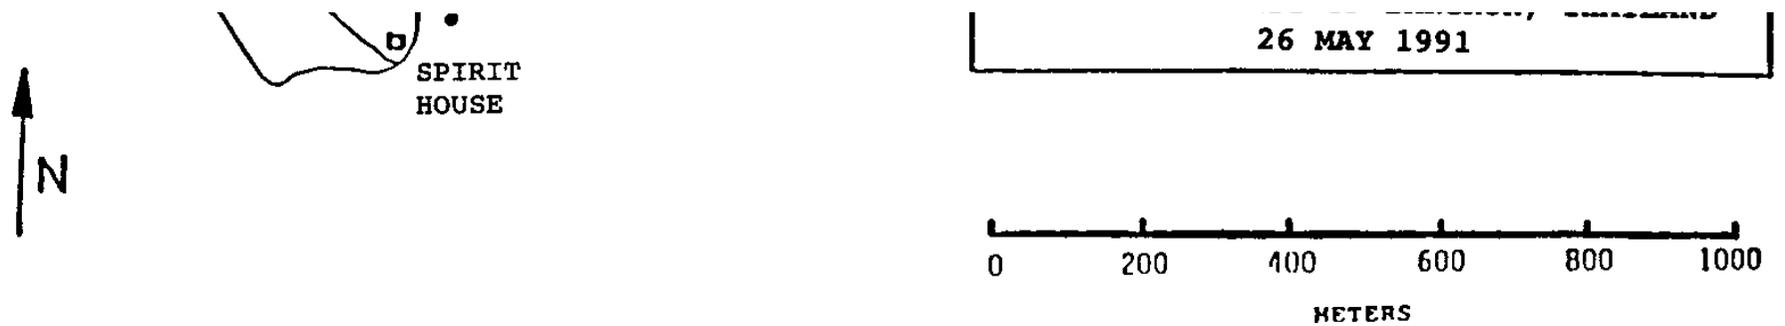
**FIGURE 1**

1. SECTION 41
2. LEFT ENGINE
3. INBOARD RIGHT WING
4. RIGHT ENGINE
5. APU
6. BURNED CORE COWL
7. OUTBOARD LEFT WING
8. SECTION 43 BELLY
9. HORIZONTAL STABILIZER JACKSCREW
10. LEFT HORIZONTAL STABILIZER NAD CENTER SECTION
11. RIGHT MAIN GEAR BEAM AND SIDE STRUT
12. RIGHT HORIZONTAL STABILIZER
13. OUTBOARD RIGHT WING
14. LEFT WING INBOARD FLAPS
15. VERTICAL STABILIZER
16. BURNED CORE COWL
17. BURNED MID-CABIN ENTRY DOOR
18. SECTION 47
19. INBOARD LEFT WING & CENTER SECTION, LEFT MAIN GEAR

**WRECKAGE DISTRIBUTION DIAGRAM
LAUDA AIR BOEING 767-329ER, OE-LAV
95nm. NORTHWEST OF BANGKOK. THAILAND**
