FINAL REPORT

97-75/A-26

PH-TKC

Final report of the investigation into the probable cause of the accident with Transavia Boeing 757, registration PH-TKC, on December 24th, 1997 at Amsterdam Airport Schiphol.

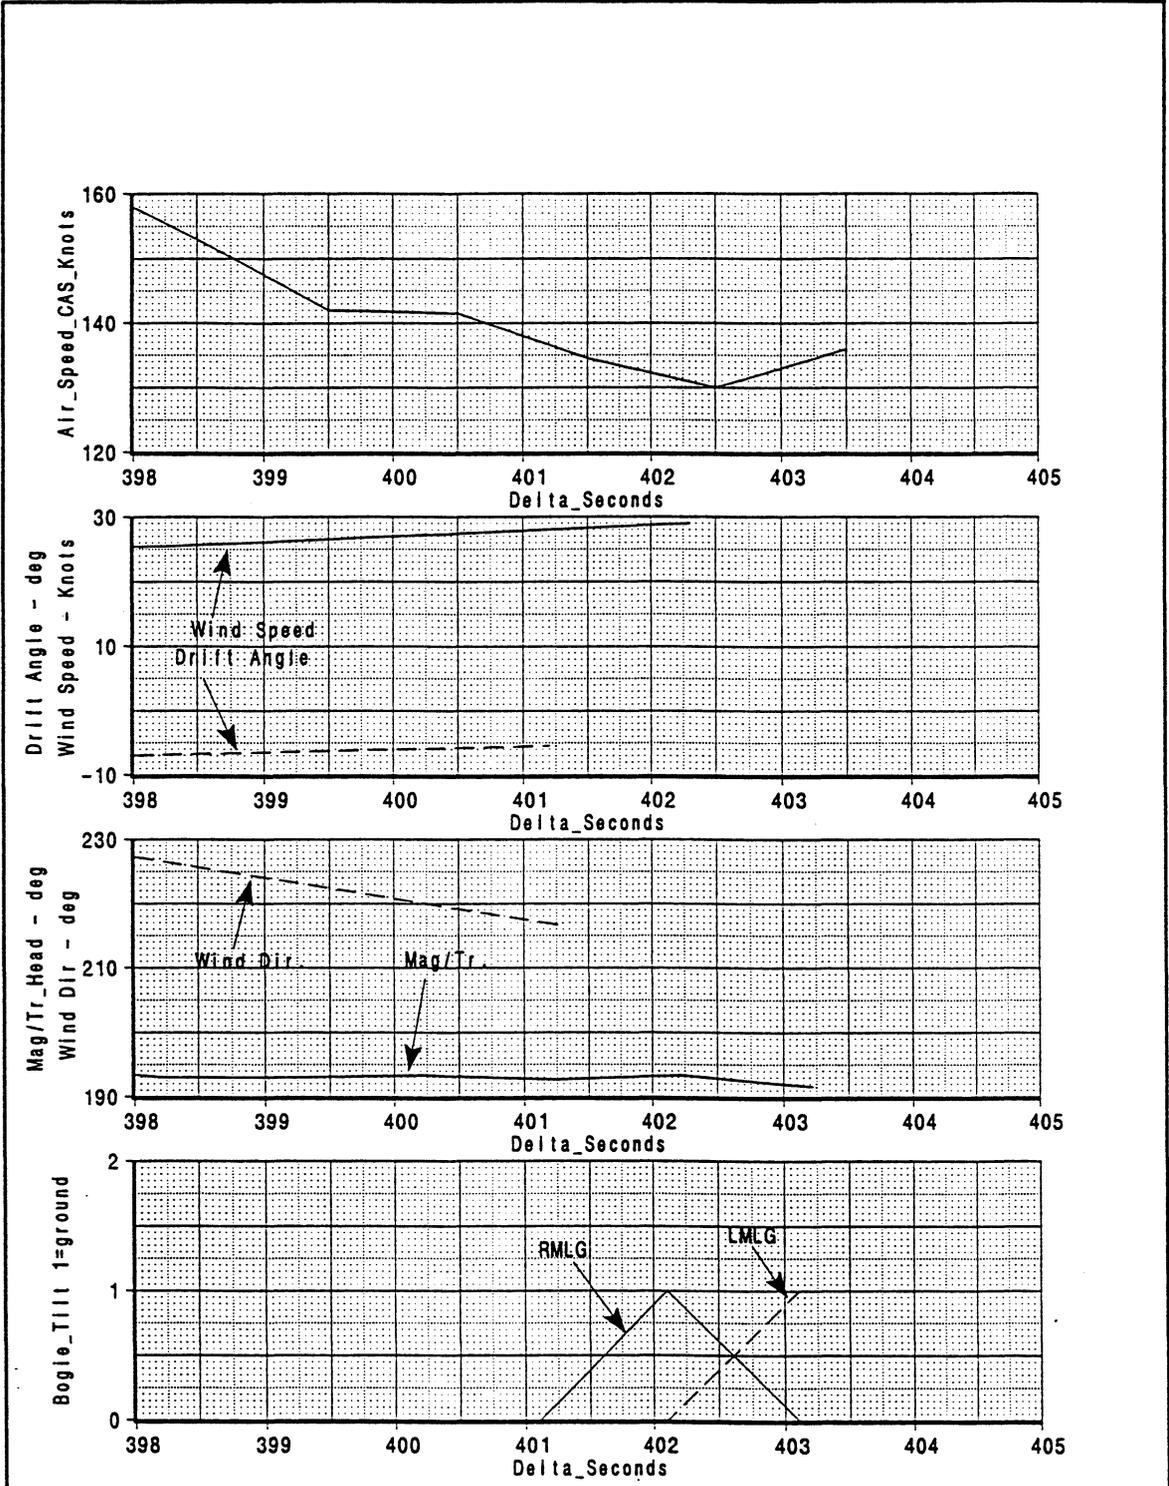
CALC	C. C. Ma	30Jul98	REVISED	DATE	TAV 757-200 PK-TKC/NB453 Landing Accident	757-200
CHECK					DFDR, Directional Parameters	
APPD.					Flare, Touchdown	
APPD.					BOEING	PAGE Figure 2

The airplane encountered a strong cross wind during landing. The drift angle varied between -4 to -10 degrees during final approach and was at about -5 degrees at time of touchdown as shown in Figures 1 and 2.

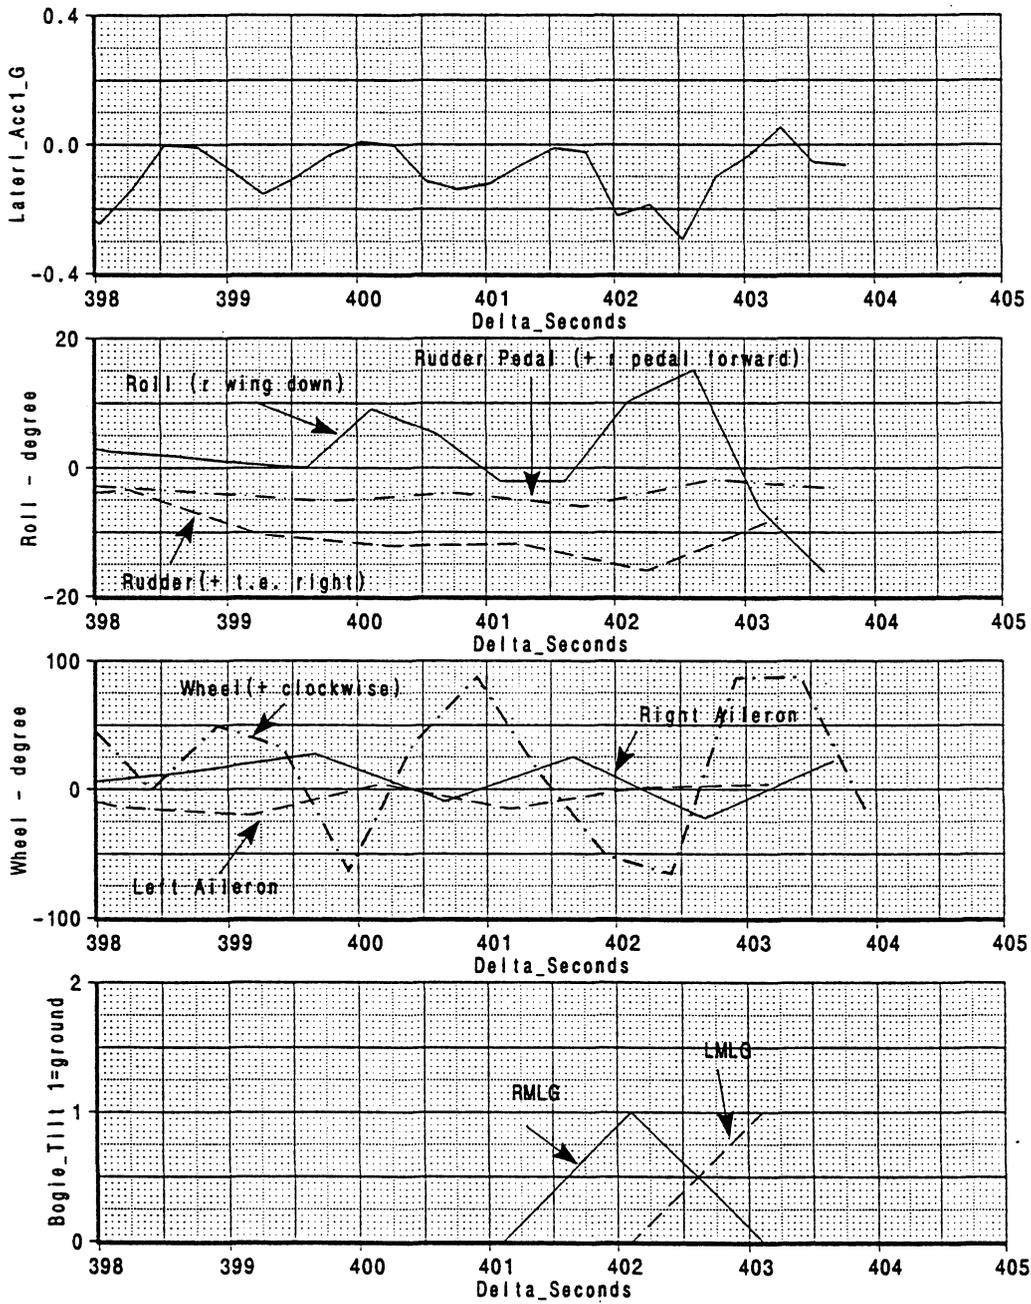
CALC	C. C. Ma	7Aug98	REVISED	DATE	TAV 757-200 PK-TKC/NB453 Landing Accident	757-200
CHECK					DFRD, Roll parameters	
APPD.					Flare, Touchdown	
APPD.					BOEING	PAGE Figure 4

From Figures 3 and 4, the pilot was very busy responding to the cross wind to keep the airplane level. During the flare, beginning about time 398, the pilot had a few rapid maximum wheel cycle commands to fight the progressively bigger roll response of the airplane.

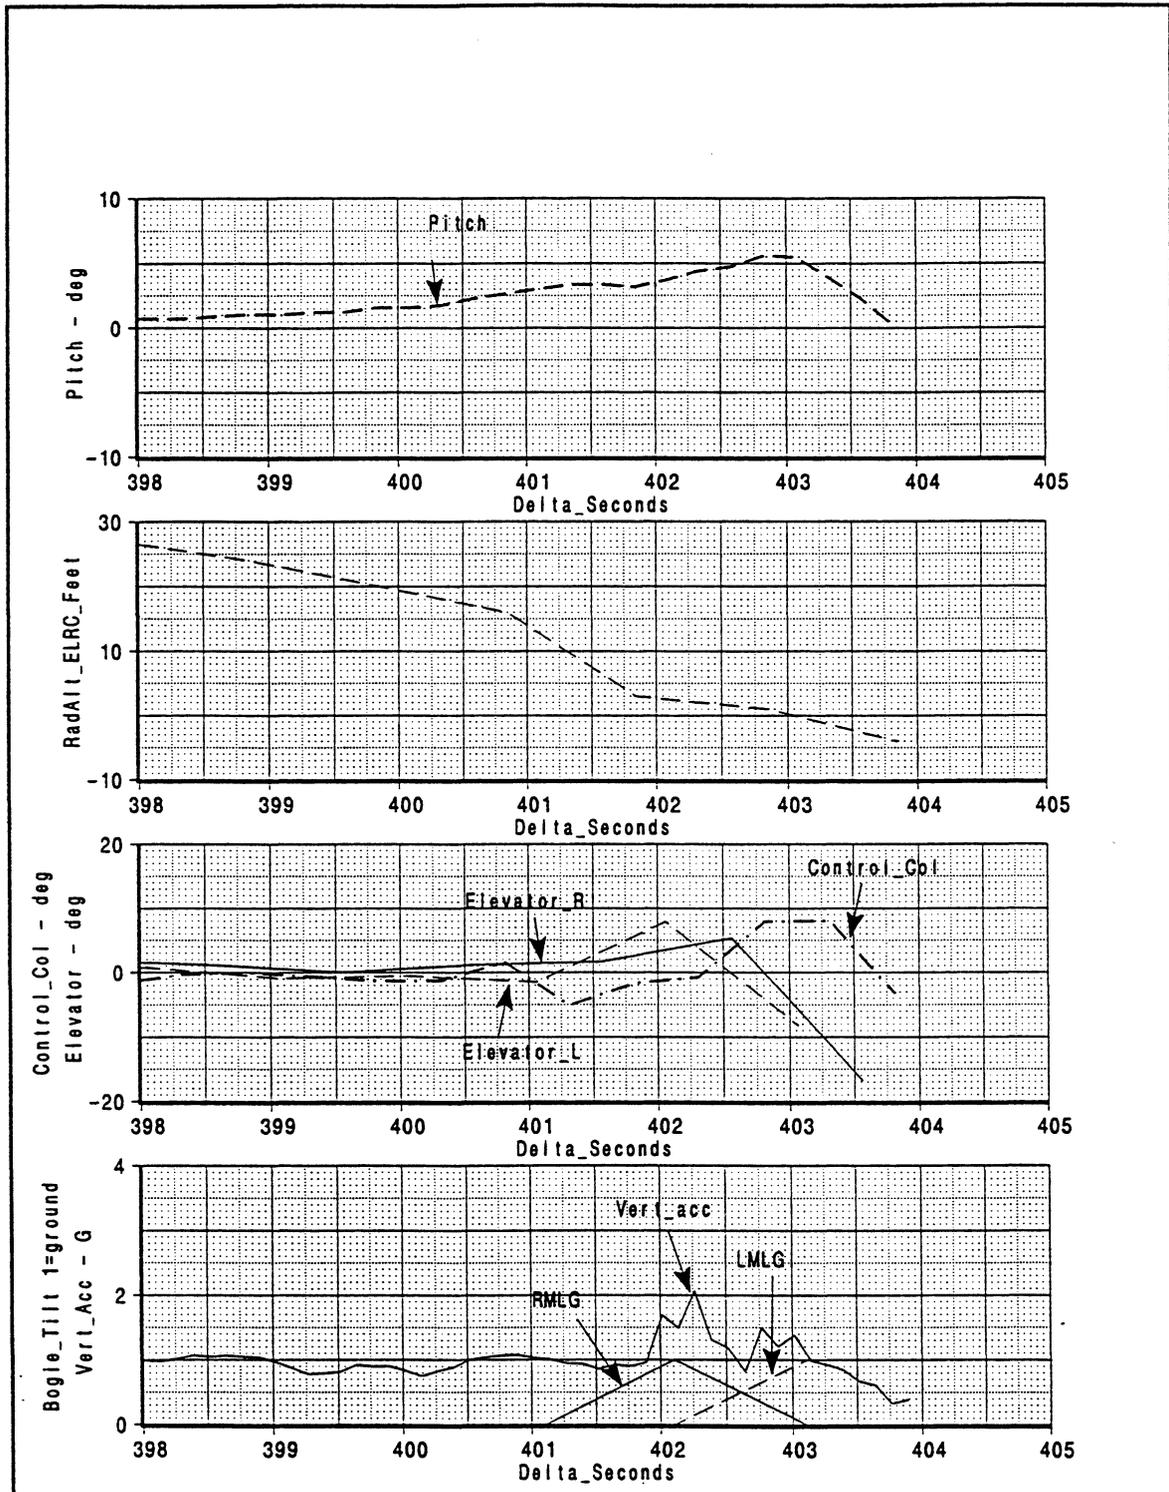
CALC	C. C. Ma	30Jul98	REVISED	DATE	TAV 757-200 PK-TKC/NB453 Landing Accident	757-200
CHECK					DFDR, Vertical parameters	
APPD.					Flare, Touchdown	
APPD.					BOEING	PAGE Figure 6

From Figure 5, it appears the pilot had a hard time keeping the airplane in constant pitch angle during approach too. From Figure 6, the sink rate at touchdown was higher than normal at 13 foot per second, exceeding the 10 foot per second design limit. The airplane landed on the right main landing gear (RMLG) and had a recorded 2.1 g's (the actual peak may be higher) hard landing, it then bounced off the RMLG and landed on the left main landing gear (LMLG) at 1.5 g's (or higher). While bouncing off the RMLG, the pilot pushed down the control column to command pitch down elevator within 1 second of RMLG touchdown. The pitch rate at nose gear contact was estimated to be at least 9 degrees per second from the pitch angle on Figure 6.

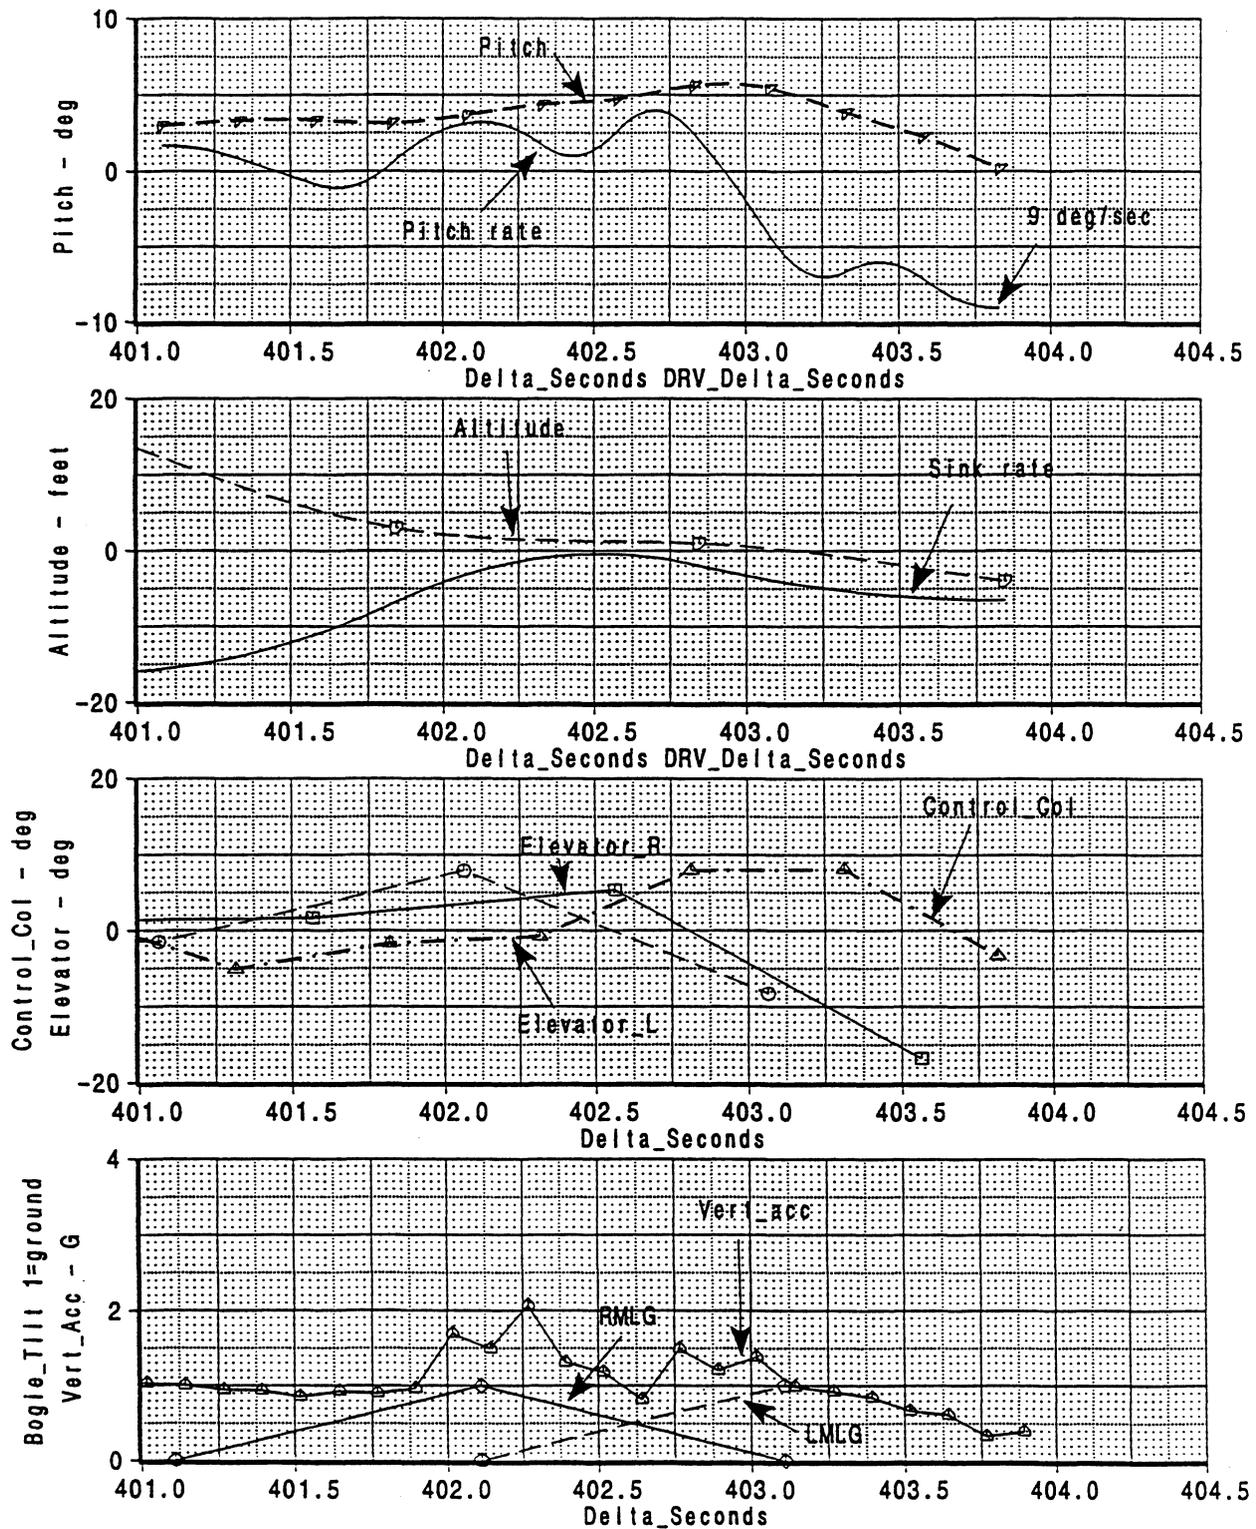
CALC	C. C. Ma	8Dec98	REVISED	DATE	TAV 757-200 PH-TKC/NB453 Landing Accident DFDR, Vertical parameters Flare, Touchdown	757-200
CHECK						
APPD.						
APPD.						
BOEING						PAGE Figure 7

In Figure 7 we have plotted airplane pitch, airplane altitude, elevator position, control column, vertical acceleration and main landing gear bogie tilt versus time following initial touchdown. These parameters were taken directly from the DFDR data. The actual data points are shown by symbols. The airplane pitch time history plot was spline curve fitted and its derivative was plotted as pitch rate. The last data point has a pitch rate of approximately 9 degrees per second. The nose landing gear ground contact occurred shortly after the last data point was recorded. The spline curve fit was also applied to the altitude time history data and its derivative was plotted as sink rate. The last data point has a sink rate of about 6 feet per second.

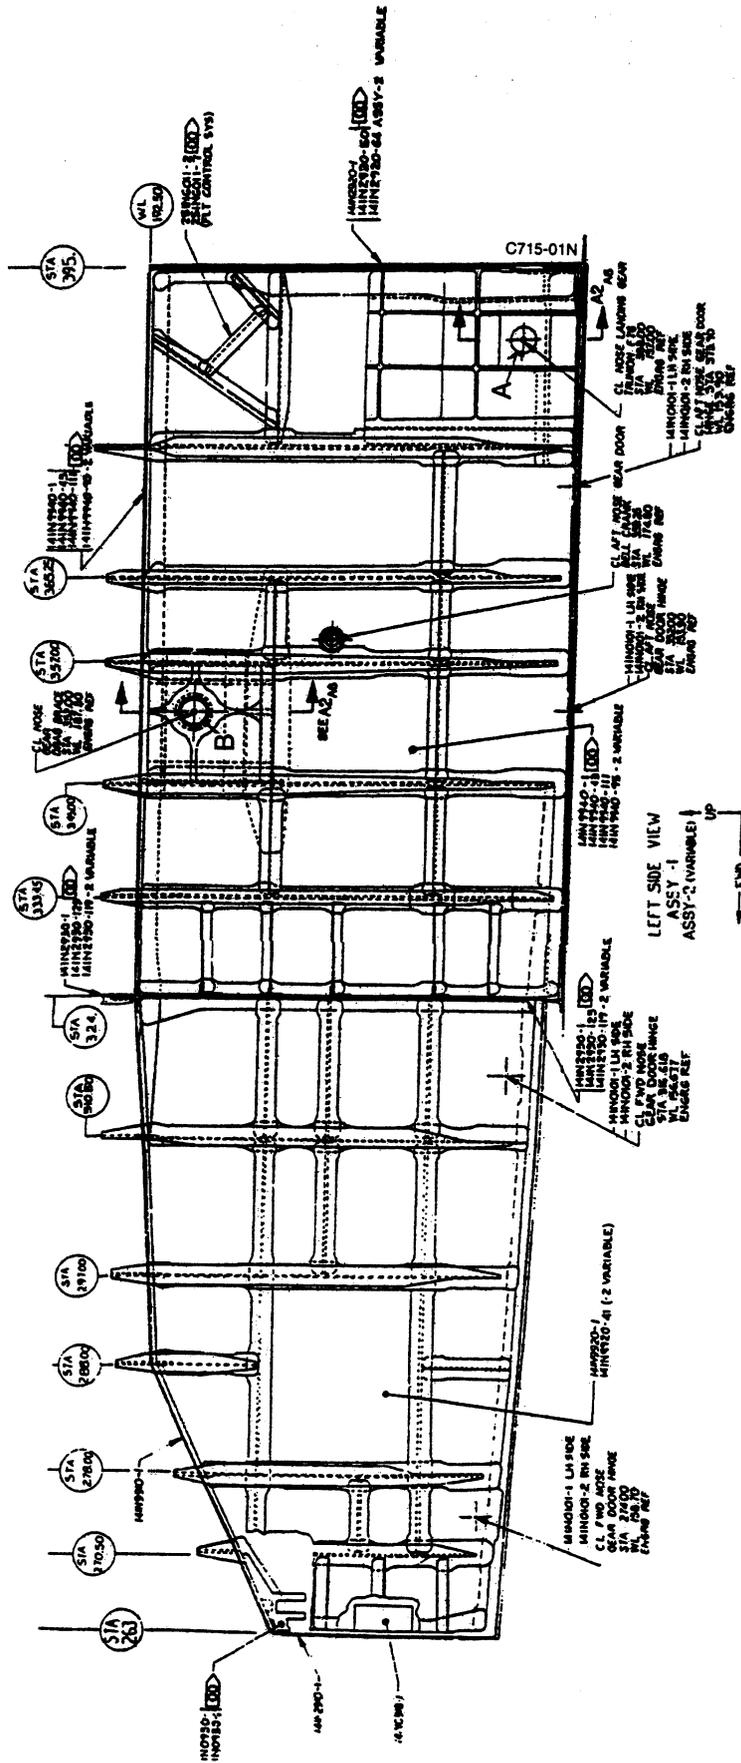
Fig. 2 Doghouse LH side

The NLG is attached to the wheel well, which is a rigid box structure (so-called dog house). A schematic of the doghouse is shown in figure 1. The dog house consists of a forward and an aft part and is tied to the fuselage main structure at bulkheads STA 263, STA 324 and STA 395. These bulkheads are part of the nose wheel well structure. A left side view of the doghouse showing the NLG attachment fittings is given in figure 2. The NLG main strut attachment fitting is located at A, see figure 2, and the drag brace attachment fitting at location B.

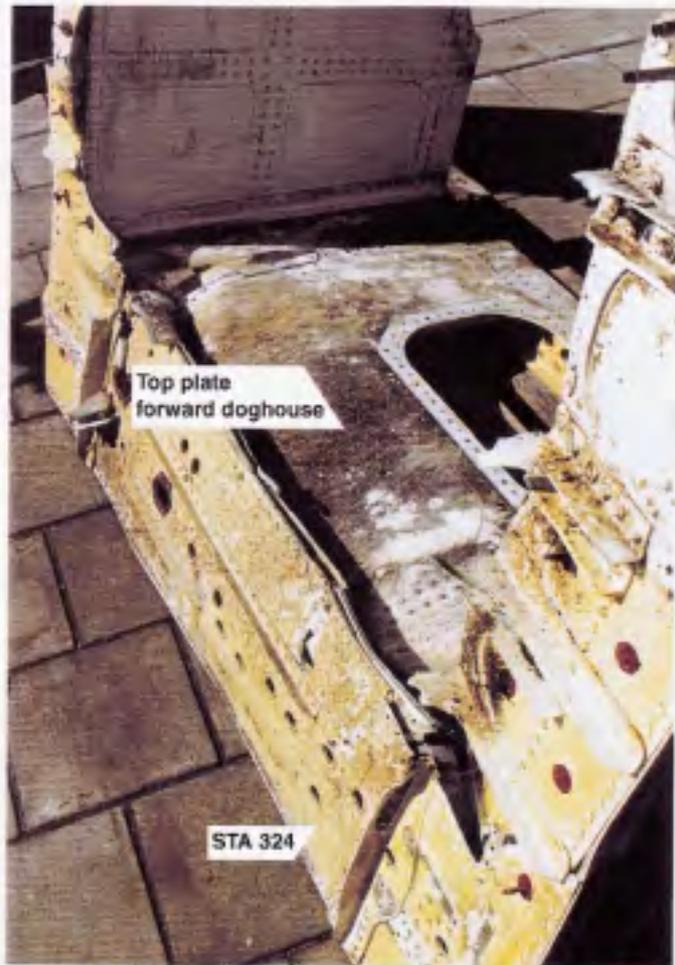
Fig. 6 Aft part of the forward doghouse
and part of the STA 324 bulkhead
(upside down position)

An overview of the fracture at STA 324 is shown in figure 5. The aft side of the top plate of the forward doghouse adjacent to the STA 324 frame was pressed in forward direction and buckled (see Fig. 6), indicating a forward displacement of the top side of the aft doghouse. At the lower side the web was pulled aft (see Fig. 5).

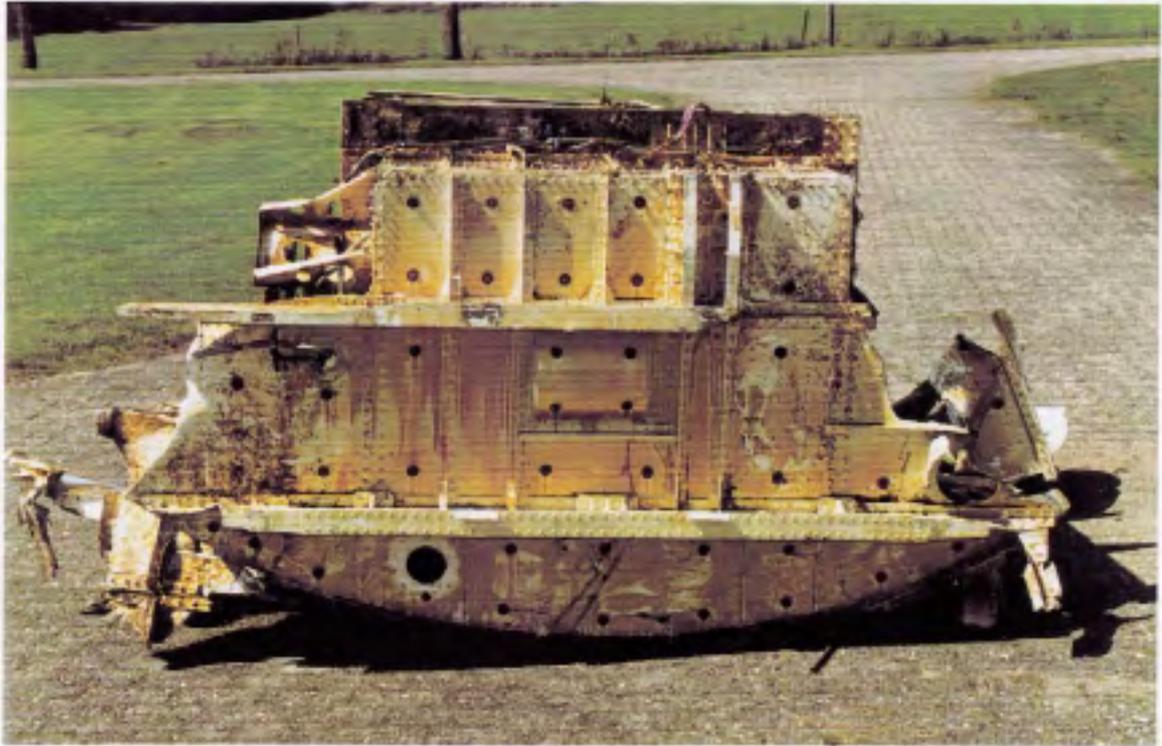
Fig. 9 Aft side of the aft doghouse

An overview of STA 395 bulkhead remnant including the aft side of the doghouse is given in figure 9. A schematic of the STA 395 bulkhead with the web fracture locations is shown in figure 10. The dashed areas are crushed areas. The LH and RH fracture locations are shown in figures 11 and 12.

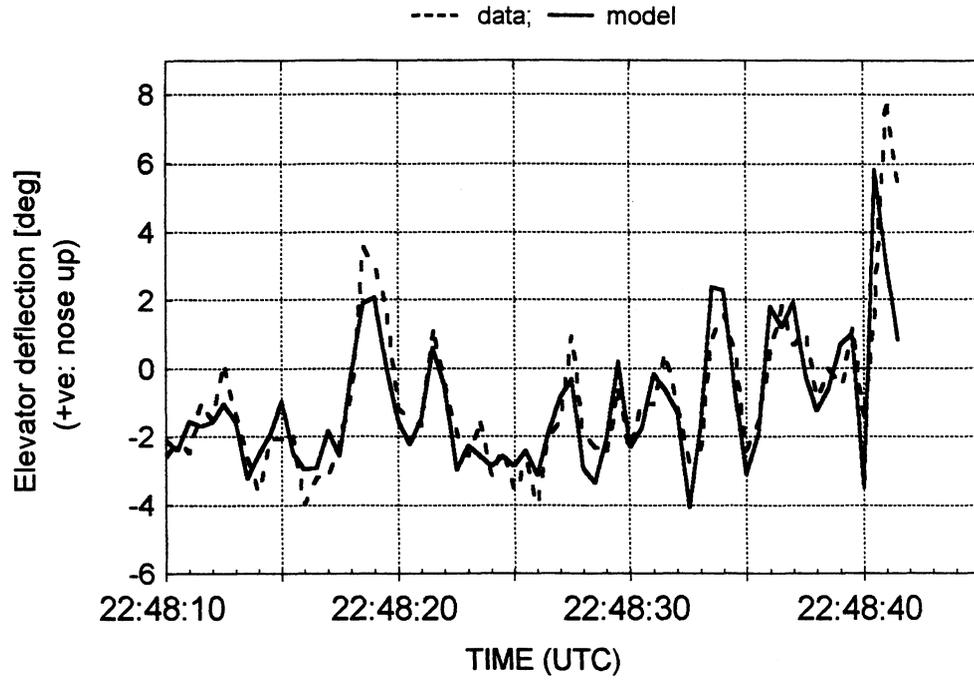
Figure 1 Comparison of model-computed and measured elevator deflection

To show how such a fit looks like, the output from the longitudinal hydraulic model, i.e. the elevator control surface deflection, computed using the control column as input into the hydraulic system, has been plotted in Figure 1, together with the measured elevator deflection. For only the last 30 seconds shown, the overall good quality of the fit is obvious!

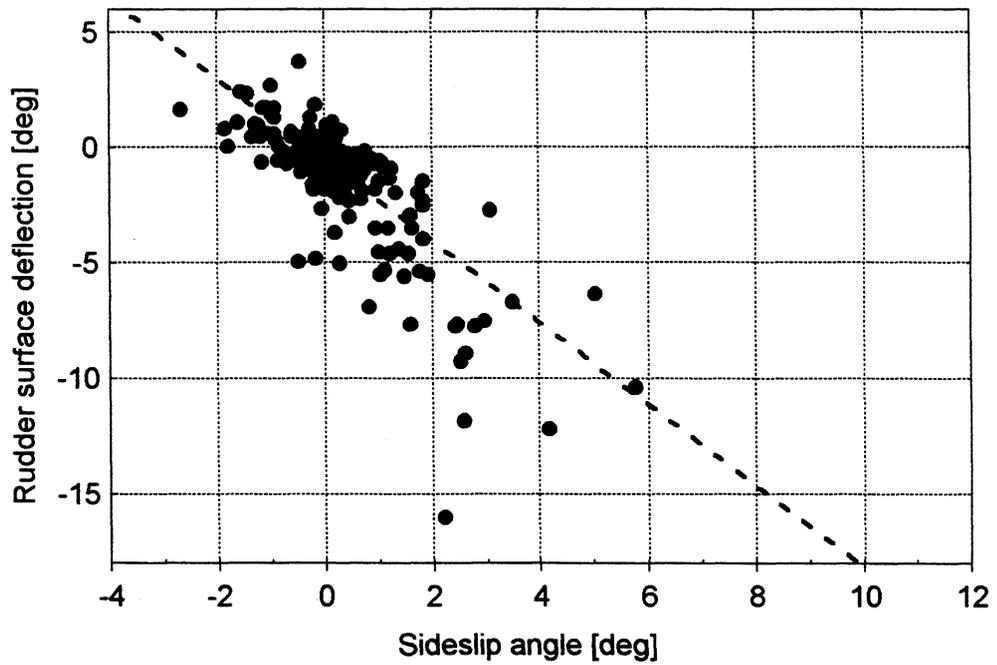
Figure 2 Correlation between sideslip angle and rudder surface deflection

It turned out that sideslip angle was a much better parameter to use than yaw rate or yaw acceleration due to the relative size of the response. A positive sideslip angle can only be achieved by a rudder deflection to the left, i.e. left-foot forward. The data showed there was a negative correlation (-0.28) between sideslip angle and rudder deflection. A scatter plot, showing this correlation, is given in Figure 2. In other words, a *negative* (i.e. left) rudder surface deflection corresponds to a *positive* sideslip angle. However, due to the positive gain, a negative rudder deflection should then also mean a negative rudder pedal deflection, i.e. right-foot forward, when adhering to Transavia’s definition. This is wrong. The proper definitions are given in Table 1, last column.

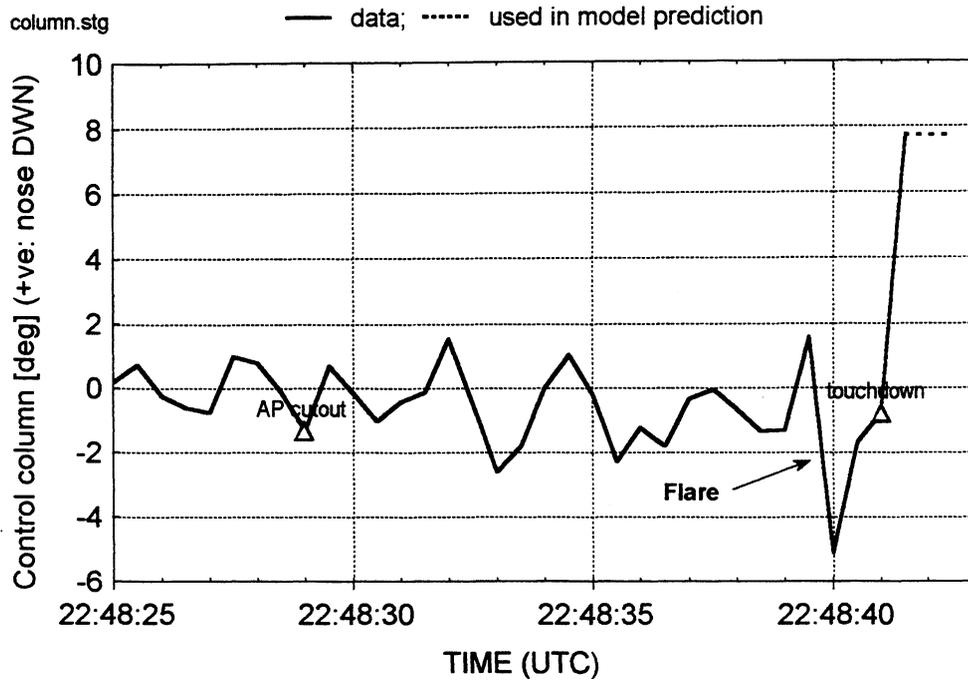
Figure 3 Control column deflection during approach, flare and landing

When predicting the elevator surface deflection during flare and landing, it is assumed that the control column input is frozen at the last moment in time where data is available. The control column input, from just before Autopilot cutout to 2 seconds after touchdown is shown in Figure 3.

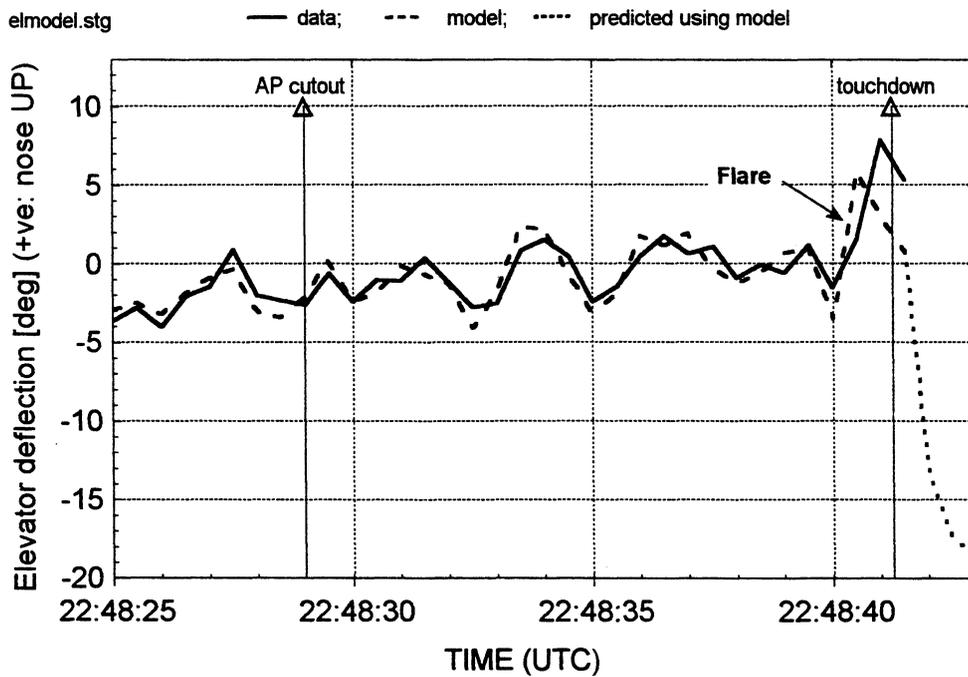
Figure 4 Elevator surface deflection (measured and predicted) during approach, flare and landing

Using the longitudinal hydraulic control model, the predicted elevator surface deflection generated by the model is as indicated in Figure 4, together with the measured elevator surface deflection response. The associated aircraft pitch angle response is given in Figure 5. Apart from the fact that the predicted elevator response matches the measured one very well, one can see the large negative (predicted) elevator response after touchdown, i.e. in a nose-down sense. Within 2 seconds from touchdown the elevator is predicted to move to about 19 degrees nose-down position. With such a fast and large input, while at the same time the pitch angle was still increasing, a quick and strong nose-down response can be expected. It is likely that this large nose-down pitch input was given due to the fact that at touchdown the pitch angle still tended to increase.

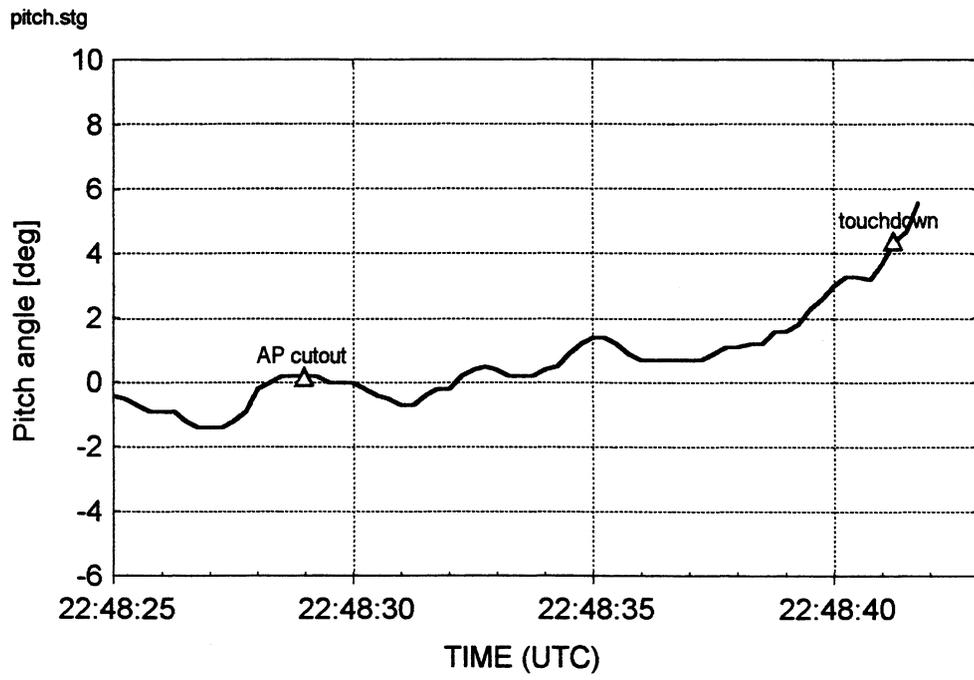
Figure 5 *Pitch angle response during flare and landing*

From inspection and analysis of the flight data it appeared that the definition for positive control column input was wrong. The implication of this is that at and just after touchdown, with the corrected sign definition it becomes possible to explain the possibility for a large negative pitch rate, with associated risk of a hard nosewheel landing. Due to the time lag between column input and elevator response the elevator response data got lost, but the use of the hydraulic model made it possible to “reconstruct” the elevator response.
