ATSB TRANSPORT SAFETY REPORT
Aviation Occurrence Investigation – AO-2010-089
Preliminary

**In-flight uncontained engine failure
overhead Batam Island, Indonesia
4 November 2010
VH-OQA
Airbus A380-842**

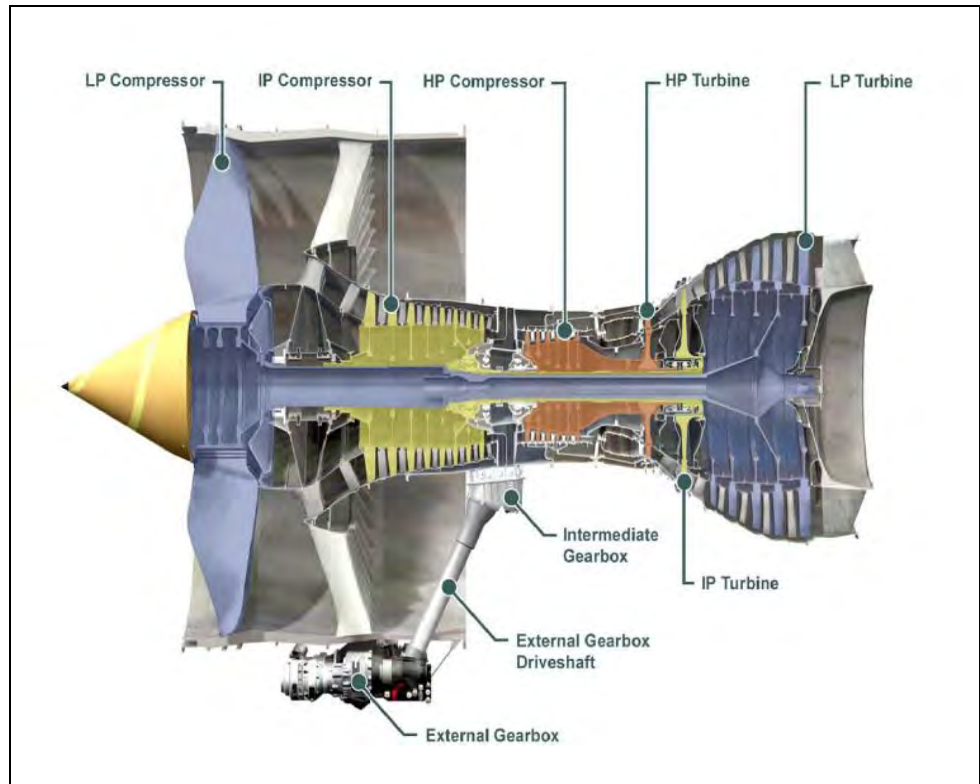
Figure 6: Trent 900 engine component layout

The Rolls Royce plc Trent 900 engine is a three-shaft, high by-pass ratio turbofan with low pressure (LP), intermediate pressure (IP) and high pressure (HP) compressors that are driven by turbines through co-axial shafts (Figure 6).

¹⁸ N3 vibration is the vibration level of the HP spool comprising the HP compressor and HP turbine. Similarly, N1 vibration is the vibration level of the LP spool, comprising the LP compressor and LP turbine. N2 vibration is the vibration level of the IP spool, comprising the IP compressor and IP turbine (refer Figure 6).

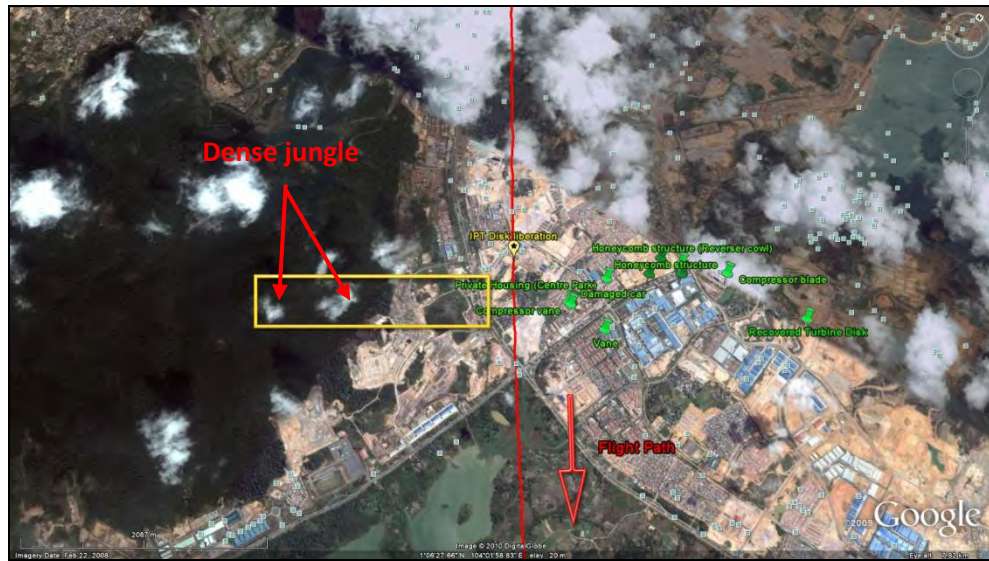
Figure 12: Estimated location of the missing disc segments (search area in yellow, including the area of dense jungle)

Trajectory analysis was undertaken to localise the search area based on a number of aircraft and engine parameters immediately prior to the failure, and on the location of the recovered segment of the IP turbine disc. On that basis, it was estimated that the missing disc segments should be located to the right of the aircraft's flight path, most likely in an area of steep, dense jungle (Figure 12).

Although the search was hampered by the local terrain, some small engine components, such as turbine blades and blade attachment points were recovered by local residents and provided to the investigation. However, no other significant turbine disc parts were recovered.

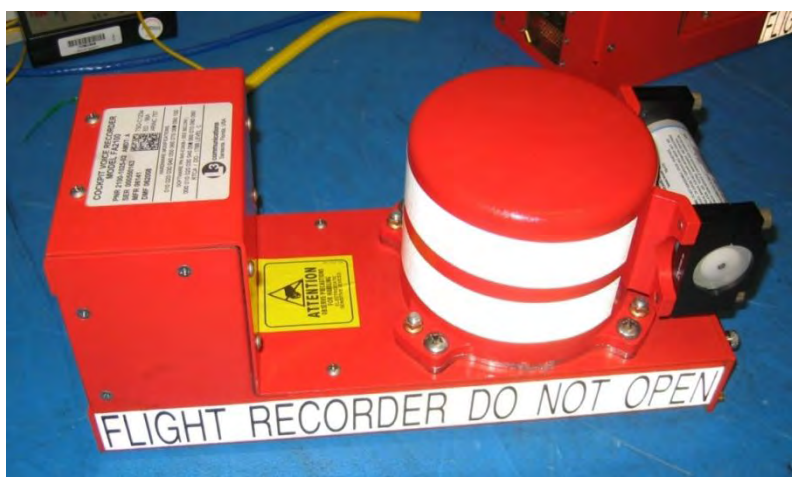
Figure 18: Cockpit Voice Recorder

The CVR contained over 2 hours of cockpit audio but, due to the continued running of the No 1 engine in Singapore, the audio at the time of the disc failure was overwritten. The available audio commenced during the landing approach and continued during the subsequent ground operations.
