FINAL REPORT

97-75/A-26

PH-TKC

Final report of the investigation into the probable cause of the accident with Transavia Boeing 757, registration PH-TKC, on December 24th, 1997 at Amsterdam Airport Schiphol.

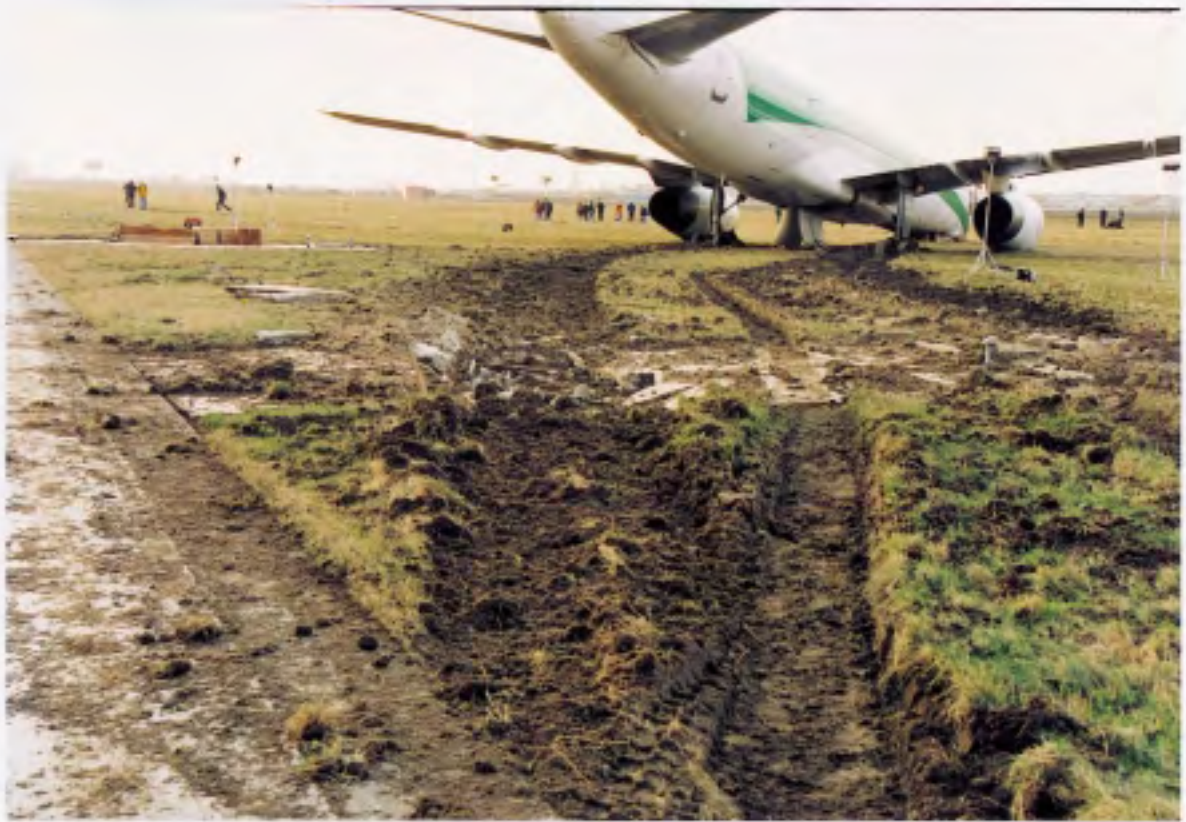
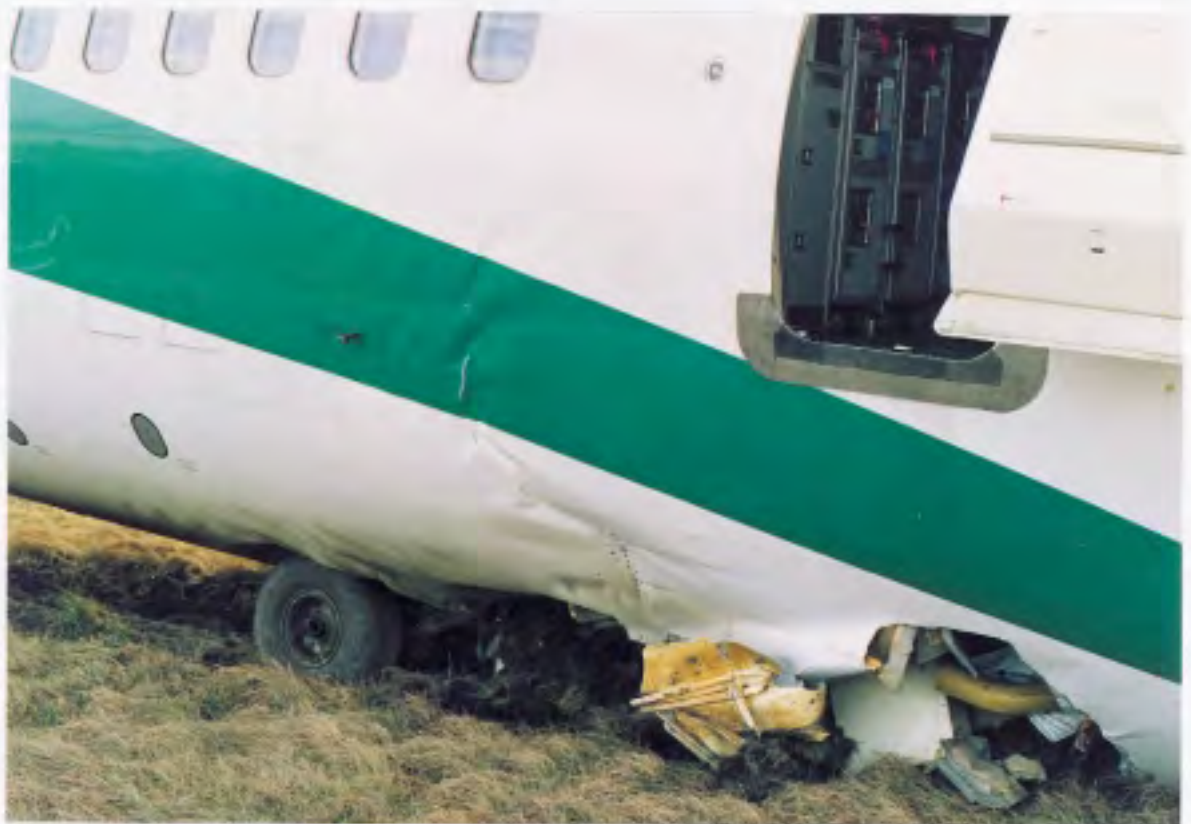
DAMAGE TO CONTROL CABLES

DAMAGE TO ELECTRONIC COMPARTMENT

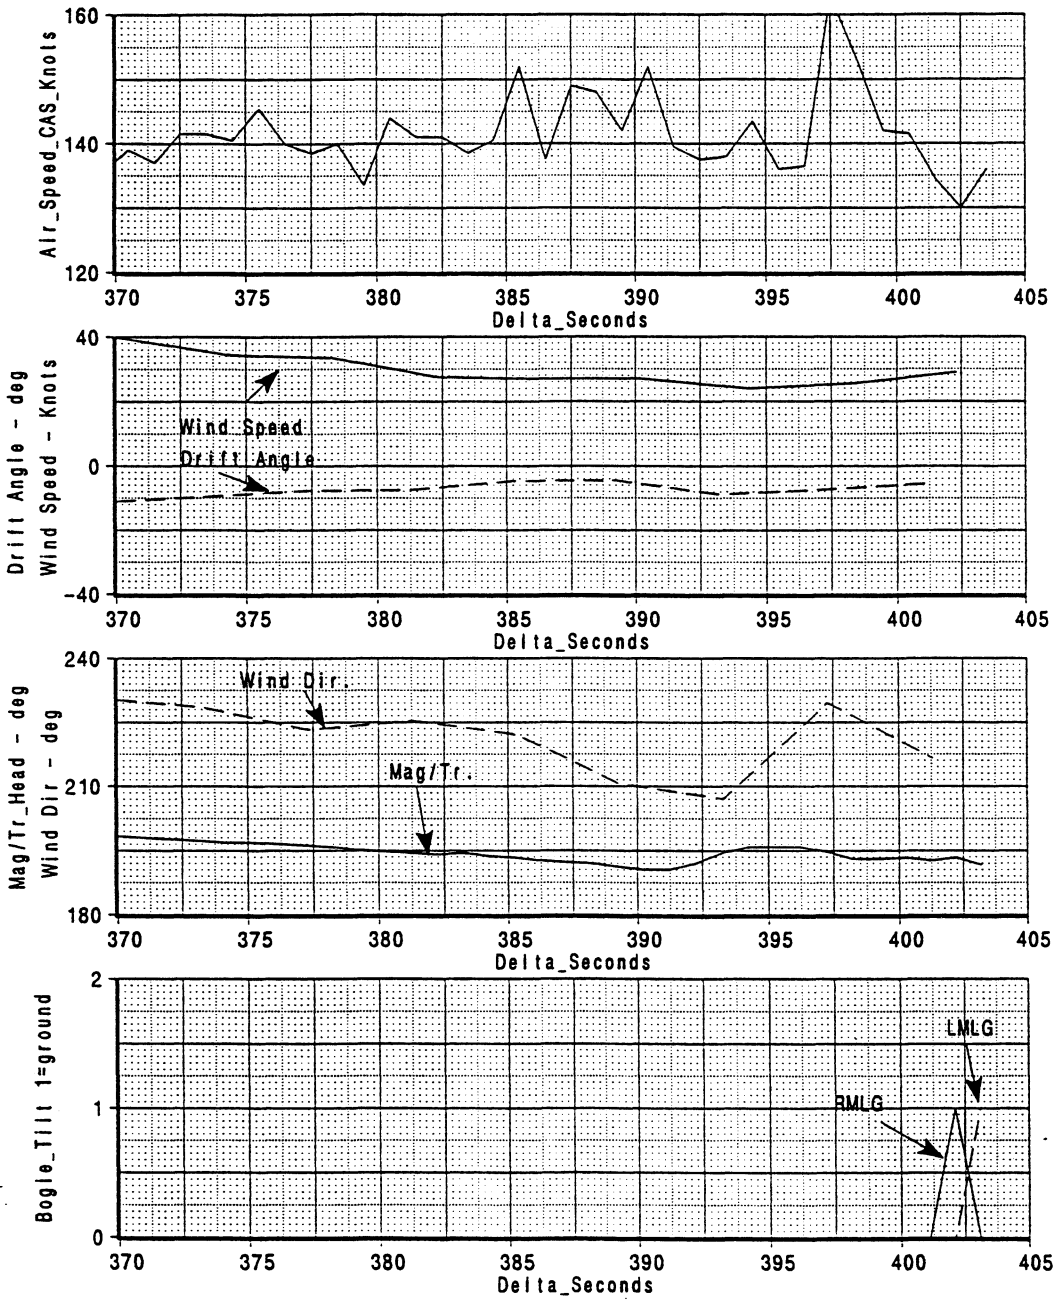
CALC	C. C. Ma	30Jul98	REVISED	DATE	TAV 757-200 PK-TKC/NB453 Landing Accident DFDR, Directional Parameters	757-200
CHECK						
APPD.						
APPD.						
BOEING					PAGE	Figure 1

The airplane encountered a strong cross wind during landing. The drift angle varied between -4 to -10 degrees during final approach and was at about -5 degrees at time of touchdown as shown in Figures 1 and 2.

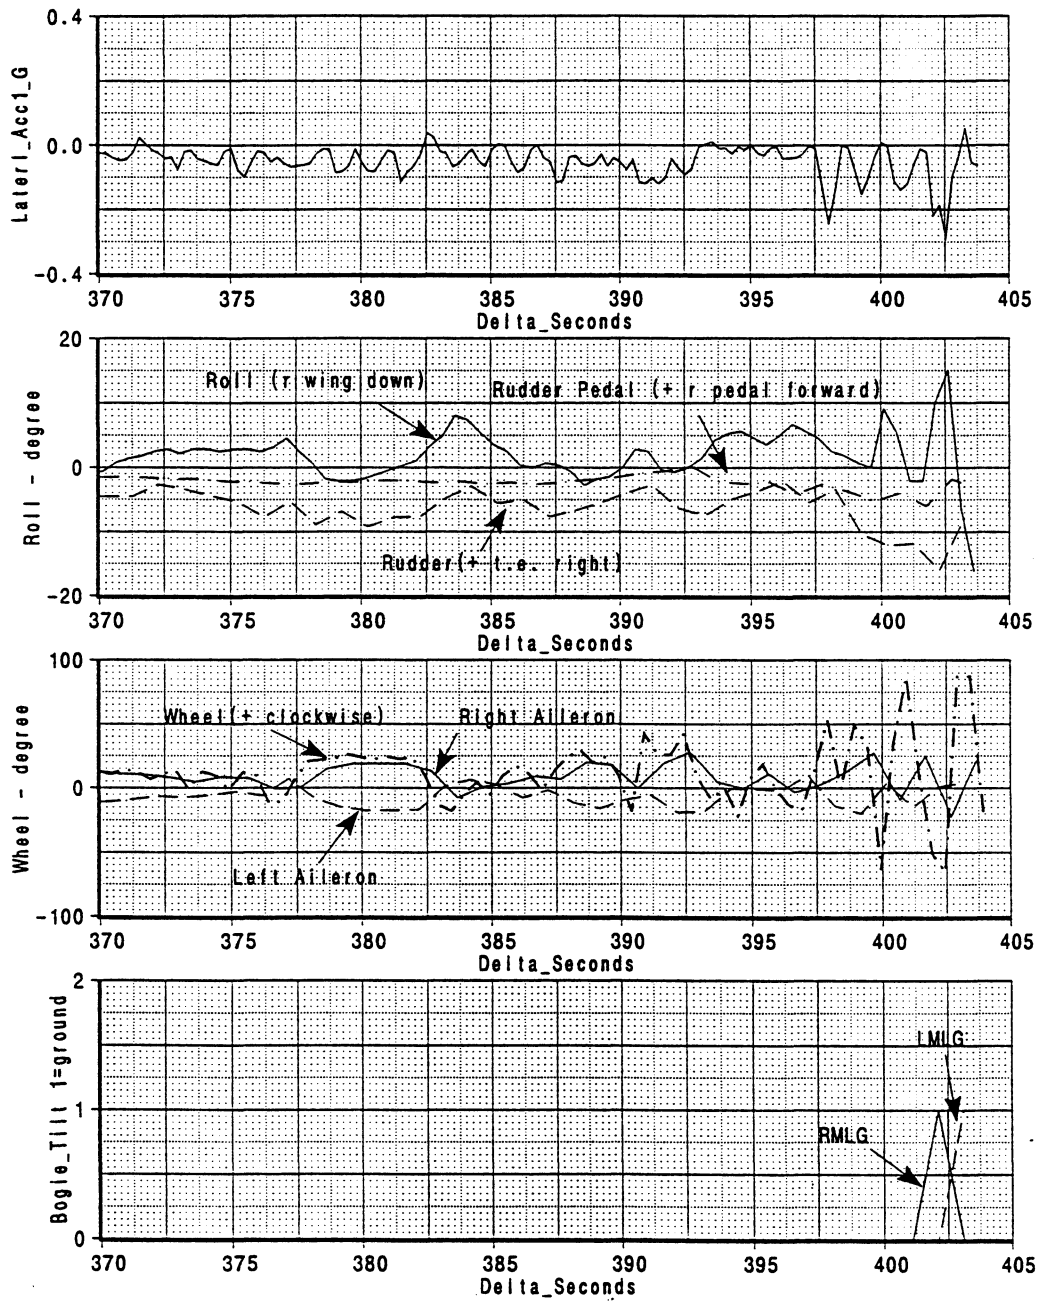
CALC	C. C. Ma	7Aug98	REVISED	DATE	TAV 757-200 PK-TKC/NB453 Landing Accident DFRD, Roll parameters	757-200
CHECK						
APPD.					BOEING	PAGE
APPD.						Figure 3

From Figures 3 and 4, the pilot was very busy responding to the cross wind to keep the airplane level. During the flare, beginning about time 398, the pilot had a few rapid maximum wheel cycle commands to fight the progressively bigger roll response of the airplane.

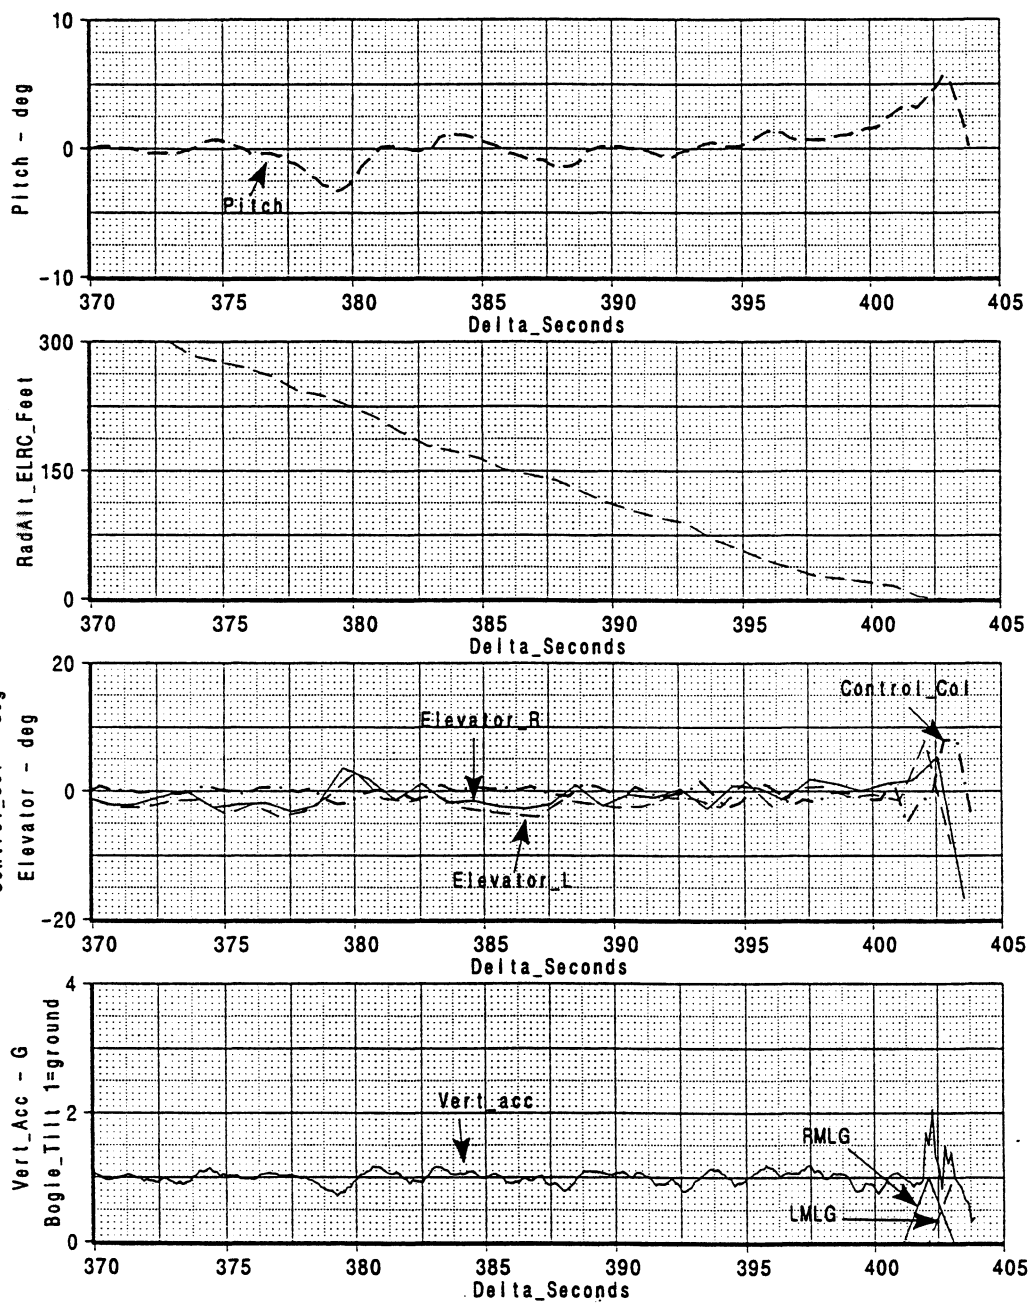
CALC	C. C. Ma	30Jul98	REVISED	DATE	TAV 757-200 PK-TKC/NB453 Landing Accident DFDR, Vertical parameters	757-200
CHECK						
APPD.						
APPD.						
BOEING						PAGE Figure 5

From Figure 5, it appears the pilot had a hard time keeping the airplane in constant pitch angle during approach too. From Figure 6, the sink rate at touchdown was higher than normal at 13 foot per second, exceeding the 10 foot per second design limit. The airplane landed on the right main landing gear (RMLG) and had a recorded 2.1 g's (the actual peak may be higher) hard landing, it then bounced off the RMLG and landed on the left main landing gear (LMLG) at 1.5 g's (or higher). While bouncing off the RMLG, the pilot pushed down the control column to command pitch down elevator within 1 second of RMLG touchdown. The pitch rate at nose gear contact was estimated to be at least 9 degrees per second from the pitch angle on Figure 6.

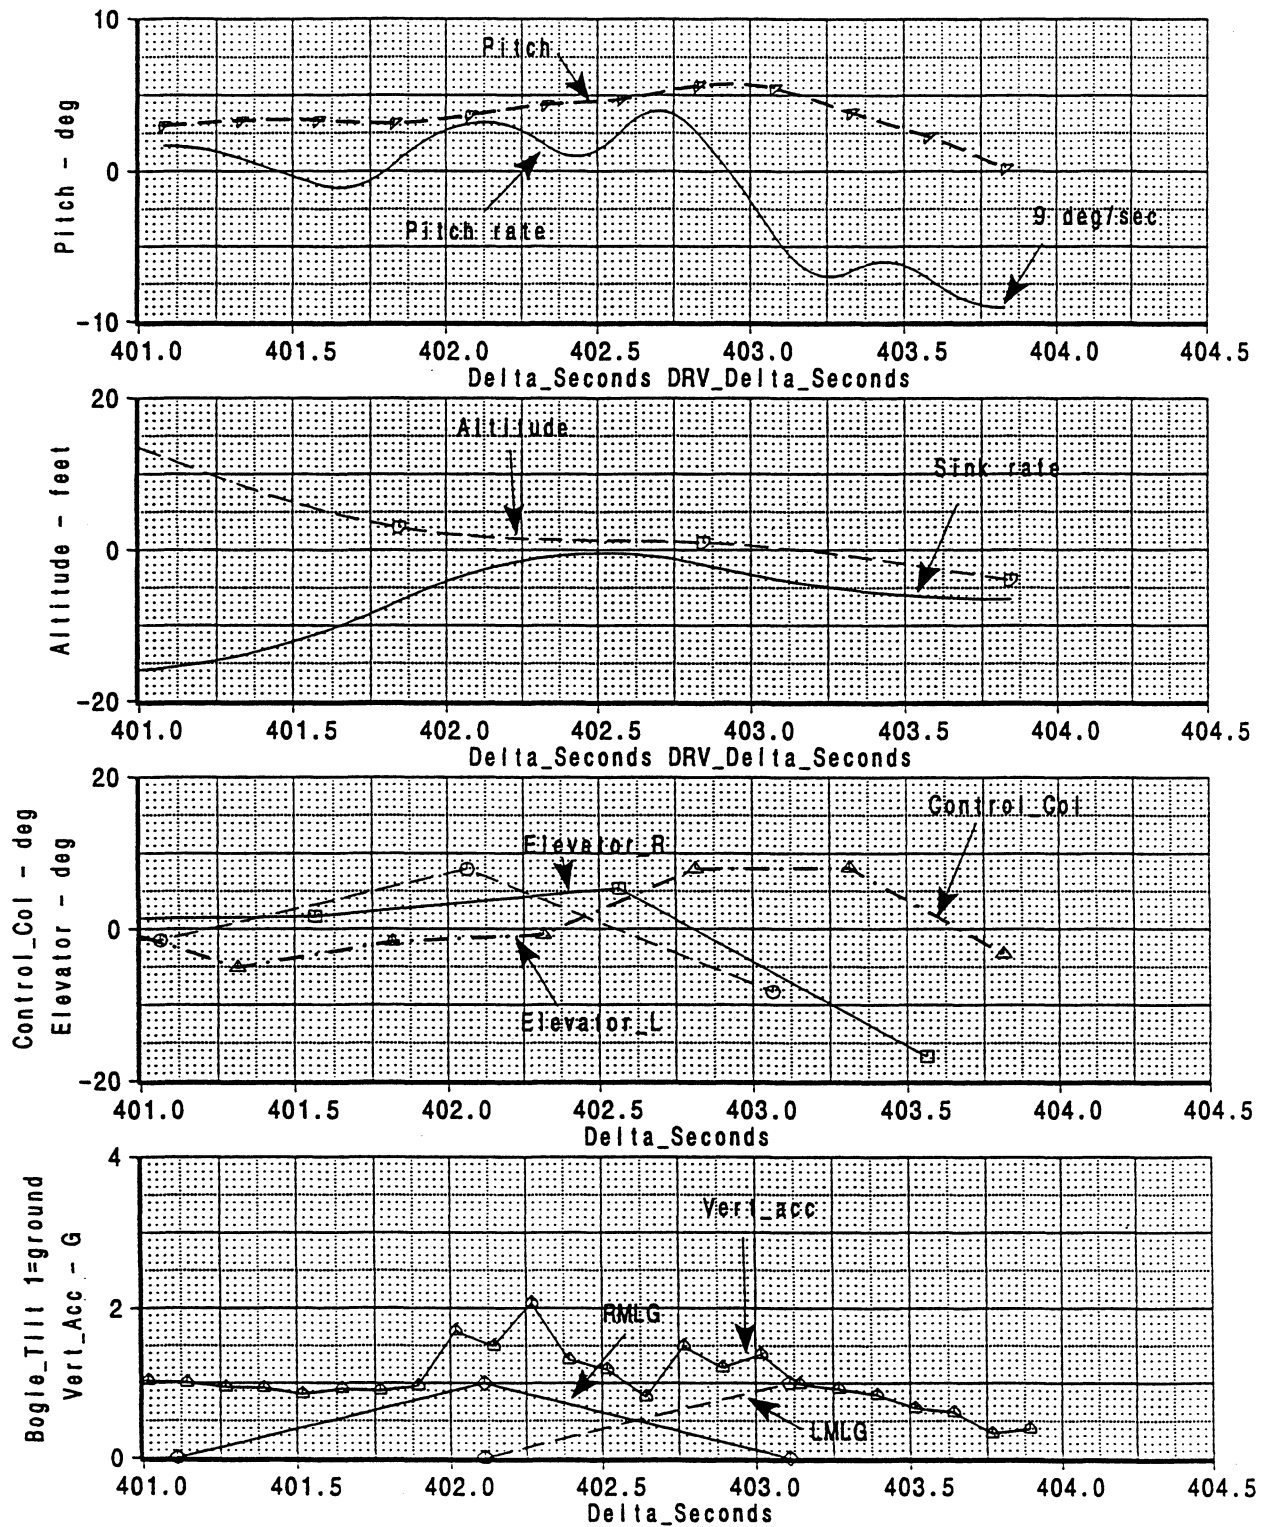
CALC	C. C. Ma	8Dec98	REVISED	DATE	TAV 757-200 PH-TKC/NB453 Landing Accident DFDR, Vertical parameters Flare, Touchdown	757-200
CHECK						
APPD.						
APPD.						
BOEING						PAGE Figure 7

In Figure 7 we have plotted airplane pitch, airplane altitude, elevator position, control column, vertical acceleration and main landing gear bogie tilt versus time following initial touchdown. These parameters were taken directly from the DFDR data. The actual data points are shown by symbols. The airplane pitch time history plot was spline curve fitted and its derivative was plotted as pitch rate. The last data point has a pitch rate of approximately 9 degrees per second. The nose landing gear ground contact occurred shortly after the last data point was recorded. The spline curve fit was also applied to the altitude time history data and its derivative was plotted as sink rate. The last data point has a sink rate of about 6 feet per second.

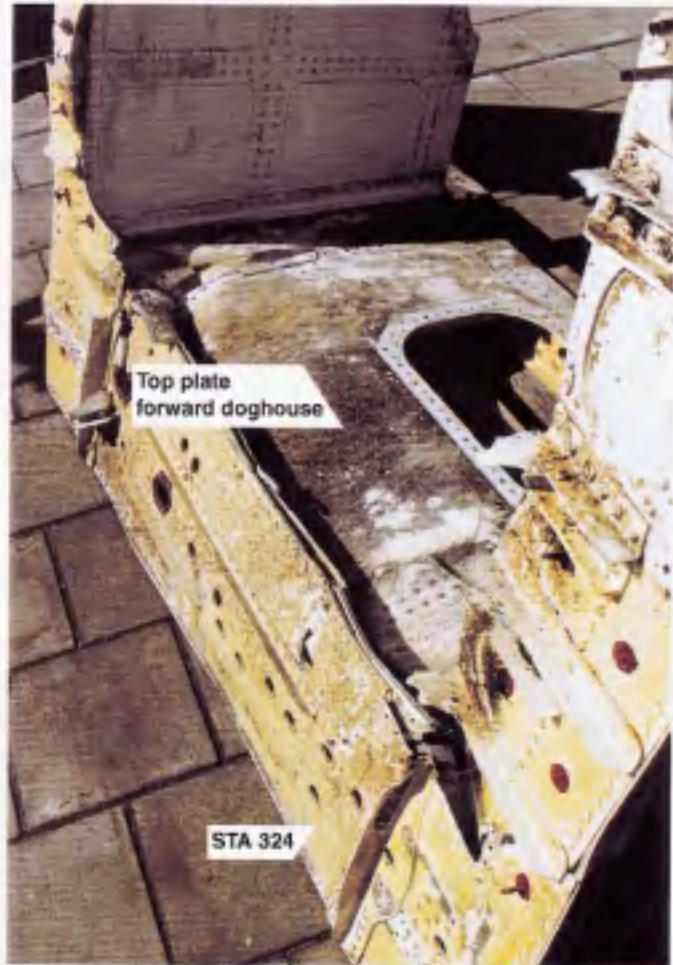
An overview of the fracture at STA 324 is shown in figure 5. The aft side of the top plate of the forward doghouse adjacent to the STA 324 frame was pressed in forward direction and buckled (see Fig. 6), indicating a forward displacement of the top side of the aft doghouse. At the lower side the web was pulled aft (see Fig. 5).

Fig. 6 Aft part of the forward doghouse
and part of the STA 324 bulkhead
(upside down position)

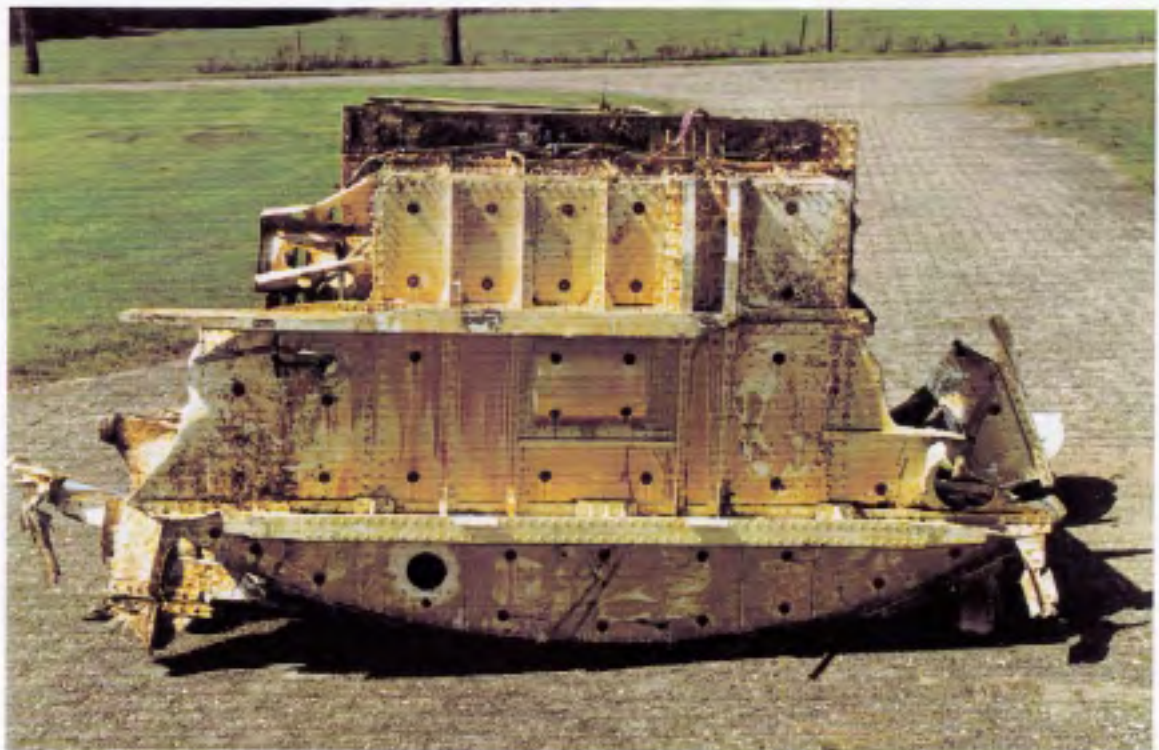
An overview of STA 395 bulkhead remnant including the aft side of the doghouse is given in figure 9. A schematic of the STA 395 bulkhead with the web fracture locations is shown in figure 10. The dashed areas are crushed areas. The LH and RH fracture locations are shown in figures 11 and 12.

Fig. 9 Aft side of the aft doghouse

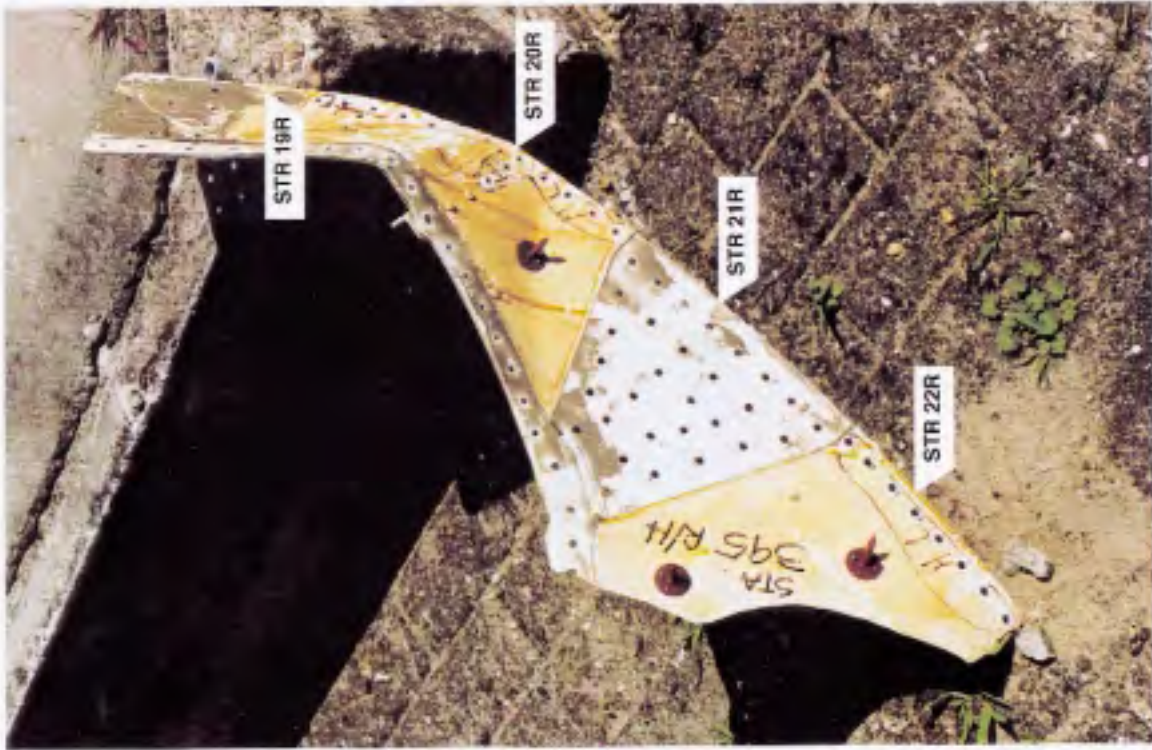
Figures 13 and 14 show disassembled parts of the STA 395 bulkhead which were still attached to the fuselage structure. The chords of the RH side bulkhead section had been removed, so only the web was available for examination, see figure 14. Both the LH and the RH bulkhead sections were buckled between stringer locations 19 and 21. The lower sides of the bulkhead sections were twisted conform the rotation of the doghouse.

Fig. 14 Section of the STA 395 bulkhead (RH-side)

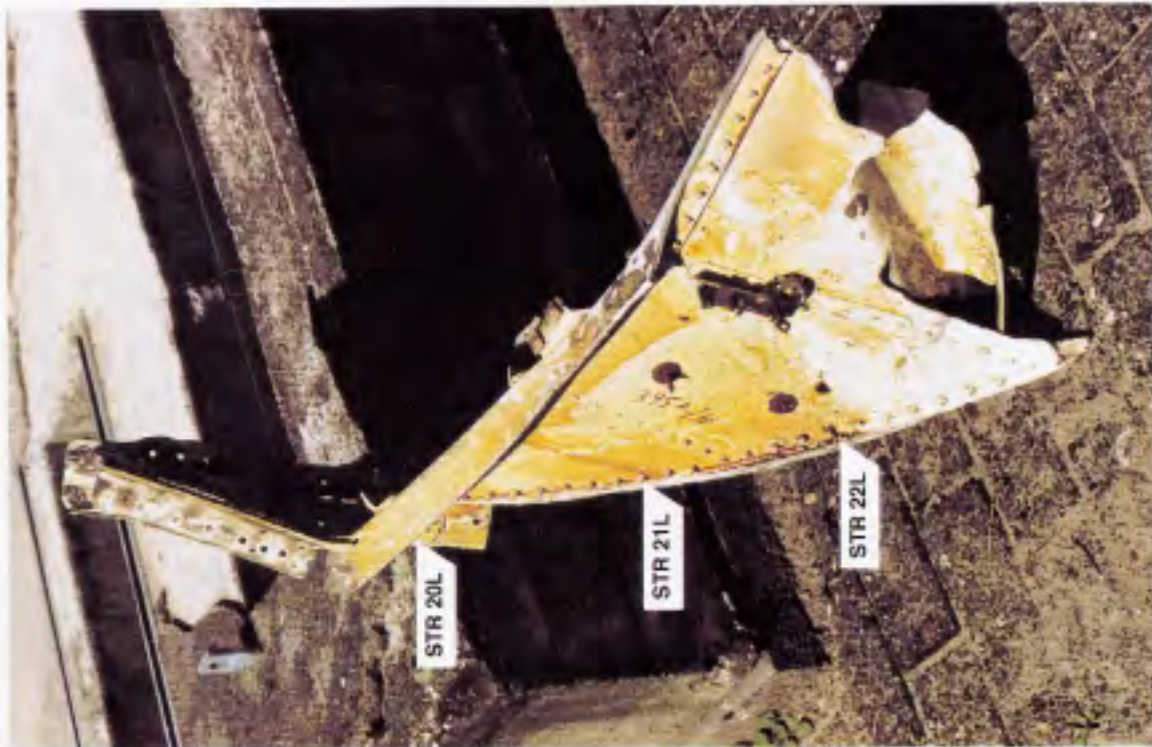
Fig. 13 Section of the STA 395 bulkhead (LH-side)

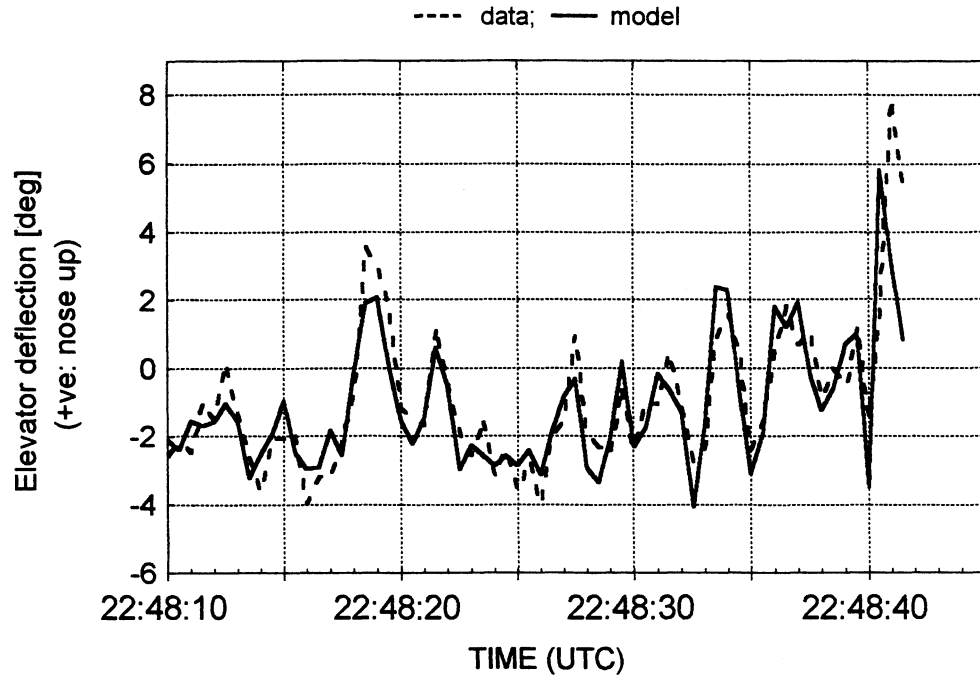
To show how such a fit looks like, the output from the longitudinal hydraulic model, i.e. the elevator control surface deflection, computed using the control column as input into the hydraulic system, has been plotted in Figure 1, together with the measured elevator deflection. For only the last 30 seconds shown, the overall good quality of the fit is obvious!

Figure 1 Comparison of model-computed and measured elevator deflection

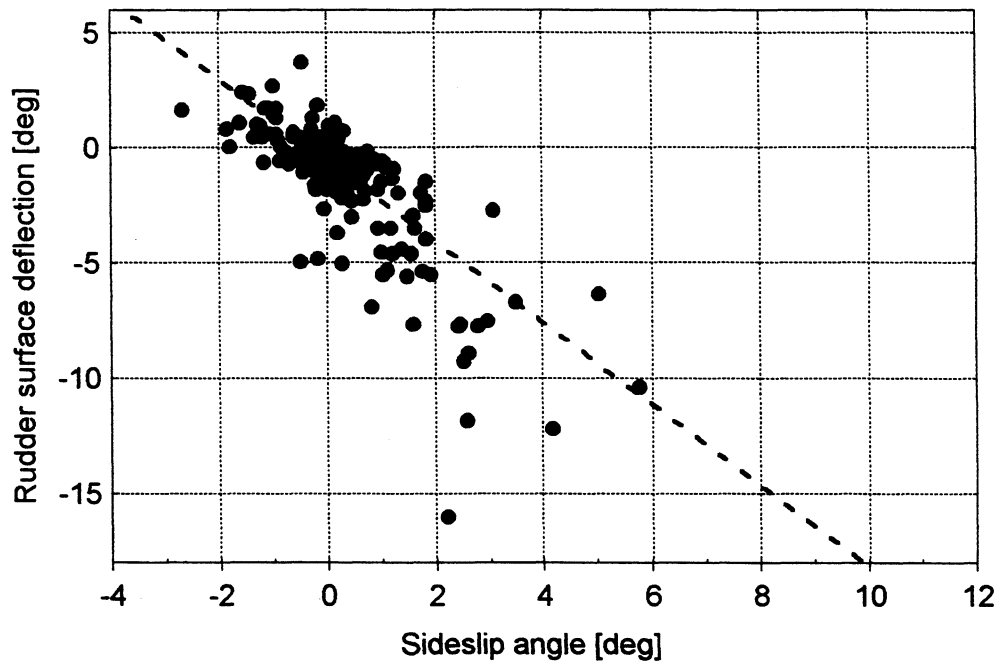
It turned out that sideslip angle was a much better parameter to use than yaw rate or yaw acceleration due to the relative size of the response. A positive sideslip angle can only be achieved by a rudder deflection to the left, i.e. left-foot forward. The data showed there was a negative correlation (-0.28) between sideslip angle and rudder deflection. A scatter plot, showing this correlation, is given in Figure 2. In other words, a *negative* (i.e. left) rudder surface deflection corresponds to a *positive* sideslip angle. However, due to the positive gain, a negative rudder deflection should then also mean a negative rudder pedal deflection, i.e. right-foot forward, when adhering to Transavia’s definition. This is wrong. The proper definitions are given in Table 1, last column.

Figure 2 Correlation between sideslip angle and rudder surface deflection

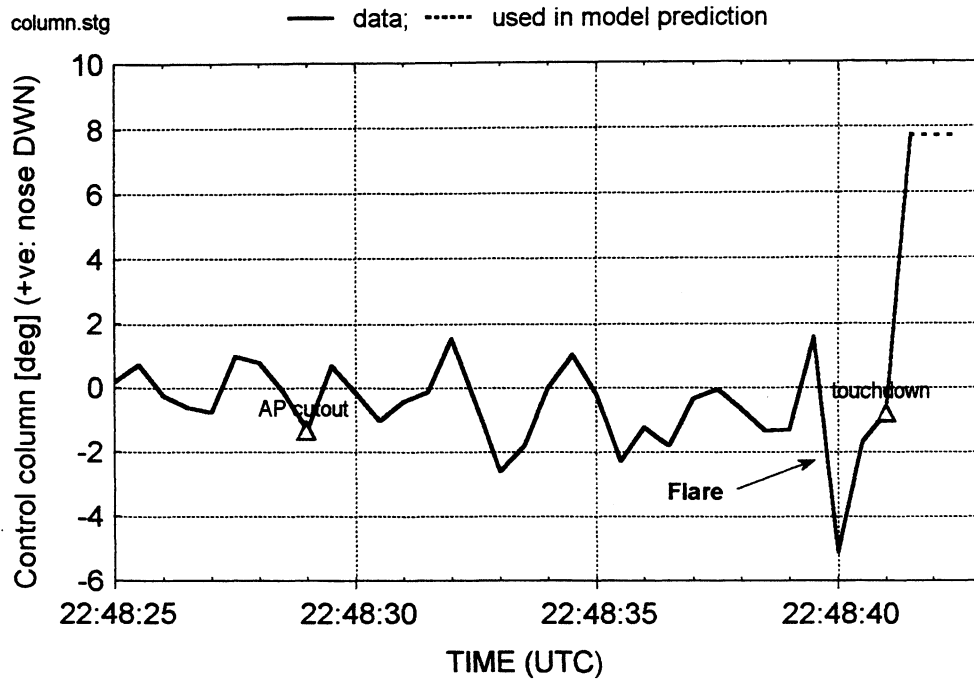
When predicting the elevator surface deflection during flare and landing, it is assumed that the control column input is frozen at the last moment in time where data is available. The control column input, from just before Autopilot cutout to 2 seconds after touchdown is shown in Figure 3.

Figure 3 Control column deflection during approach, flare and landing

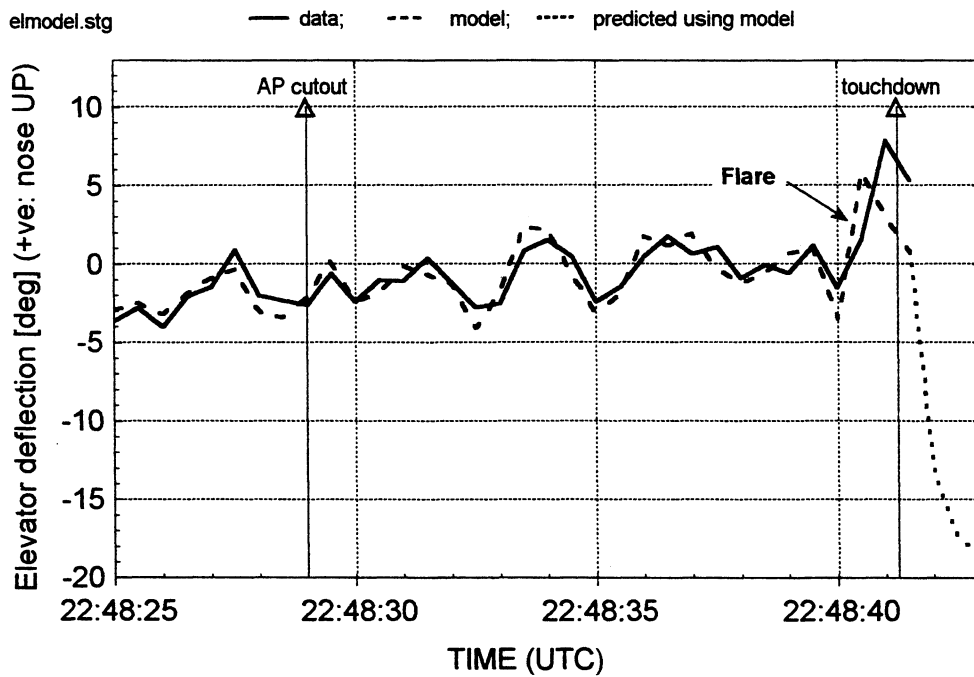
Using the longitudinal hydraulic control model, the predicted elevator surface deflection generated by the model is as indicated in Figure 4, together with the measured elevator surface deflection response. The associated aircraft pitch angle response is given in Figure 5. Apart from the fact that the predicted elevator response matches the measured one very well, one can see the large negative (predicted) elevator response after touchdown, i.e. in a nose-down sense. Within 2 seconds from touchdown the elevator is predicted to move to about 19 degrees nose-down position. With such a fast and large input, while at the same time the pitch angle was still increasing, a quick and strong nose-down response can be expected. It is likely that this large nose-down pitch input was given due to the fact that at touchdown the pitch angle still tended to increase.

Figure 4 Elevator surface deflection (measured and predicted) during approach, flare and landing

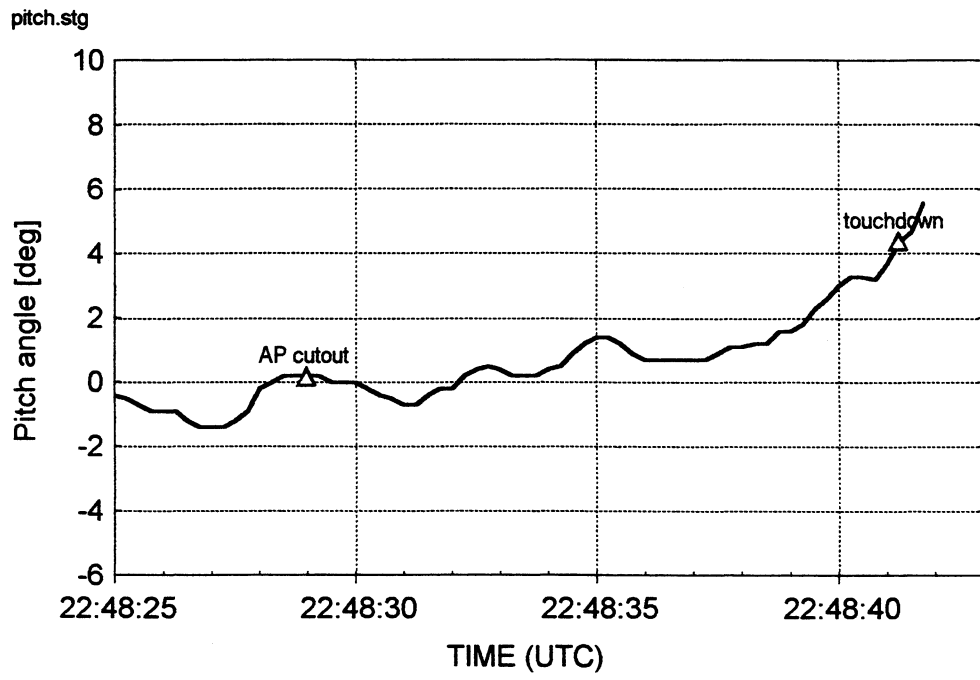
Figure 5 *Pitch angle response during flare and landing*

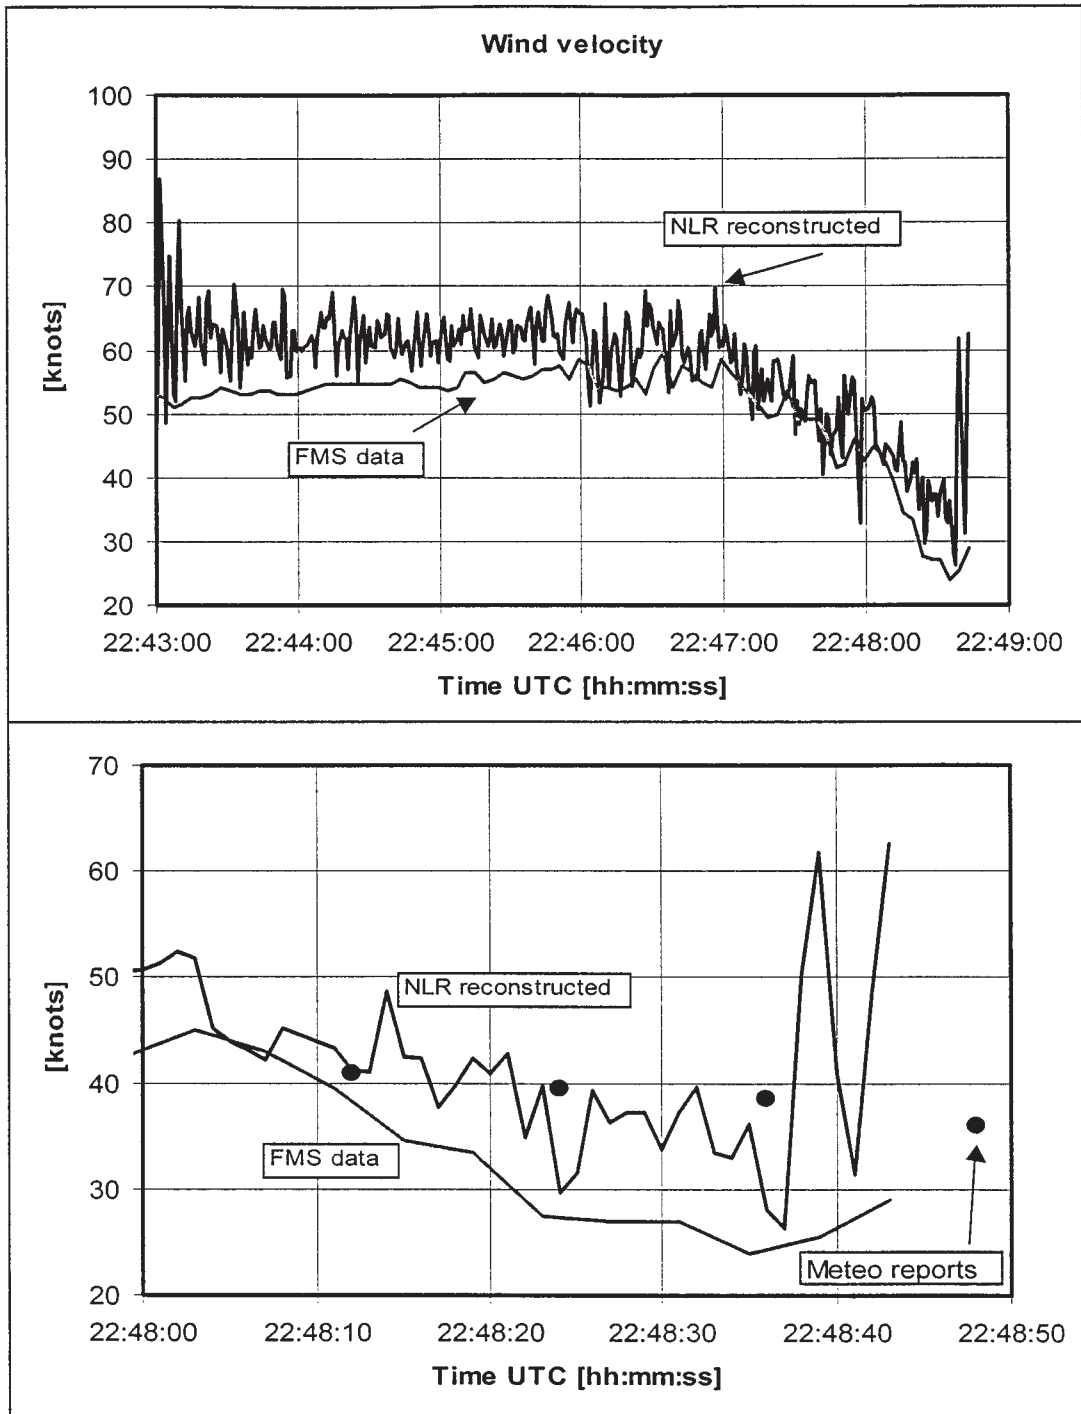
Figure 2: Gereconstrueerde windsnelheid

The characteristics of turbulence are determined essentially by scale length (a measure for band width) and standard deviation (a measure for the intensity). Intensity is defined as the quotient of the standard deviation and the mean wind. An intensity of 0.1 is the normal intensity. An intensity of 0.2 is defined as storm intensity. At the time of the Transavia accident the turbulence intensity immediately prior to the landing was approximately $6/28 \approx 0.2$ (see figures 2 and 6).

Figure 2 : Reconstructed wind speed

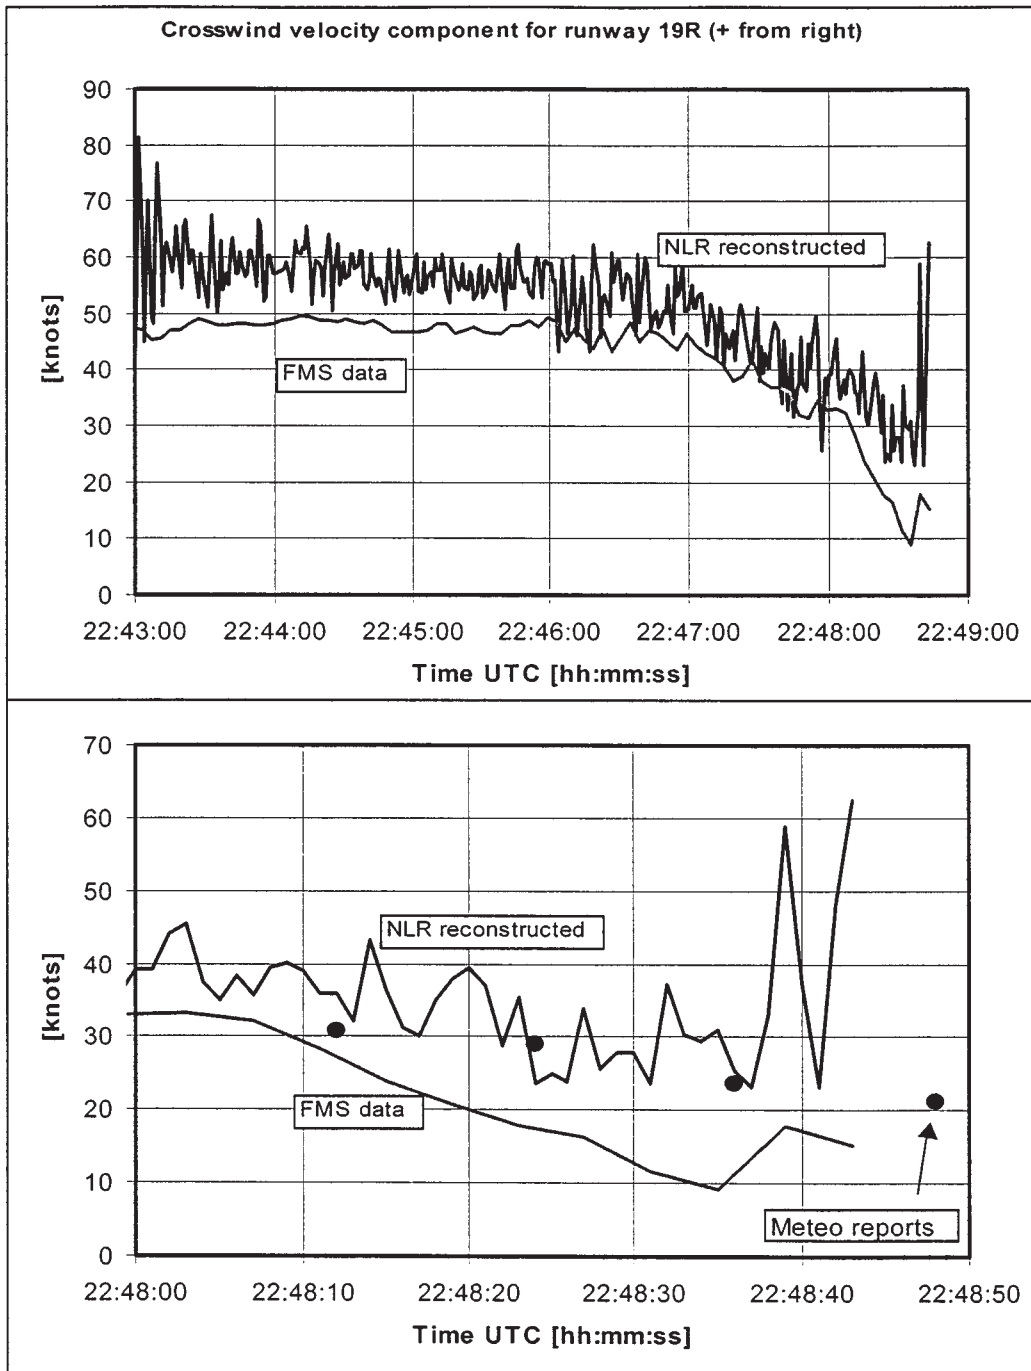
Figure 5: Gereconstrueerde dwarswind voor Runway 19R

Figure 5 : Reconstructed cross wind for Runway 19R

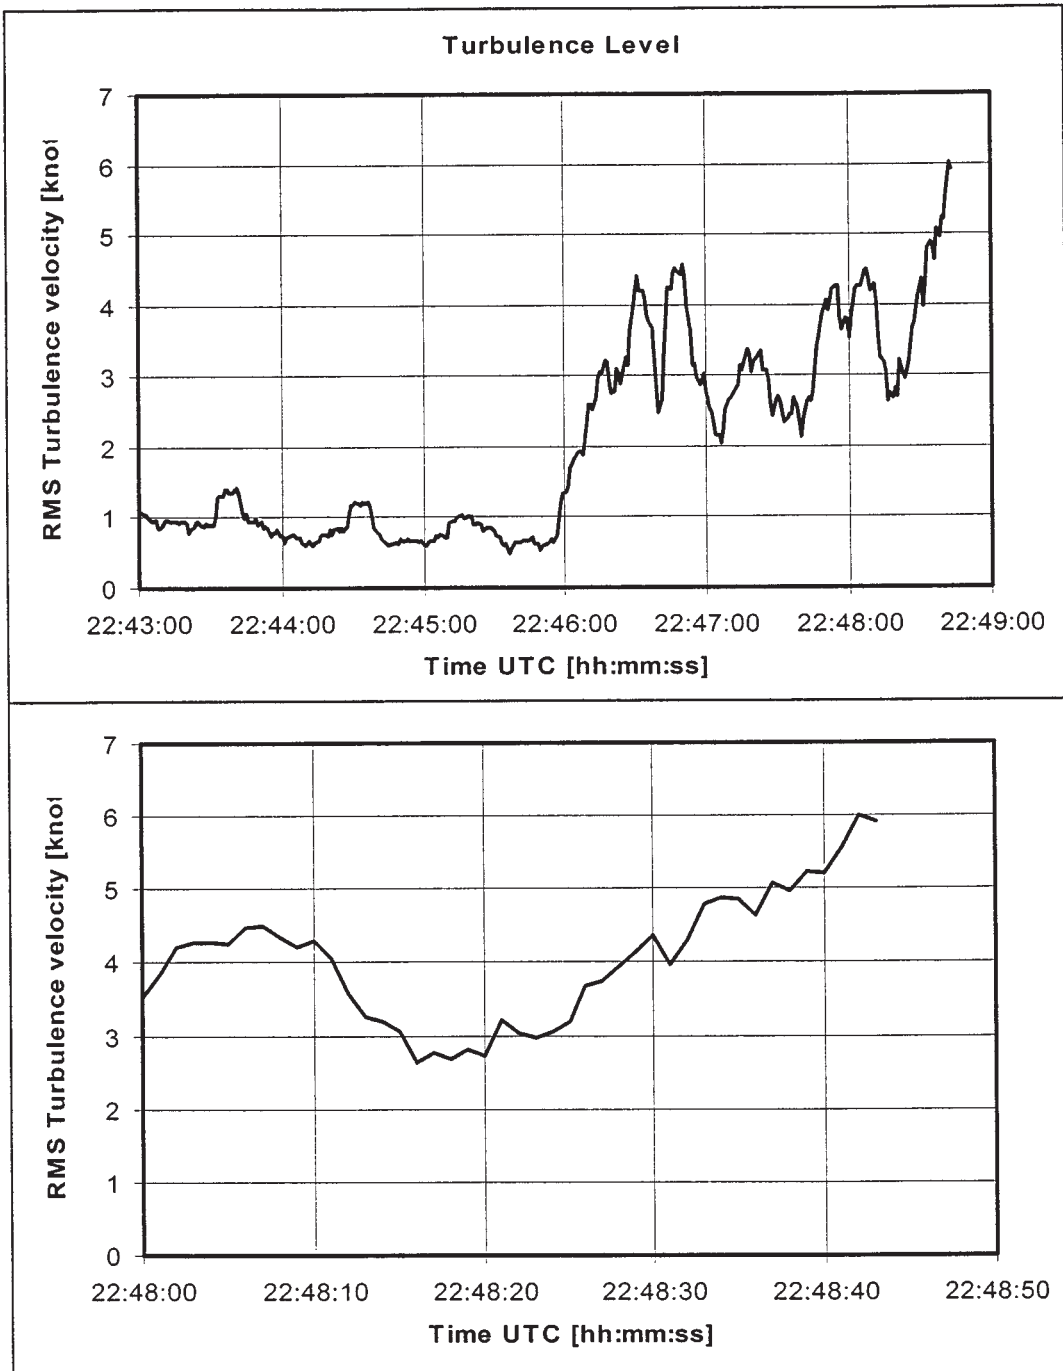
Figure 6: Gereconstrueerd turbulentie niveau

Figure 6 : Reconstructed turbulence level
