Failure of Stabilizer-trim System Blamed For Crew's Loss of Control of MD-83

Insufficient lubrication led to excessive wear and to failure of the jackscrew assembly in the McDonnell Douglas MD-83's horizontal-stabilizer-trim system. The failure caused the horizontal stabilizer to jam in a position beyond normal limits and the aircraft to enter a nose-down pitch attitude from which recovery was not possible.

At 1621 local time Jan. 31, 2000, a McDonnell Douglas MD-83, being operated as Alaska Airlines Flight 261, struck the Pacific Ocean about 2.7 nautical miles (5.0 kilometers) north of Anacapa Island, California, U.S. The two pilots, three cabin crewmembers and 83 passengers were killed. The airplane was destroyed.

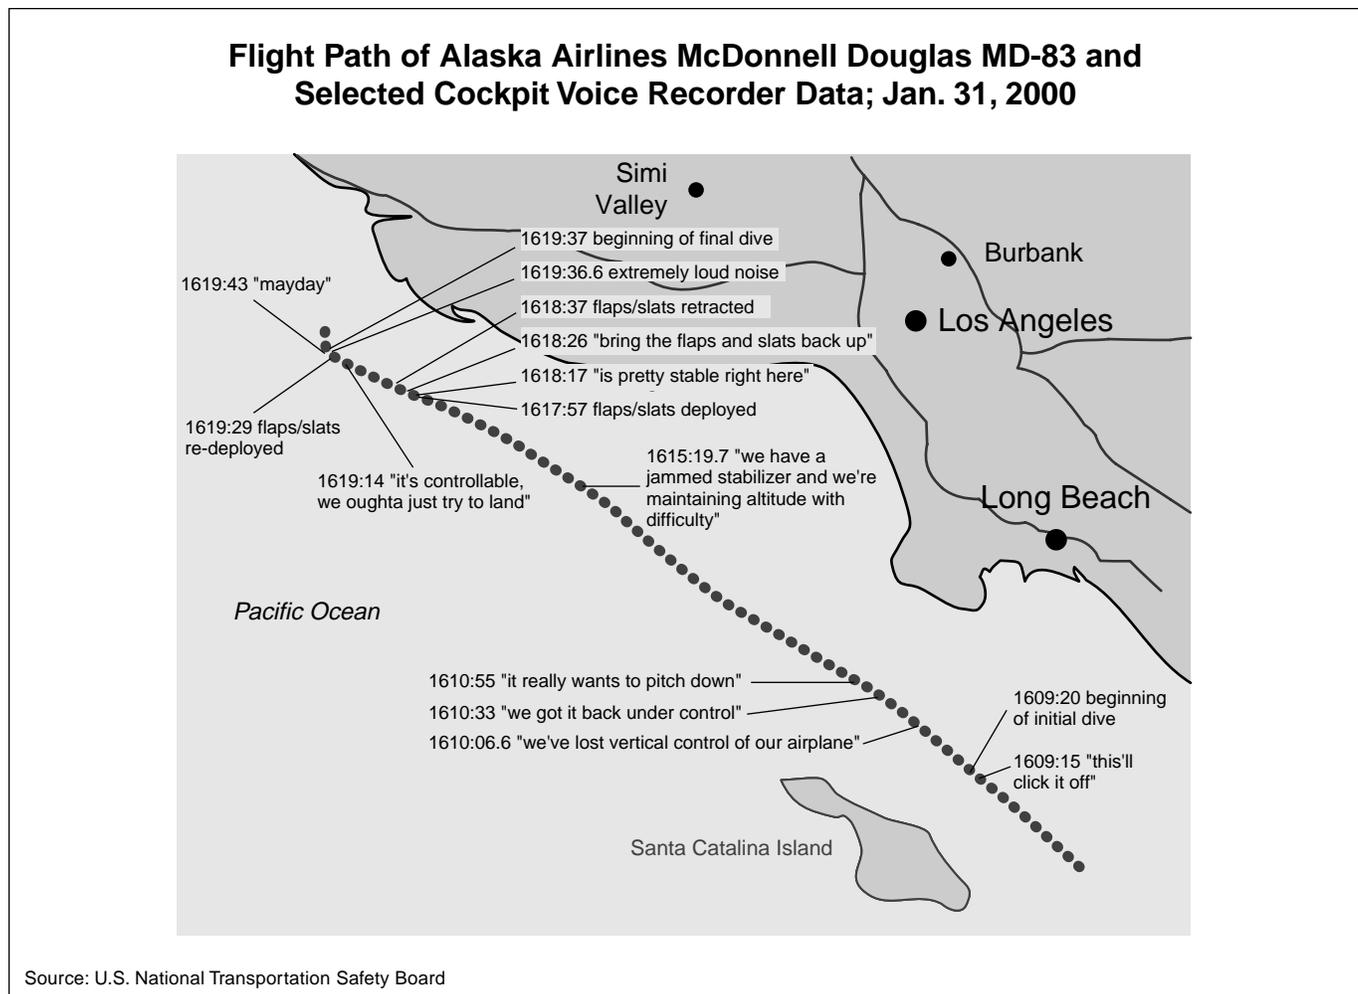
Figure 2

At 1609:13, the captain told the first officer, “Let’s do that.” The CVR then recorded the sound of a click and the captain saying, “This’ll click it off.” FDR data showed that the autopilot was disengaged. [Figure 2 shows the airplane’s position at this time.]

“The captain [apparently] disconnected the autopilot when he activated the primary-trim-control system by using either the control-wheel trim switches, the longitudinal-trim handles, or both,” the report said. “Consequently, although operation of

the primary trim motor as part of troubleshooting attempts earlier in the flight did not release the jam, the torque created by the primary trim motor when the captain activated the primary trim system at 1609:16 apparently provided enough force to overcome the jam between the acme nut and [acme] screw.”

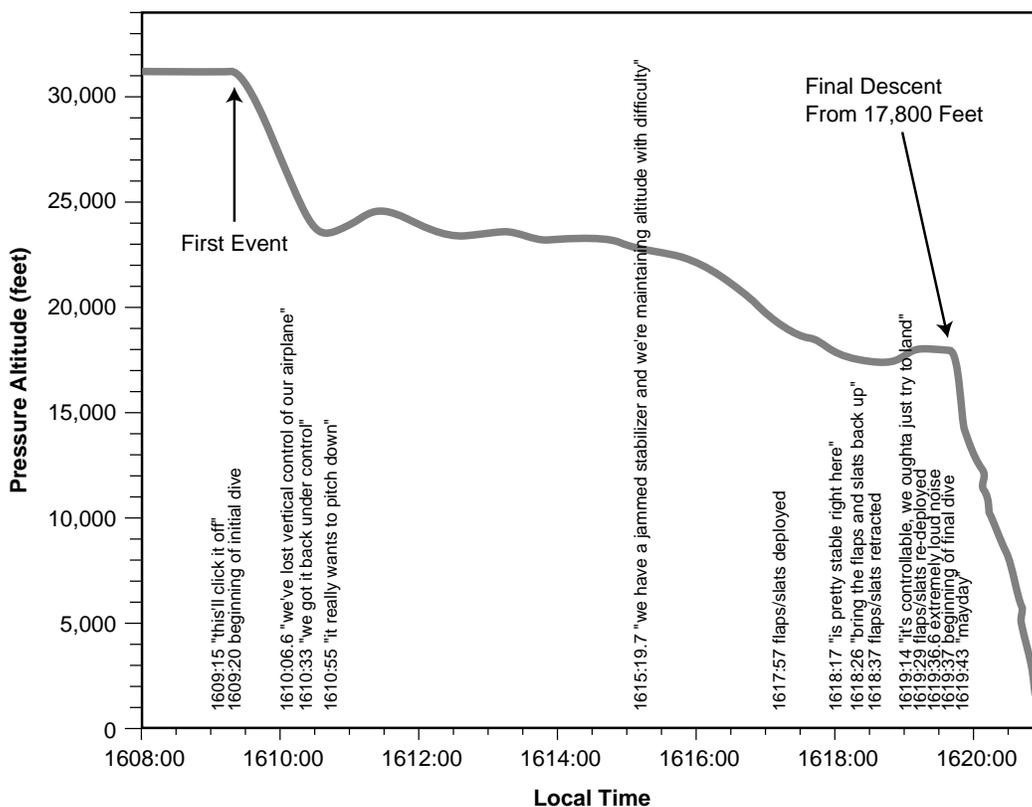
Figure 3

The airplane entered a dive at 1609:20 [Figure 3]. The CVR recorded the captain voicing an expletive and saying, “You got it?”

Vertical Flight Path of Alaska Airlines McDonnell Douglas MD-83 and Selected Cockpit Voice Recorder Data; Jan. 31, 2000
