**AIRCRAFT SERIOUS INCIDENT REPORT**  
**OCCURRENCE NUMBER 00/2518**  
**B767-319ER**  
**ZK-NCJ**

**NZ 60**  
***'ERRONEOUS'* GLIDESLOPE CAPTURE,**  
**AUTOCOUPLED APPROACH,**  
**AND GO-AROUND**

**FALEOLO AIRPORT, SAMOA**  
**29 JULY 2000**

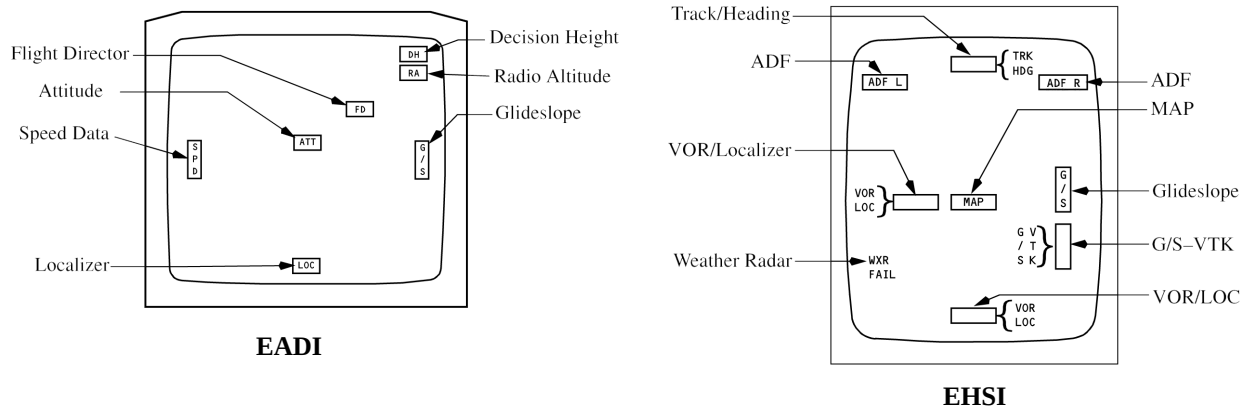
### EFIS Failure Displays

Various failures may be displayed on each EADI or EHSI. When information is not reliable, or radio signals are not received, the display is removed. Numeric indications are replaced with dashes. If aircraft equipment fails, a failure flag is displayed.

An amber box displayed on the EADI in place of the glideslope deviation scale indicates an internal glideslope receiver system failure. If a valid G/S signal is not available the glideslope deviation indicator will not be displayed, however the G/S scale will display on the instrument.

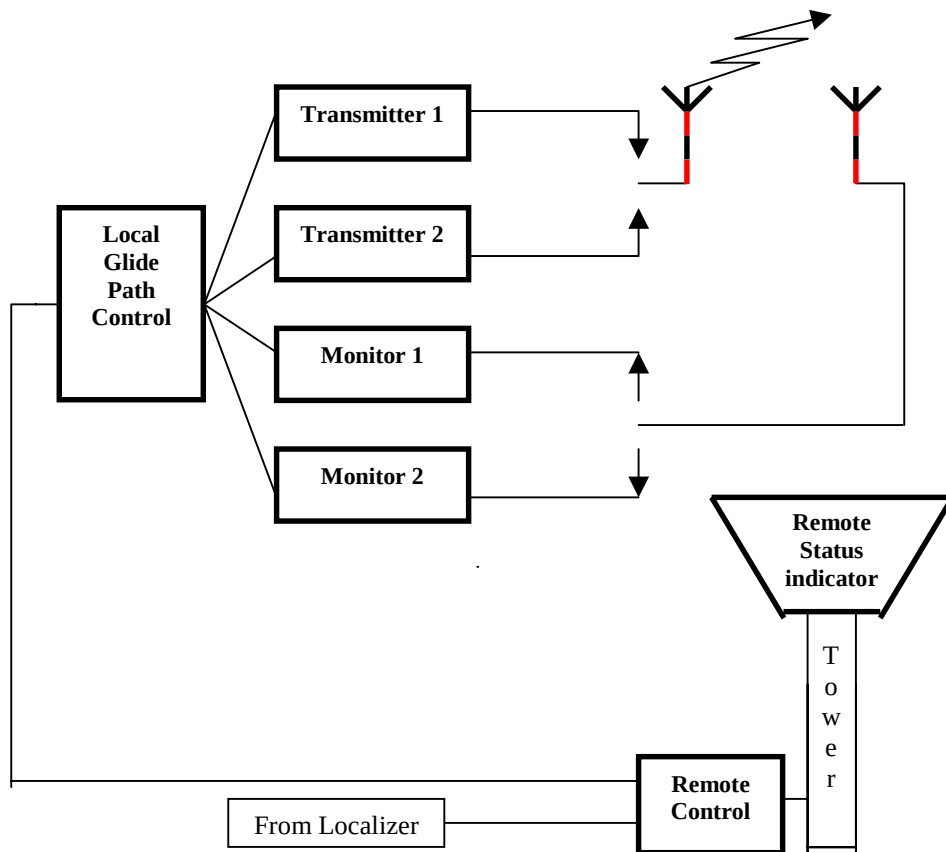
**Schematic of glide path equipment**

Annex 10 also requires the monitor and alarm circuits to be designed to be fail-safe to ensure the navigation guidance and identification is removed and a warning provided at the designated remote control points in the event of a failure of the monitor system itself.

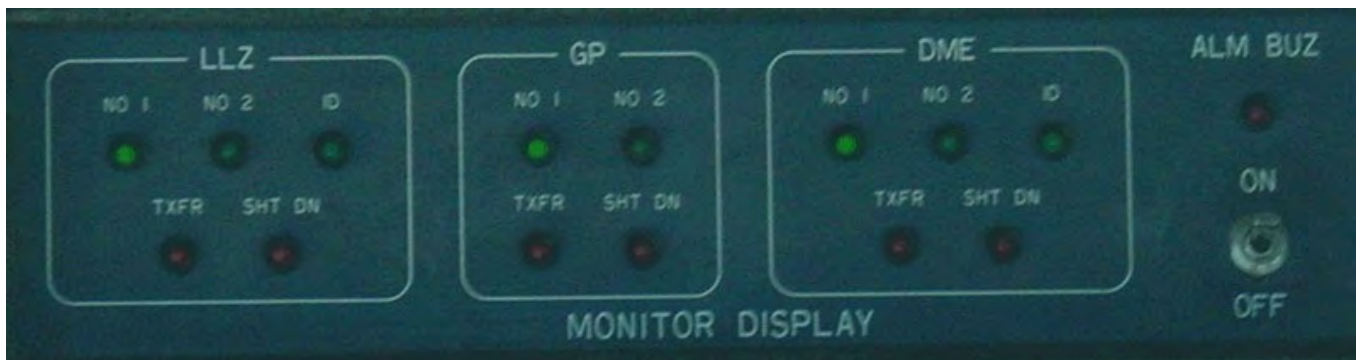
**Tower Remote Status Indicator Panel at Faleolo**

A tower 'monitor', as it is often referred to, is specified in ICAO Annex 10 as a remote control and indicator and indicates the operational status of the respective navigation aid to the controller. The remote indicator is usually simple, e.g. a green light for a normally operating system and a red light for a failed system. To reset the ILS system (in the case of Auckland) the tower staff selects the other runway and then reselects the ILS to the desired runway. Once the equipment is transmitting, the equipment (field) monitors are the sole arbiters of determining whether the equipment should remain transmitting. In the Faleolo tower only the status of the ILS is displayed and no selections are possible other than to silence the audible alarm. At the base of the Faleolo tower is the ILS remote control. This panel is the communication point for the LLZ and GP. It shows the transmitters selected, remotely (at this panel) or local (at the LLZ or GP hut on the field), any maintenance or executive alarms, transmitter transfer or shut downs, and if the equipment is in control bypass, i.e. the executive monitor is **NOT** in control.

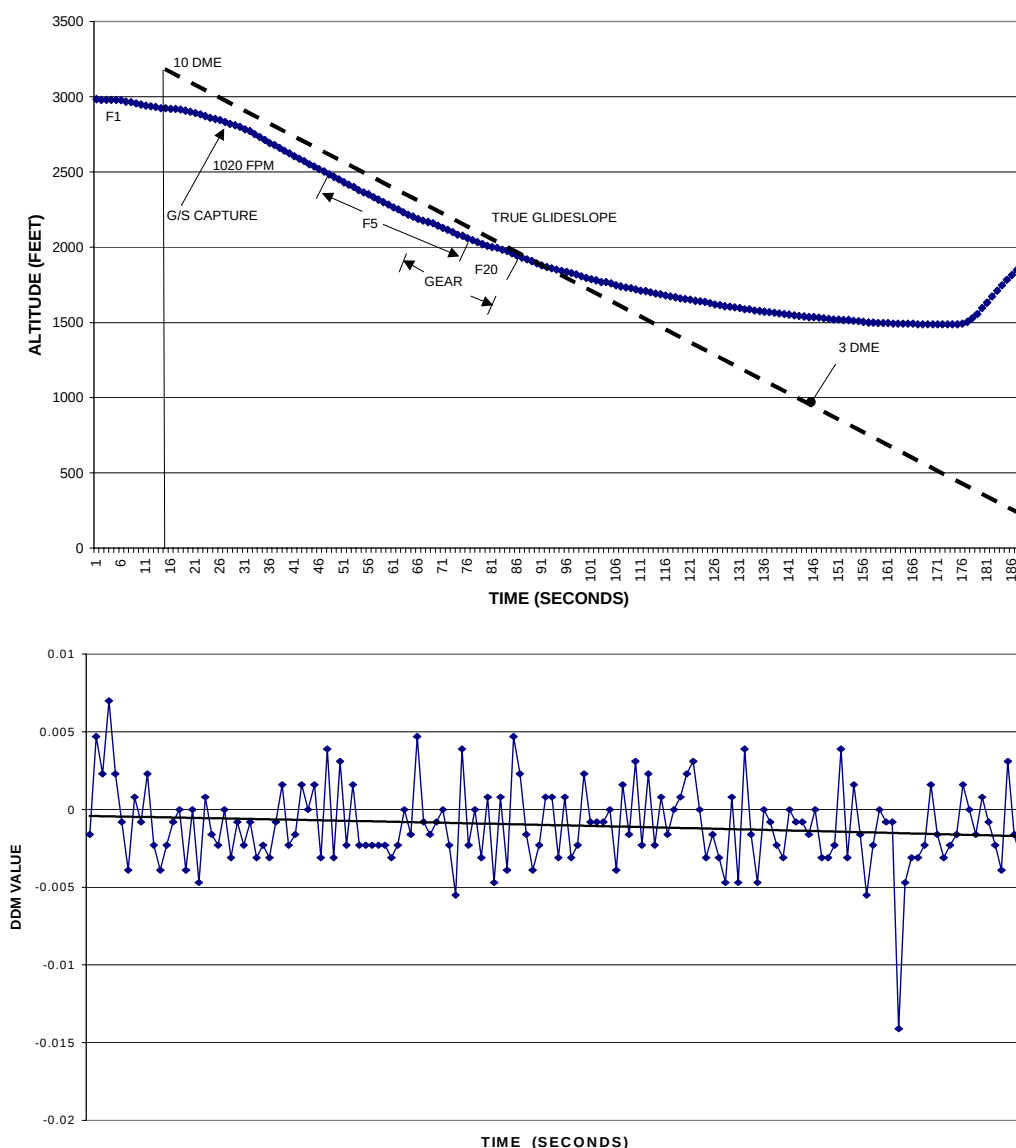
### Proving Flight One – Profile One

The first profile was flown to replicate the aircraft entry speed and configuration as at Faleolo. The aircraft was positioned around an arc from the South to intercept the localizer for runway 05. At glideslope capture the aircraft was at 2800 ft altitude and at 9.3 DME, with a ROD of 600 fpm.

The transition to glideslope capture occurred from the Vertical Speed mode with the left autopilot engaged in CMD. From glideslope capture the aircraft assumed a ROD of 1000 fpm which decreased throughout the profile to a point 7.8 track miles after glideslope capture where the aircraft was at 1480 ft altitude and in level flight.

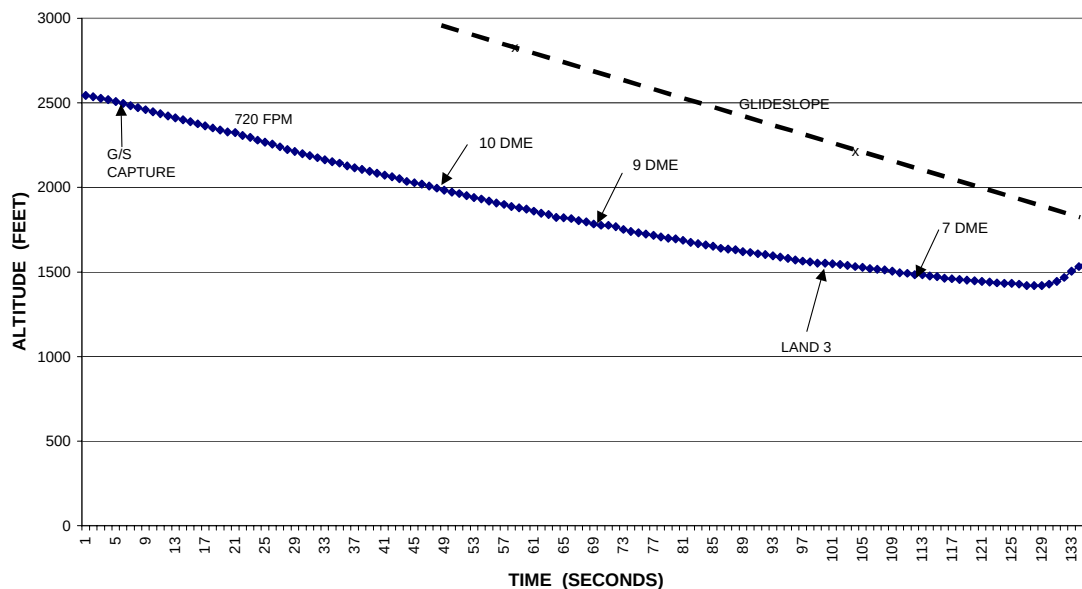
### Proving Flight One – Profile Two

The second profile was made to attempt to ascertain the influence of flap configuration on aircraft pitch attitude and trim and to capture the glideslope sector from the Northern side of the localizer. Off an arc from the North, the aircraft was positioned to intercept the glideslope at 2500 ft, 12 DME, flap 20 at 165 KIAS. Glideslope capture transitioned from the Vertical Speed mode with an entry ROD of 500 fpm. Immediately after glideslope capture the ROD increased to 700 fpm. During the descent the ROD slowly decreased.

Glideslope capture occurred some 1000 ft below the actual glideslope. The aircraft remained on a 'below glideslope' profile, and 'LAND 3' was annunciated on the Autoland Status Annunciator panel at 1500 ft RA. The aircraft descended on a shallow profile, losing approximately 1100 ft in 5.5 track miles.

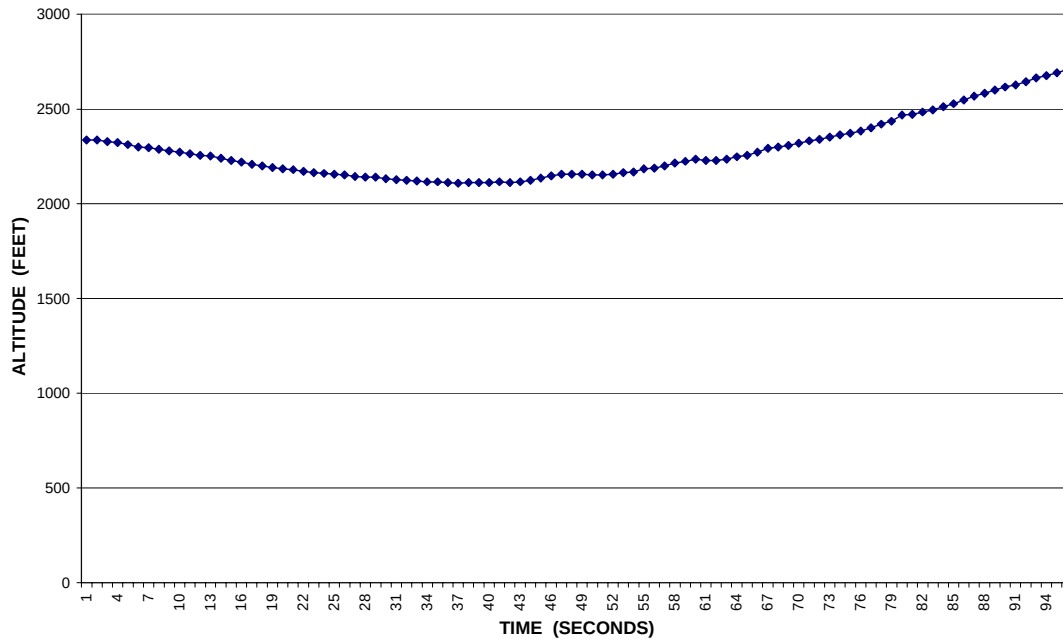
### Proving Flight One – Profile Three

For the third approach the aircraft was positioned to intercept the glideslope from the altitude capture mode to ascertain whether the aircraft would pitch down at the glideslope capture point. The aircraft was positioned at the glideslope capture point at flap up, 240 KIAS. At glideslope capture the ROD was 200 fpm in a level-off manoeuvre. After glideslope capture the aircraft slowly drifted down initially then commenced a gentle climb.

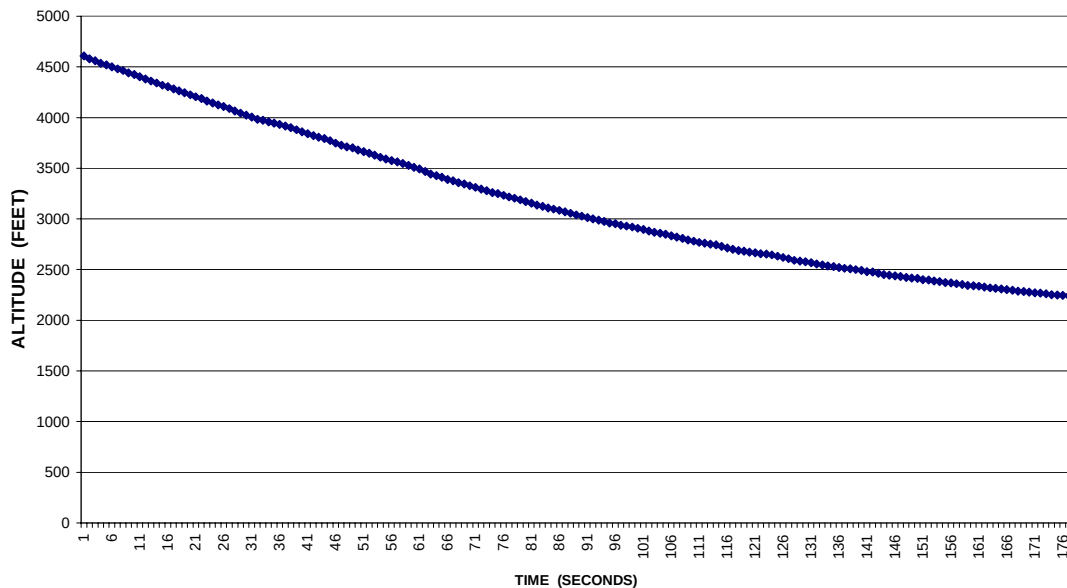
#### Proving Flight One – Profile Four

For the fourth approach the aircraft was positioned above the true glideslope in the Vertical Speed mode and with a ROD of 1500 fpm selected. At the glideslope capture point the ROD decreased to 1200 fpm. During descent the ROD slowly bled back to 1000 fpm until the go around point.

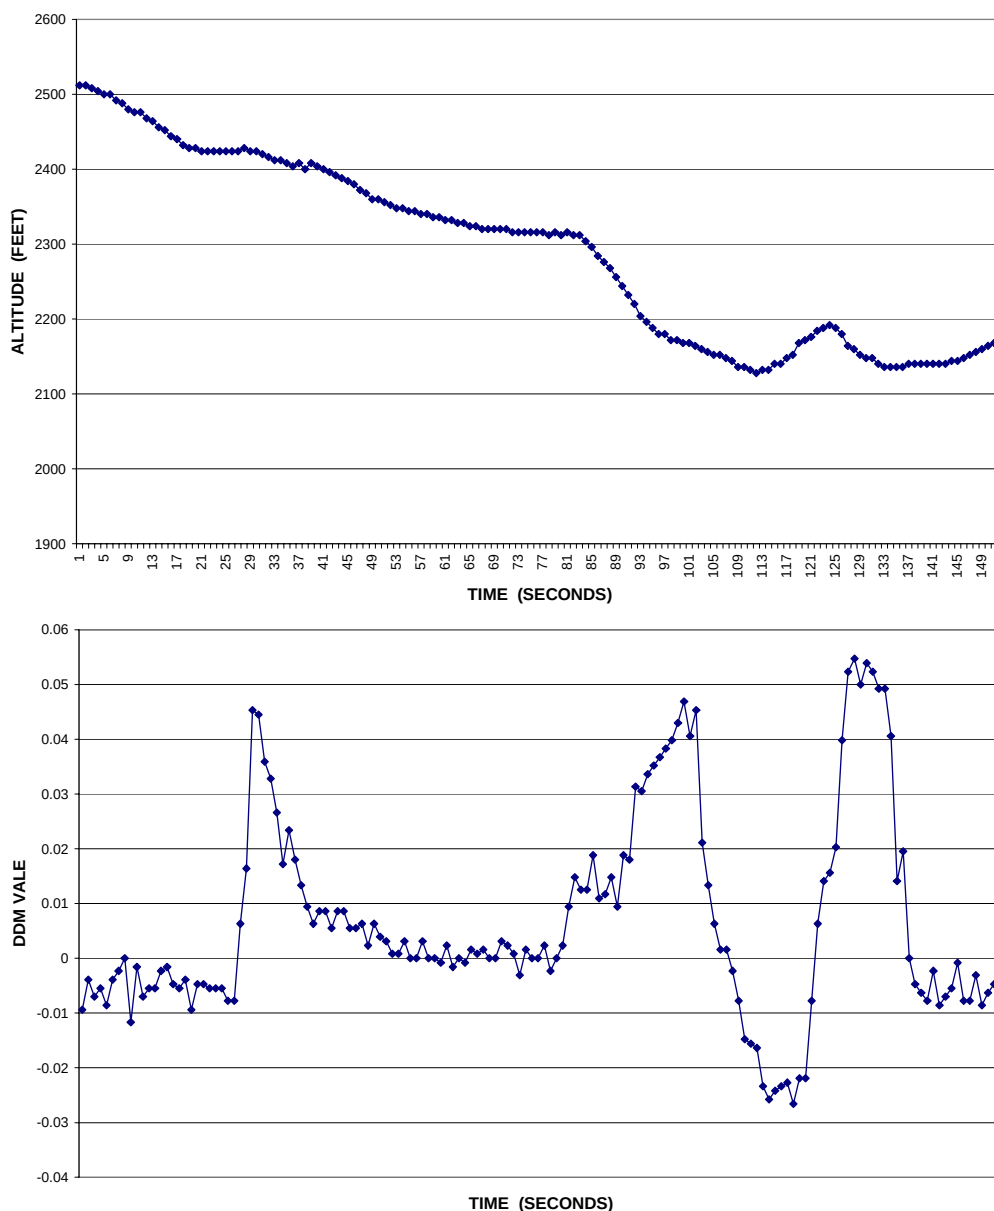
### Proving Flight One – Profile Five

For the fifth approach the DDM value was varied from the ground to establish whether the residual DDM value could affect the aircraft flight path. Transition to glideslope capture occurred from Altitude Hold mode. Glideslope capture occurred with the aircraft in level flight at 160 knots and with the flaps at 20. Subsequent to glideslope capture there was no change in flap position and little change in airspeed or thrust setting. It was noted that varying the DDM value would vary the aircraft profile.

Further analysis of the data from profile five indicated that the unbalanced value of the CSB DDM value (positive versus negative) was the most likely cause of the profiles differing from that recorded at Faleolo. To validate this supposition a second proving flight was scheduled.

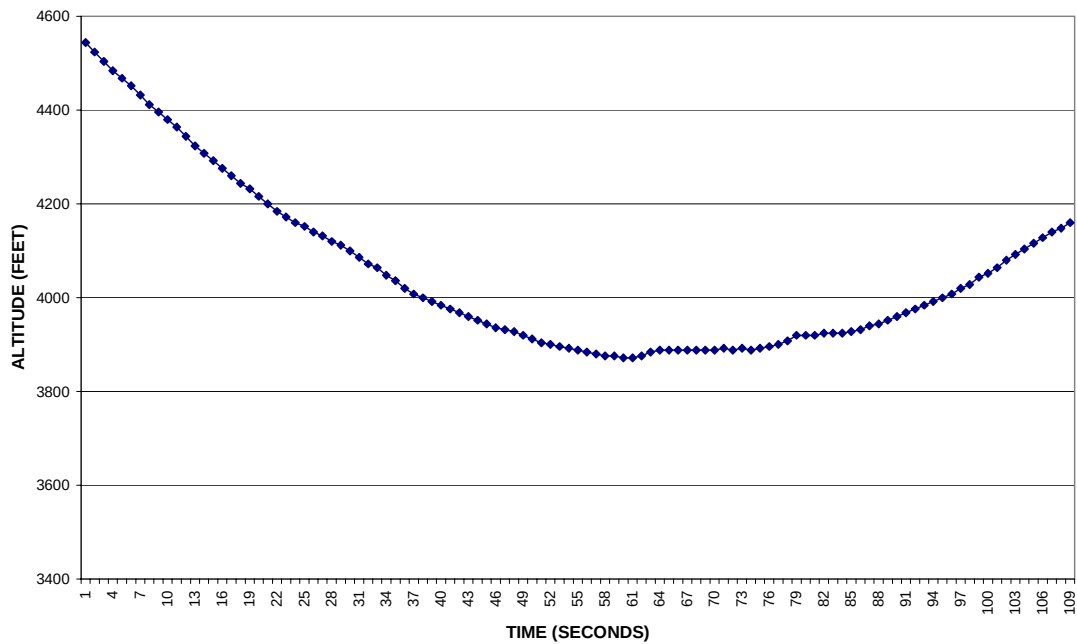
### Proving Flight Two – Profile Three

As experienced on proving flight one, the aircraft commenced an approach and gently flattened out. The aircraft descended some 1600 ft before reaching straight and level flight, subsequently climbing away as the landing configuration was reached.

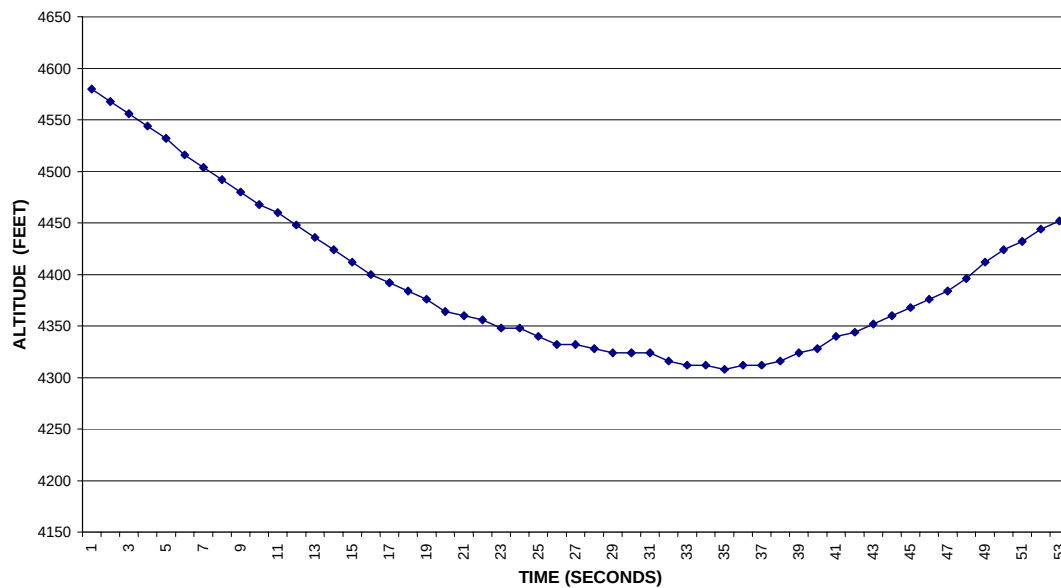
#### Proving Flight Two – Profile Four

The Auckland runway 05 ILS glideslope CSB signal is biased with a ‘fly up’ DDM of approximately  $-0.0016$  to ‘trim’ the cumulative signal and generate the required glideslope angle. As expected, the approach flattened and the aircraft subsequently flew away. In this case, only 250 ft of altitude was lost prior to the aircraft climbing.

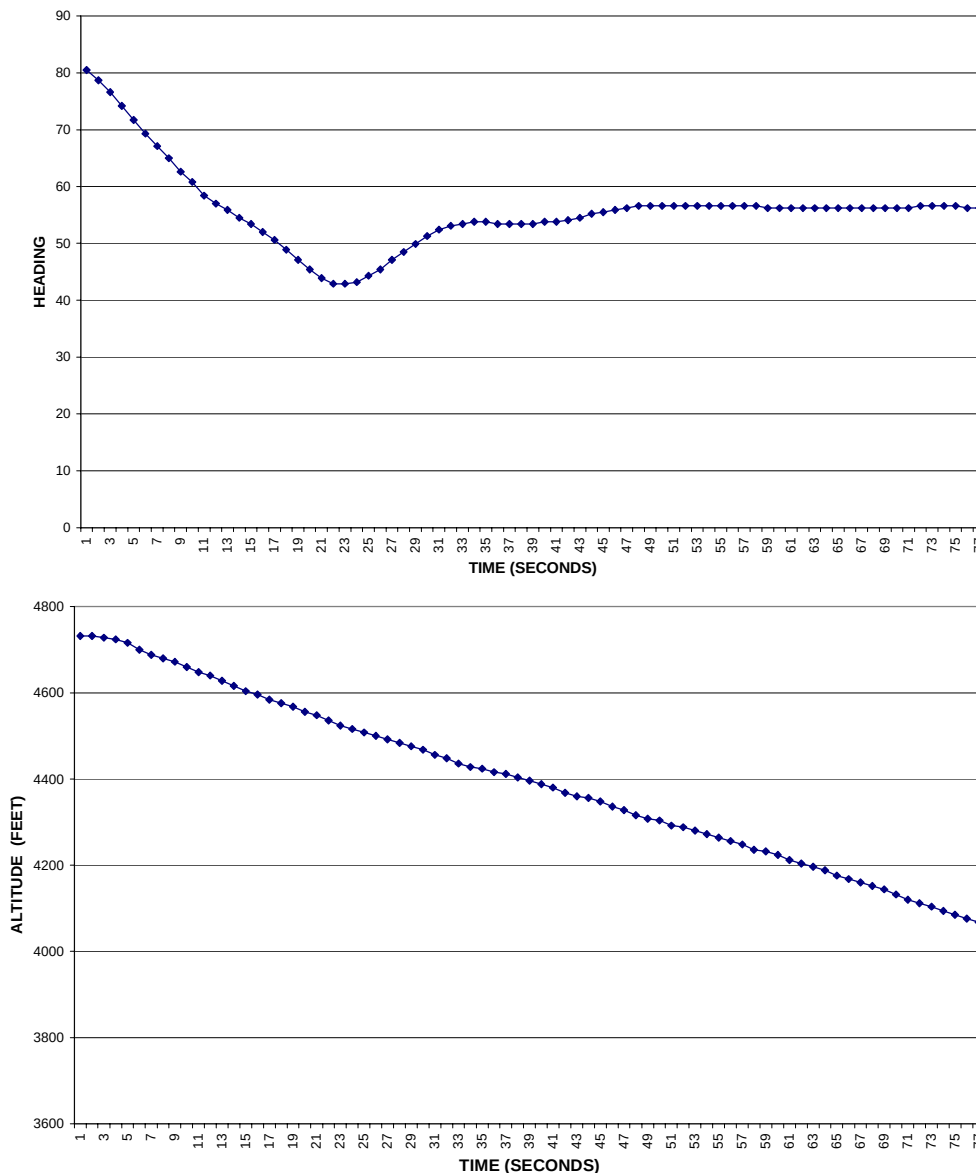
### Proving Flight Two – Profile Five

It was understood that there is no technical reason why the localizer cannot transmit the same erroneous path. To test this hypothesis, the glideslope CSB signal was returned to a 'fly down' DDM, and the localizer left transmitting a CSB only. From an intercept heading of 080° and with an on-track indication, the APP mode was armed, resulting in an instantaneous G/S and localizer capture. The aircraft turned left to 043° then turned right on to a heading of 053° and finally stabilised on a heading of 058°. There was an initial suspicion that there was some logic related to the selected front course of 051°, and a second profile was flown to better understand this. Of interest on this first localizer profile was the recording again of a steepening vertical profile.

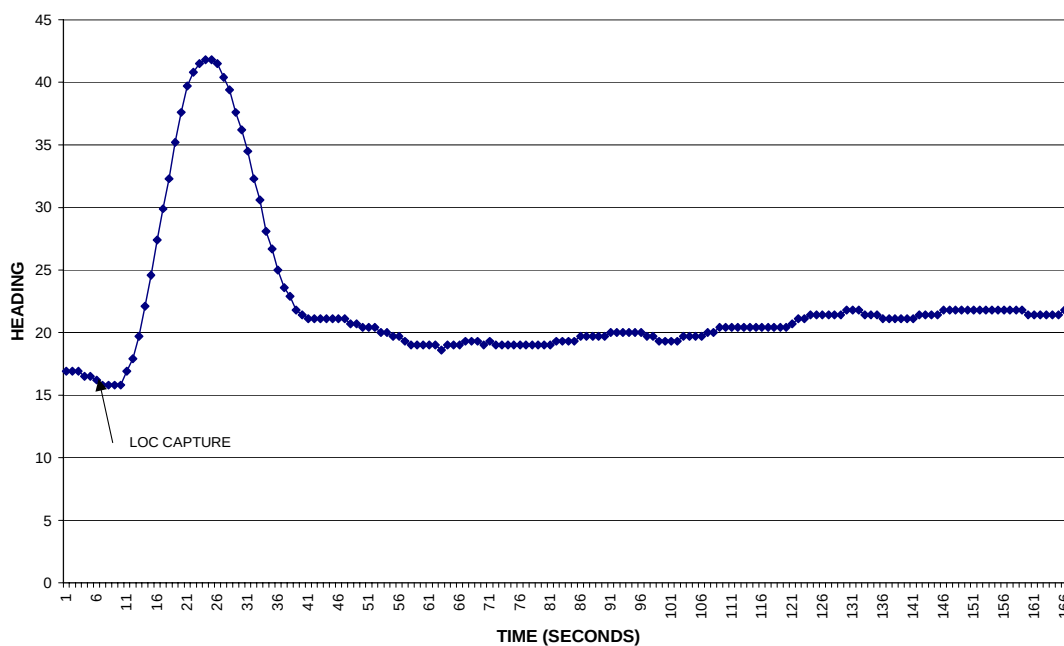
### Proving Flight Two – Profile Six

On the second localizer profile, the localizer was armed and captured from a heading of  $016^{\circ}$ . A right turn onto a heading of  $042^{\circ}$  followed, with a subsequent left turn onto  $021^{\circ}$ , stabilising on  $020^{\circ}$  with a very slight bias towards further small turns to the left. With an on-track indication on the EADI, the aircraft flew through the centreline of Runway 05 towards the rising terrain to the Northwest of the airfield.

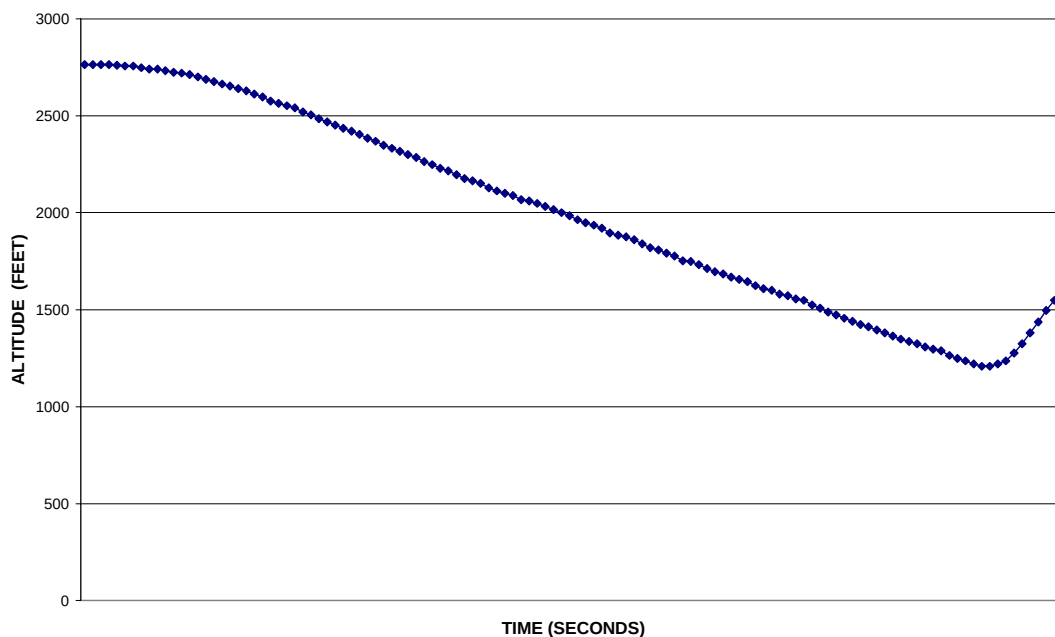
### Proving Flight Two – Profile Seven

Profile 7 was flown with the ILS restored to normal operation. The aircraft positioned around the northern arc to observe ‘normal’ indications. As the aircraft travelled around the arc toward the localizer the Standby Attitude Indicator’s glideslope deviation indicator moved erratically as it caught the false slopes off other lobes. This was unlike the steady ‘on glideslope’ indication noted around the arc on the previous proving flight. As anticipated, no glideslope information appeared on the EADI until the track was within 90° of the selected front course. Once the EADI glideslope deviation indication was displayed, normal movement of the glideslope deviation indicator was observed as the aircraft approached the glideslope from below.

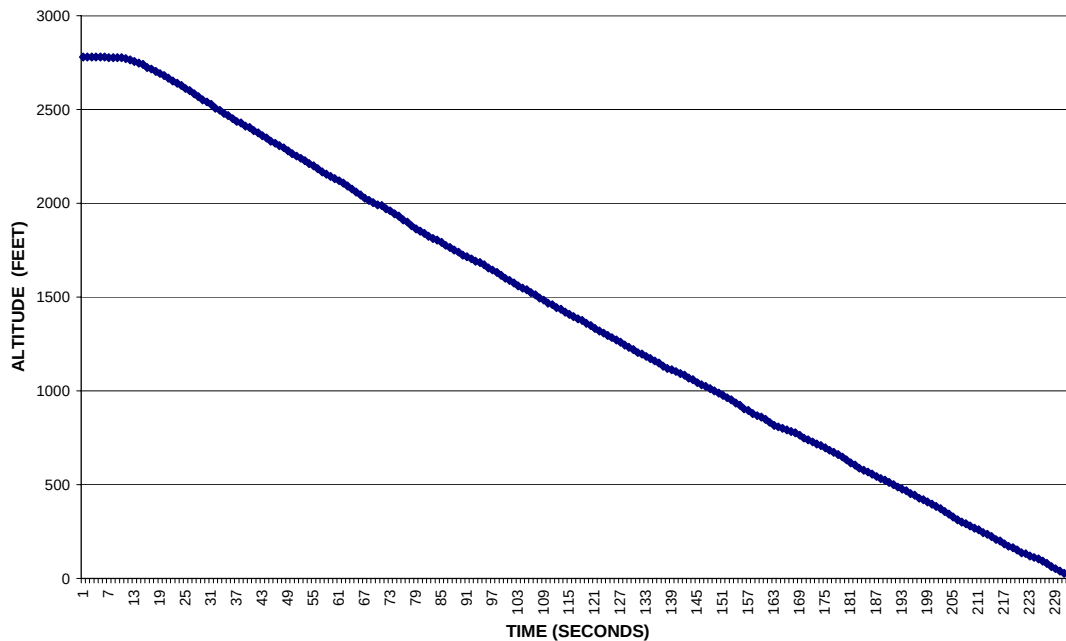
### Proving Flight Two – Profile Eight

A DDM value of 0.01 DDM was noted at glideslope capture.

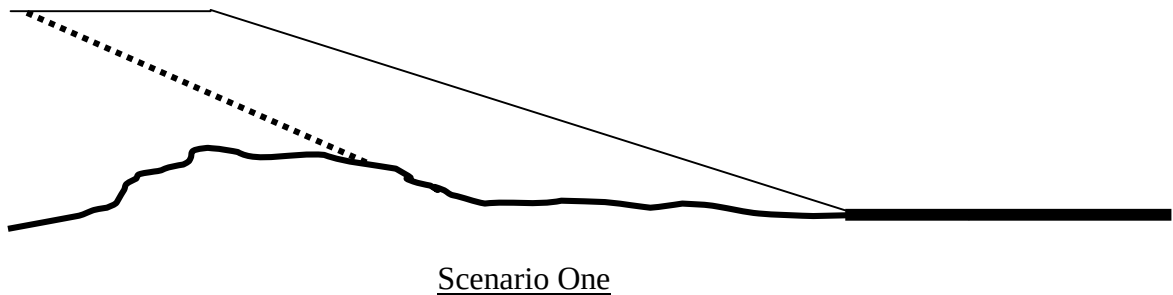
- Scenario one is where the aircraft captures the 'glideslope' prior to actual descent point and on a profile close to the expected 3°. If the erroneous glideslope is not detected, terrain/obstacles may be a factor prior to the briefed decision point.

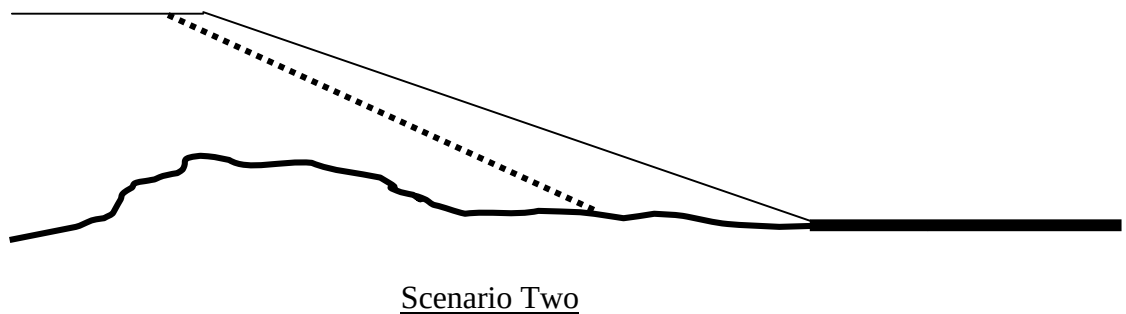
- Scenario two is where the aircraft captures the 'glideslope' slightly short of the true glideslope intercept point and flies a profile steeper than but close to the expected 3°. The crew may not identify the discrepancy with a glideslope intercept distance/altitude check. The resultant profile will take the aircraft to a point short of the true decision point.

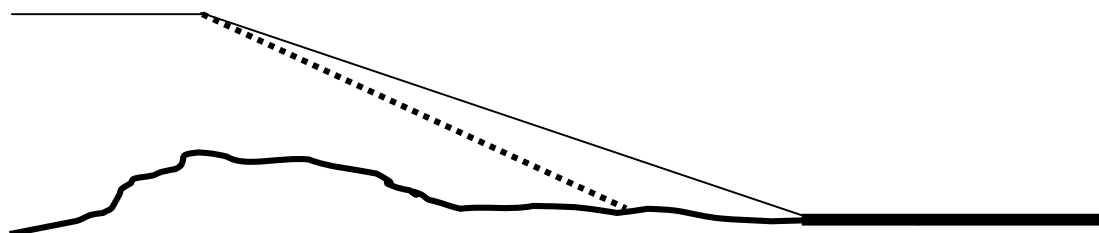
Scenario Three

- Scenario three is where the aircraft captures the 'glideslope' at the correct intercept point, but not on a true glidepath. The profile flown will not necessarily be a 3° glidepath and there is nothing to ensure the aircraft maintains the path. If the path is greater than 3°, the aircraft will still fall short of true decision point.

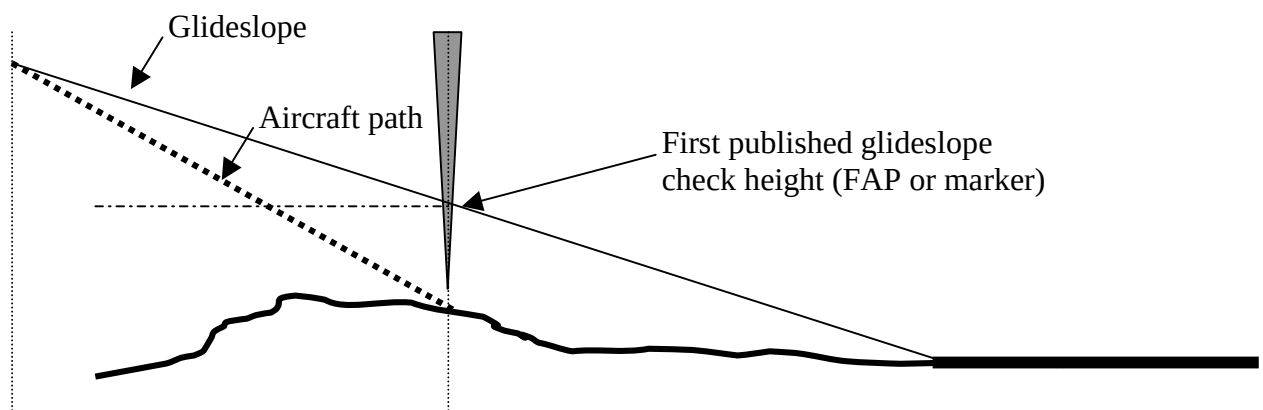
Therefore, unless the crew has a positive and accurate orientation of position relative to glideslope, the charted glideslope check height cannot be considered as a reliable method of detecting an erroneous glideslope in all cases and is only guaranteed to provide protection against an error in the on-board equipment – experience has taught us that incorrectly set altimeters are the most likely cause. A good glideslope will provide some protection against altimeter error, but until a reference point is reached the altimeter does not necessarily provide protection against an erroneous glideslope.

Crew must be aware of the potential for maintenance error to cause a glideslope (or localizer) to radiate erroneous information with no on-board warning due to systemic failure. Therefore they must maintain a 'reasonableness' check of the ILS and be prepared for a missed approach if they have an unresolved discrepancy by a defined point, but must also have confidence in the precision aspect of the approach.

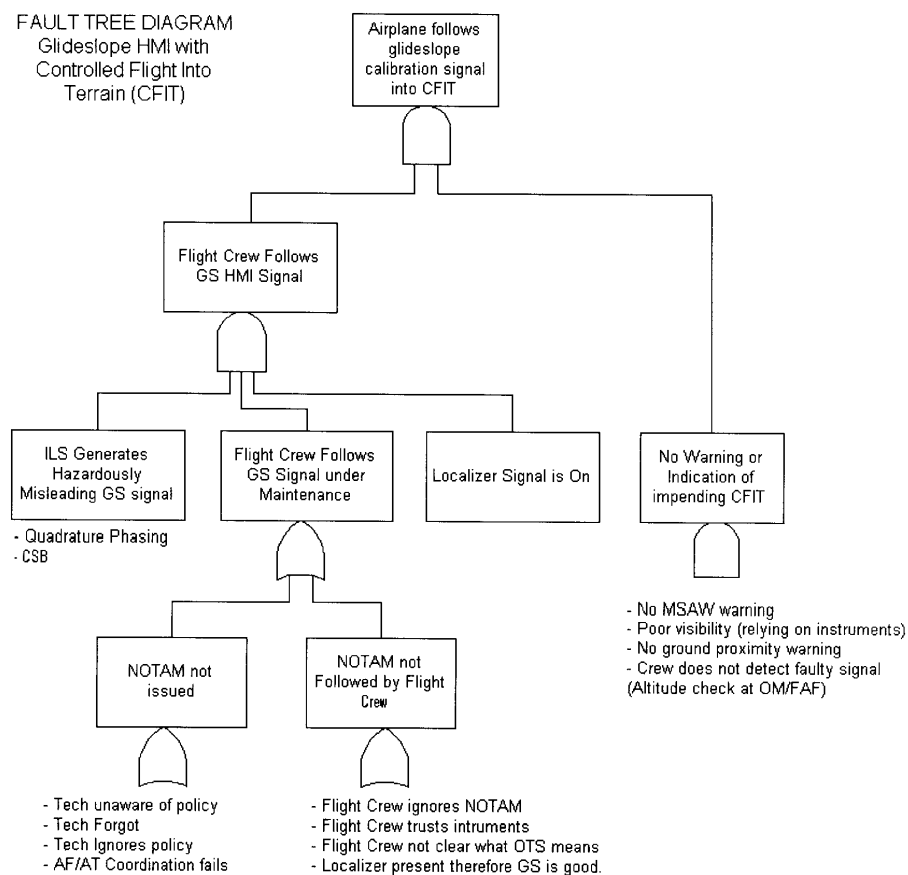
### Appendix 5. Fault Tree

FAULT TREE DIAGRAM  
Glideslope HMI with  
Controlled Flight Into  
Terrain (CFIT)

Probability of undetected failure of ILS signal under normal conditions [ $<10^{-9}/30$  sec]  $\sim 10^{-11}/\text{hr}$
