NATIONAL TRANSPORTATION SAFETY BOARD

AIRCRAFT ACCIDENT REPORT

**CHINA AIRLINES BOEING 747-SP, N4522V
300 NAUTICAL MILES NORTHWEST OF
SAN FRANCISCO, CALIFORNIA
FEBRUARY 19, 1985**

NTSB/AAR-86/03

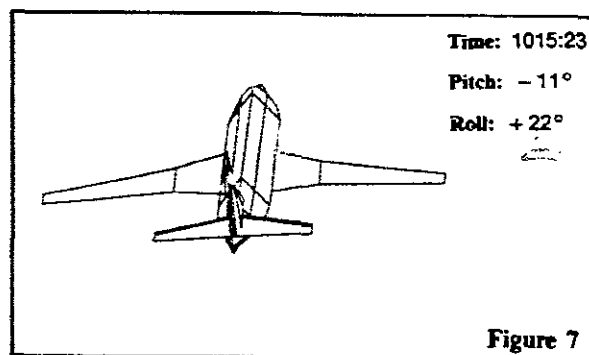
Figures 1.--Excerpts from Computer Animation.

Between 1013:10 and 1015:06, the Nos. 1, 2, and 3 engines remained at about 1.5 EPR while the No. 4 engine remained at about 1.1 to 1.2 EPR. The airplane continued level at 40,900 feet, but the airspeed continued to decrease at a rate of about 0.25 KIAS/sec. Although the roll angle of the airplane remained fairly constant at about 2.6° to 3.5° left-wing-down, the left-wing-down deflection of the control wheel continued to increase as the indicated airspeed decreased, and, by 1013:43 the deflection had increased to 22.9°, the maximum available input from the autopilot. As the airspeed continued to decrease and with the control wheel deflected to, and remaining essentially at, the 22.9° left-wing-down deflection, the airplane began rolling slowly to the right, reaching a wings-level attitude by 1013:58 and then continuing on into a right-wing-down attitude. (See figure 1.)
