# ERRONEOUS

## FLIGHT INSTRUMENT INFORMATION

FLIGHT OPERATIONS		AERO 11
<b>DAVE CARBAUGH</b> <i>CHIEF PILOT</i> <b>FLIGHT OPERATIONS SAFETY</b> <i>BOEING COMMERCIAL AIRPLANES GROUP</i>	<b>DOUG FORSYTHE</b> <i>MANAGER</i> <b>FLIGHT OPERATIONS SAFETY</b> <i>BOEING COMMERCIAL AIRPLANES GROUP</i>	<b>MELVILLE MCINTYRE</b> <i>TECHNICAL FELLOW</i> <b>AIRPLANE SYSTEMS</b> <i>BOEING COMMERCIAL AIRPLANES GROUP</i>

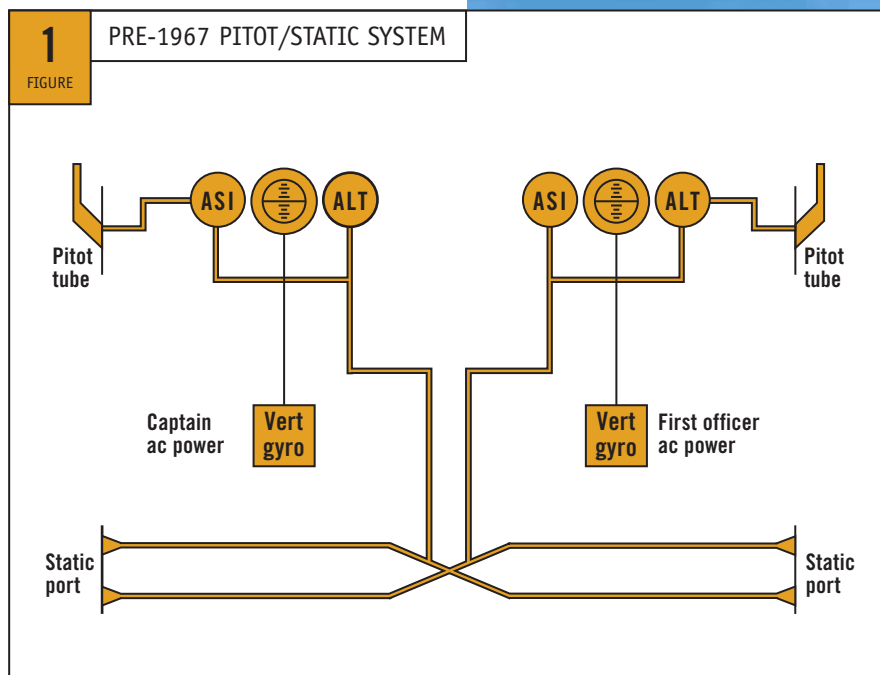
Only captain and first officer primary flight instruments, but no standby instruments, were installed on early Boeing commercial airplanes (fig. 1). The two artificial horizons (attitude indicators) are powered by analog signals from remotely located vertical gyros. Both gyros are lost if all the main airplane generators fail. Because of this, the U.S. Federal Aviation Administration required a third, panel-mounted gyro instrument to be installed in the center of the instrument panel on later models. The third gyro is ac powered by a static inverter that receives its dc power from the main airplane battery.

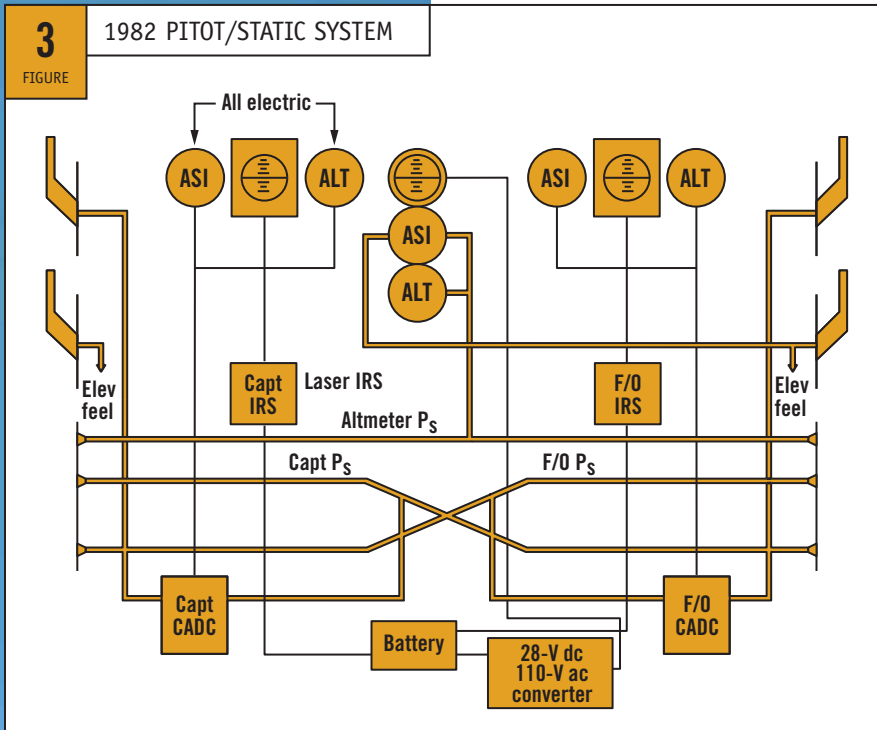
Eventually, the 747-200 evolved to all-electrical air-data instruments driven only by CADCs, with no pneumatic backup. At that time a third standby airspeed indicator and altimeter were added. These additional standby instruments were all-pneumatic and became the standard for all Boeing airplanes designed after 1969 and before the 777 in 1994 (fig. 3).

With the development of inertial navigation systems (INS), a new source of information for the captain and first officer attitude indicators was available. The standby attitude indicator power source remained ac from an inverter, powered by the airplane battery.

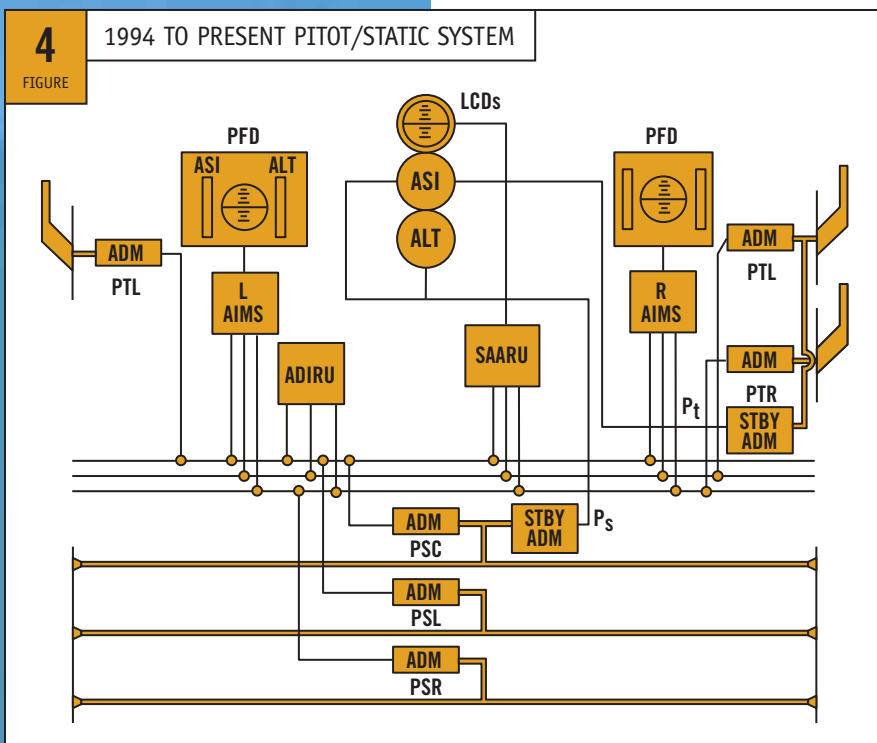
The primary source for attitude, airspeed, and altitude is the air data inertial reference unit (ADIRU) (fig. 4). The attitude and air data signals are formatted for display by the airplane information management system. The ADIRU design differs from the traditional left-right system partitioning. The ADIRU is a single, fault-tolerant, high-integrity data source for both primary flight displays (PFD). The ADIRU uses multiple redundant inertial sensors for computing attitude and also selects a best altitude and airspeed from three pitot and static pressure sources. As a result it provides a single set of data for both the captain and first officer, eliminating cross-channel splits. The pitot and static pressures are measured by small air data modules (ADM) located as close as possible to the respective pressure sources. The ADMs transmit their pressures to the ADIRU through data buses. In the highly improbable event that the ADIRU totally fails, a secondary

attitude air data reference unit (SAARU) provides comparable attitude and air data to both PFDs. The SAARU also supplies standby attitude directly to an electronic standby horizon instrument. The standby airspeed indicator and altimeter, both electronic, receive pitot and static pressure from the standby ADMs. This design ensures that displayed data are immune to any first and most second failures of their respective sensors or pressure probes.
