FLIGHT SAFETY FOUNDATION

OCTOBER 1998

International Regulations Redefine V1

Recent revisions of the U.S. Federal Aviation Regulations and the European Joint Aviation Requirements redefine V₁ as the maximum airspeed at which a flight crew must take the first action to safely reject a takeoff. Other revisions change the method of compensating for the time required by pilots to take action to reject a takeoff; require accelerate-stop data based on airplanes with fully worn brakes; and require wet-runway takeoff-performance data in airplane flight manuals.

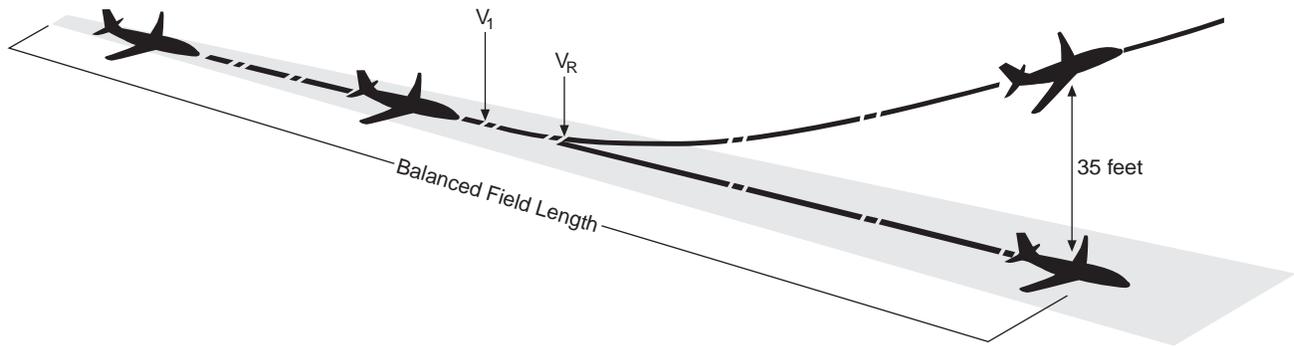
Figure 1

Balanced Field Length Means that Accelerate-stop Distance And Accelerate-go Distance Are Equal

Source: Adapted from SimuFlite Training International Learjet 55 Cockpit Reference Handbook

V1 concept is critical to takeoff planning. The FARs require the flight crew of a transport-category airplane to ensure that the runway intended for use (including any clearway or stopway off the end of the runway) is long enough to allow the takeoff to be safely continued or rejected from a predetermined go/no-go point on the runway. The go/no-go point is where the airplane reaches V_1 while accelerating for takeoff (Figure 1, page 3).

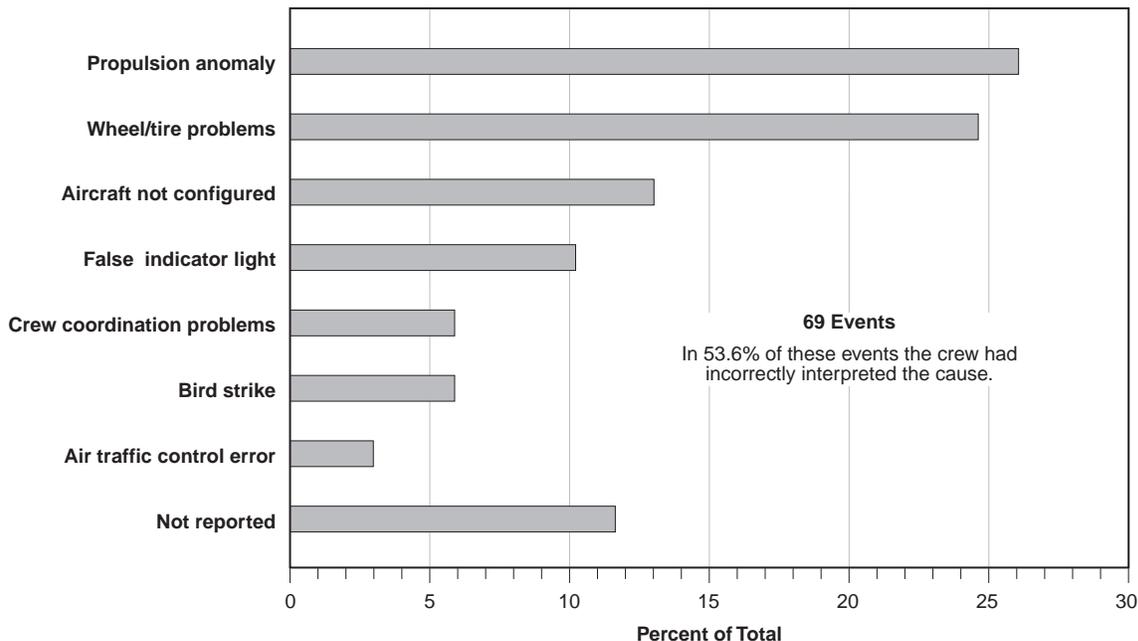
Figure 2

Causes of Rejected Takeoffs by Western-manufactured Commercial, Turbine-powered Airplanes, 1959–1988

Source: The Boeing Co. from U.S. National Transportation Safety Board Special Investigation Report: *Runway Overruns following High Speed Rejected Takeoffs*

In its 1990 report, NTSB said, "Based on an analysis of its data for transport-category aircraft, Boeing projected one RTO in every 3,000 takeoffs and one high-speed RTO in every 150,000 takeoffs."² (A chart from the NTSB report of events causing RTO accidents and incidents is shown in Figure 2. A chart by Boeing of events that have caused recent takeoff accidents is shown in Figure 3, page 8).

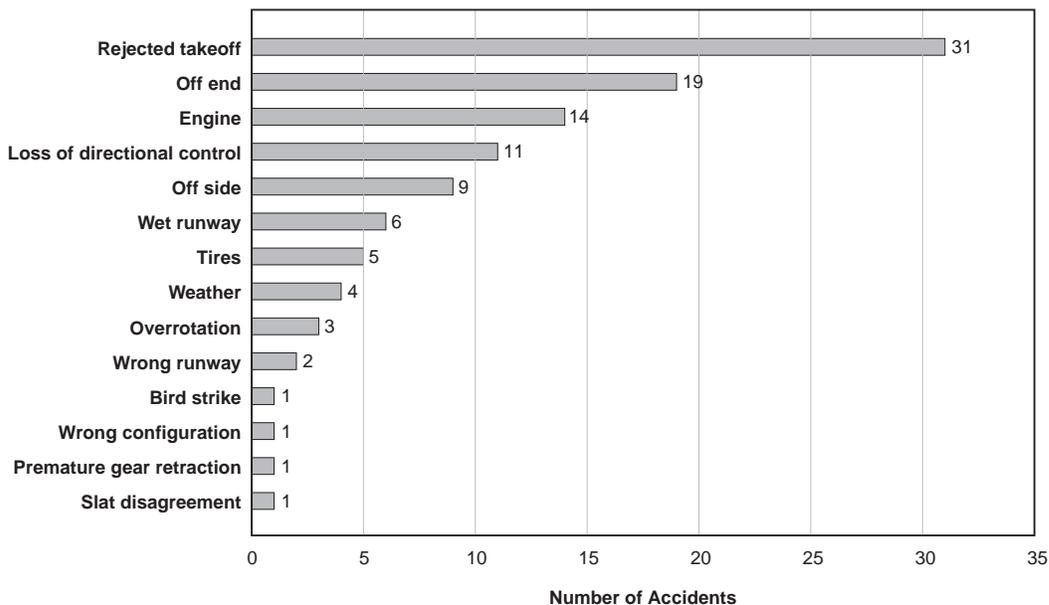
Figure 3

Events Involved in Commercial, Turbine-powered Airplane Accidents, 1988–1997

Note: Statistics apply to civilian, commercial jet airplanes weighing more than 60,000 pounds (27,216 kilograms), except those manufactured in the Commonwealth of Independent States (former Soviet Union).

Source: Boeing Commercial Airplane Group

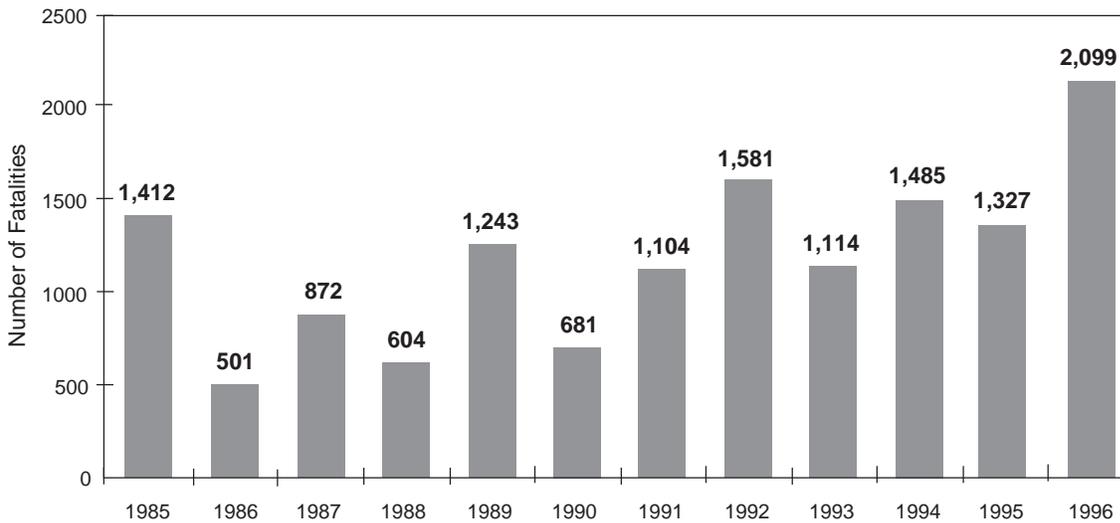
Worldwide Airplane Fatalities — Public Transport Operations*
Jet-powered and Turboprop-powered Airplanes with Maximum Takeoff Weights
More than 5,700 Kilograms (12,566 Pounds)

* Public transport operations include scheduled and unscheduled passenger and freight operations, and pleasure flights such as helicopter tours.

Figure 1 (page 20) shows that 13,996 fatalities occurred in public-transport airplane accidents worldwide in 1985 through 1996. “In 1996, there was a substantial increase in fatalities due to [airplane] accidents, including the [Boeing 747 and Ilyushin Il-76] mid-air collision over India, killing 349 people,” said CAA.

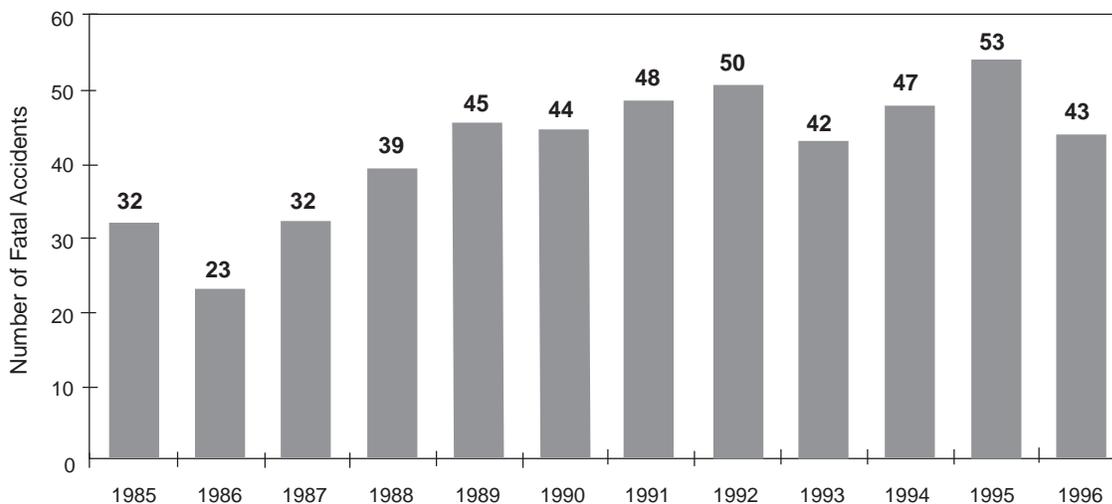
Worldwide Airplane Fatal Accidents — Public Transport Operations
Jet-powered and Turboprop-powered Airplanes with Maximum Takeoff Weights
More than 5,700 Kilograms (12,566 Pounds)

* Public transport operations include scheduled and unscheduled passenger and freight operations, and pleasure flights such as helicopter tours.

Figure 2 (page 20) shows that 498 fatal accidents occurred in public-transport airplane operations worldwide in 1985 through 1996. The data in Figure 1 and Figure 2 are for jet and turboprop airplanes with maximum takeoff weights more than 5,700 kilograms (12,566 pounds). The data do not include accidents in 1985 through 1989 involving aircraft built in what was then the Union of Soviet Socialist Republics, now the Commonwealth of Independent States (CIS).

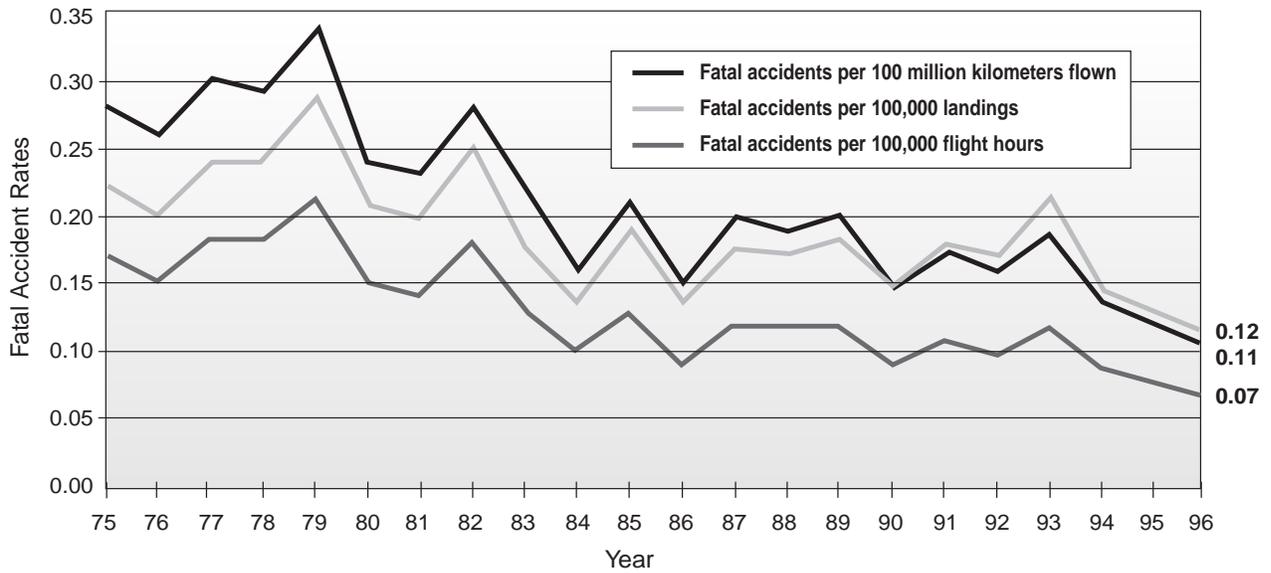
Worldwide Airplane Fatal Accident Rates — Scheduled Passenger Services

Source: U.K. Civil Aviation Authority and International Civil Aviation Organization

Figure 3 (page 21) shows that although there were increases in some years, the rates at which fatal accidents occurred in scheduled passenger operations worldwide have decreased significantly since 1975. The data do not include accidents in the CIS.

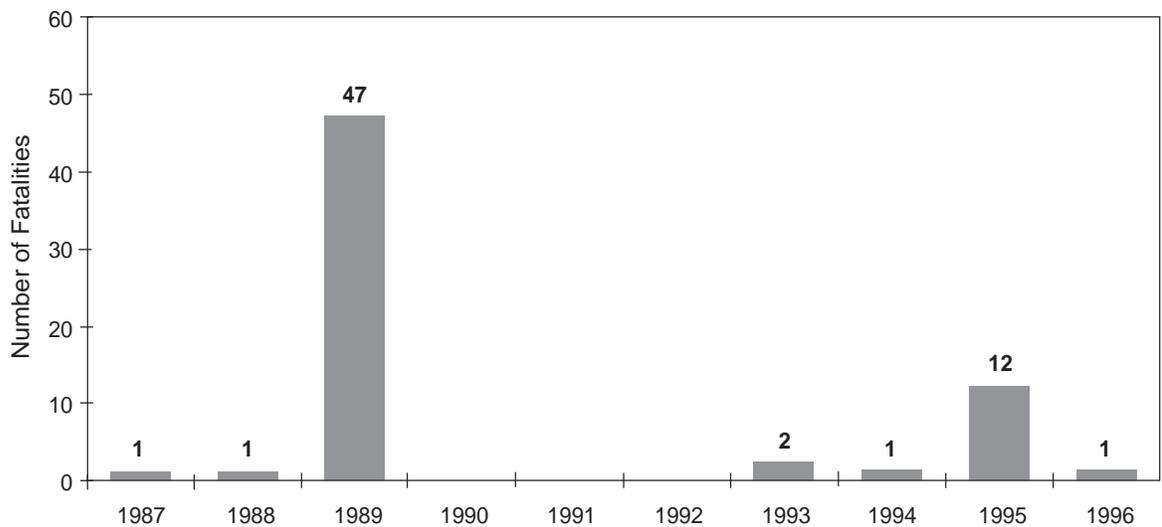
U.K. Airplane Fatalities — Public Transport Operations* Maximum Takeoff Weights More than 2,300 Kilograms (5,071 Pounds)

* Public transport operations include scheduled and unscheduled passenger and freight operations, and pleasure flights such as helicopter tours.

Figure 4 (page 21) shows that in 1987 through 1996, 65 fatalities occurred in public-transportation accidents involving airplanes registered in the United Kingdom. Figure 5 (page 22) shows that during the same period, 152 reportable accidents, including seven fatal accidents, occurred.

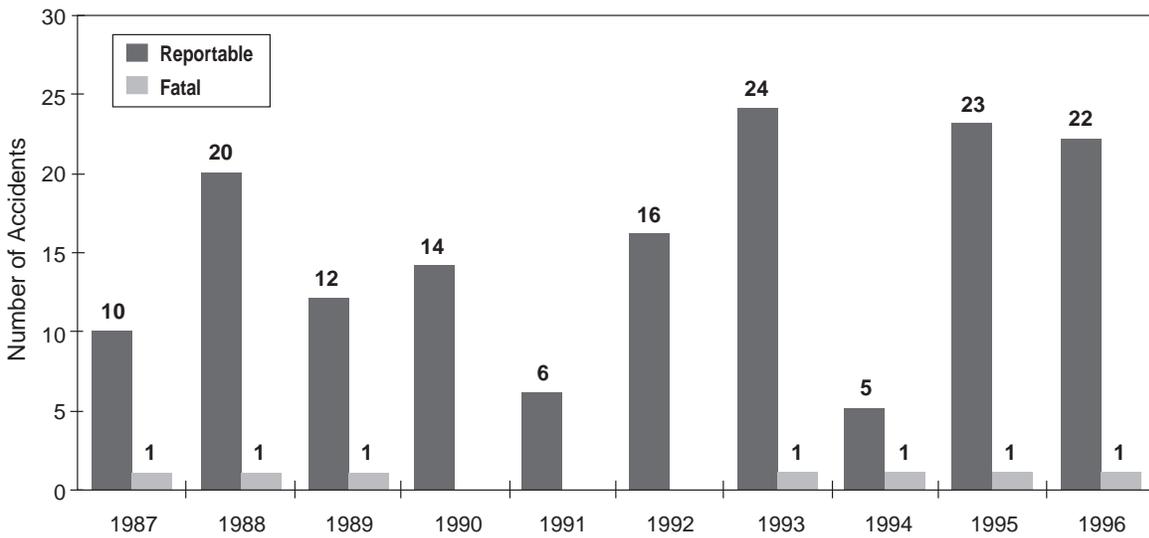
Figure 5

**Worldwide Airplane Accidents — Public Transport Operations*
Maximum Takeoff Weights More than 2,300 Kilograms (5,071 Pounds)**

* Public transport operations include scheduled and unscheduled passenger and freight operations, and pleasure flights such as helicopter tours.

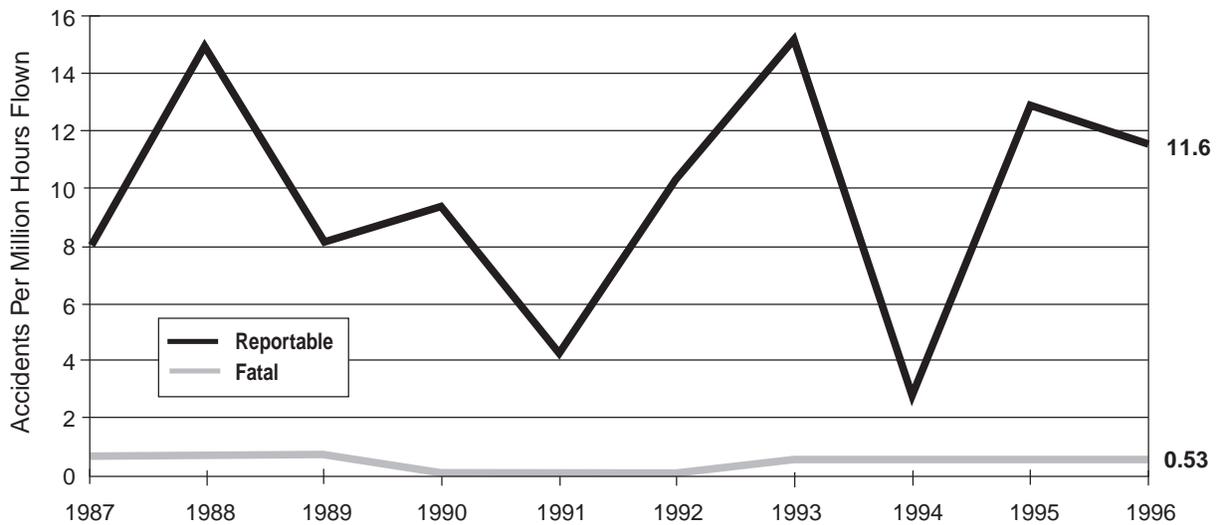
**U.K. Airplane Accident Rates — Public Transport Operations*
Maximum Takeoff Weights More than 2,300 Kilograms (5,071 Pounds)**

* Public transport operations include scheduled and unscheduled passenger and freight operations, and pleasure flights such as helicopter tours.

Figure 6 (page 22) shows the number of reportable accidents and fatal accidents that occurred per million hours flown in 1987 through 1996 by U.K. airplanes with maximum takeoff weights over 2,300 kilograms. ♦
