Erroneous Airspeed Indications Cited in Boeing 757 Control Loss

Investigators concluded that the airplane had a blocked pitot tube and that, during departure, the flight crew became confused by false indications of increasing airspeed and did not respond to a stall warning. All the occupants were killed when the airplane struck the Caribbean Sea off the northern coast of the Dominican Republic.

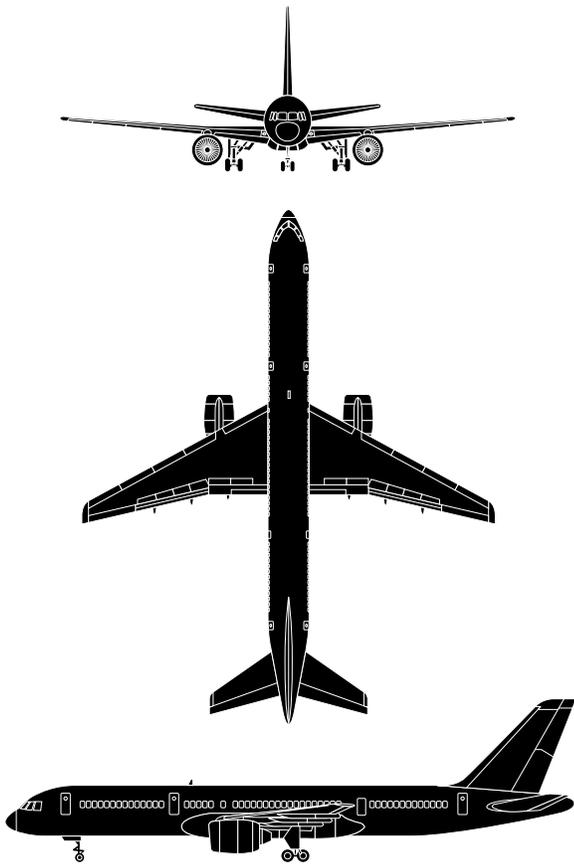
Boeing 757

The Boeing 757-200 series is a medium-range airliner designed to carry 186 passengers in a typical mixed-class configuration. The B-757 can accommodate up to 239 passengers in charter service, putting its capacity between that of the Boeing 737-400 and the Boeing 767. A longer range version and a freighter configuration of the B-757 are also available.
