# FLIGHT SAFETY

## Propulsion System Malfunction Plus Inappropriate Crew Response (PSM+ICR)

Human Factors Report

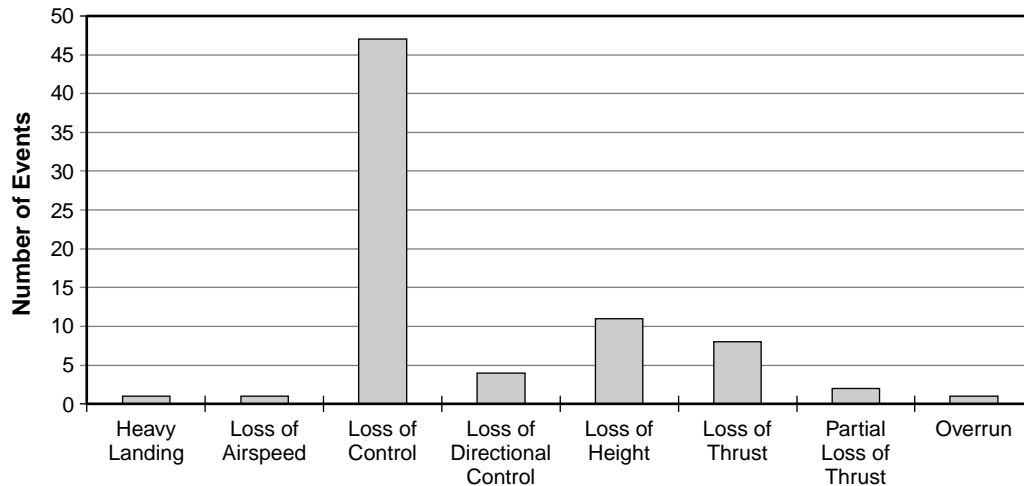
Figure 9

### Results of Turboprop PSM+ICR\* Events

The accidents were categorized, and the results are plotted on Figure 9. The dominant event category is loss of control, accounting for 63 percent of all events.

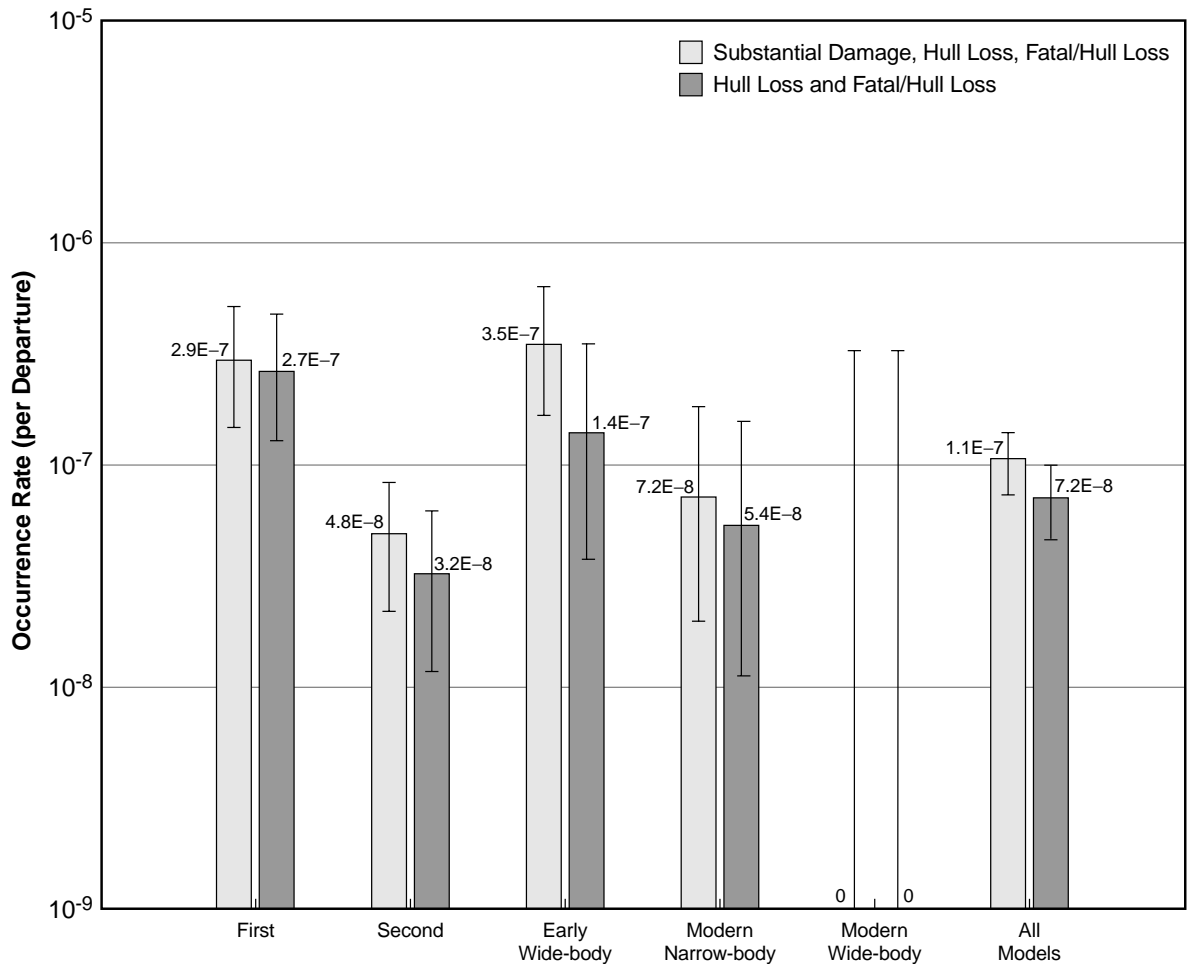
### PSM+ICR\* Differences by Airplane Generation; Turbofan Airplanes Since Start of Service Through End of 1996

Events	11	10	9	6	10	4	4	3	0	0	34	23
Departures (Millions)	37.5	37.5	185.8	185.8	28.6	28.6	55.6	55.6	11.1	11.1	318.7	318.7
