FLIGHT SAFETY FOUNDATION

SPECIAL ISSUE

Protection Against Icing: A Comprehensive Overview

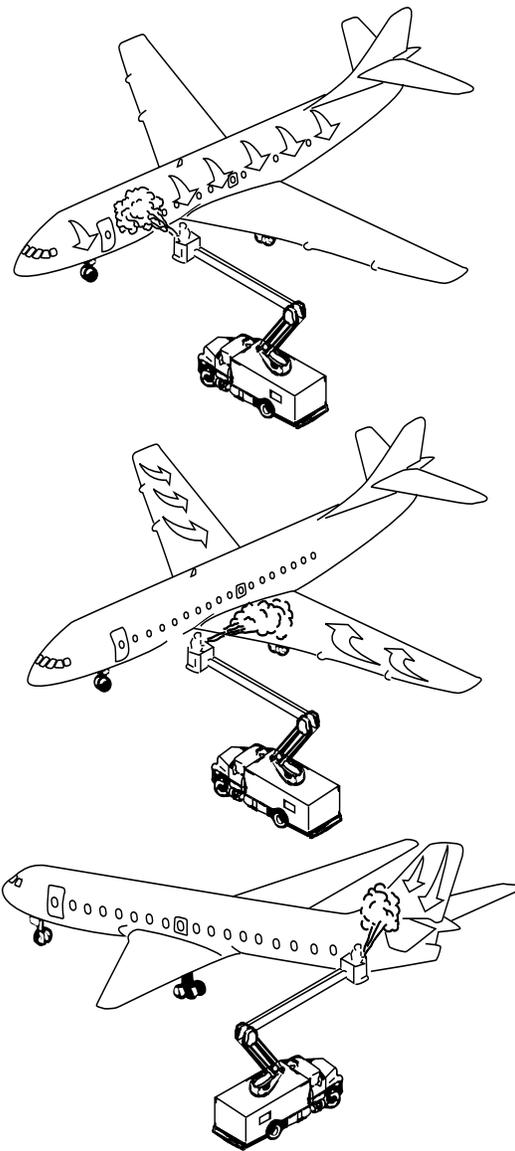
Figure 2

Systematic Deicing of Aircraft in Conditions Conducive to Icing

An aircraft must be systematically deiced and anti-iced in weather conditions conducive to icing (Figure 2). Each aircraft surface requires a specific technique to achieve a clean aircraft.

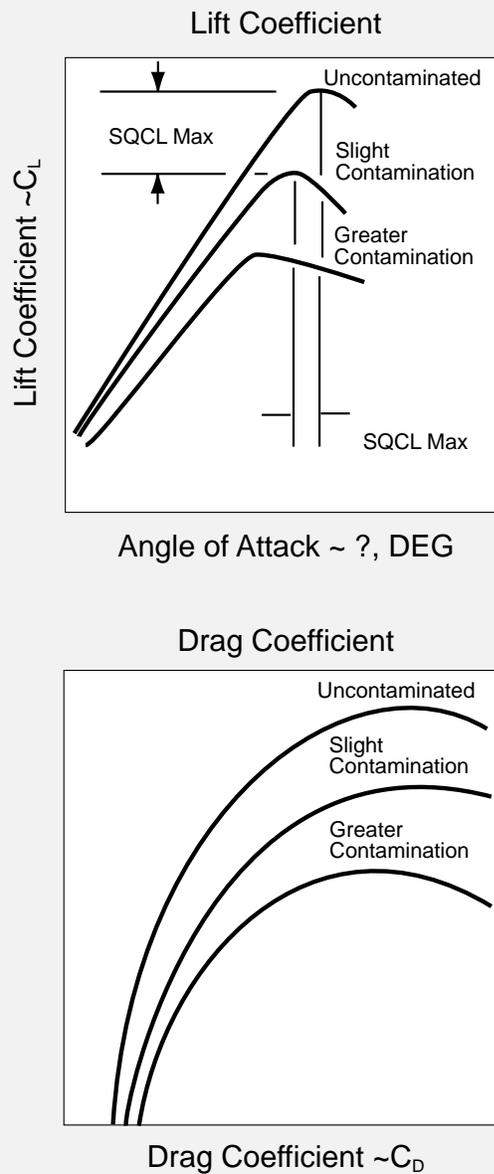
Figure 1

Typical Effect of Contamination On Lift and Drag

sandpaper on the leading edge and upper surfaces of a wing can reduce wing lift by as much as 30 percent and increase drag by 40 percent. See Figure 1. As illustrated in Figure 2, greater surface roughness can increase these values. Some aircraft are more susceptible to the effects of surface roughness than others.

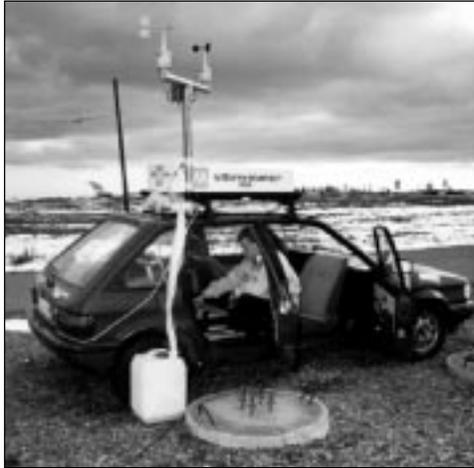
A car is equipped with a simulated aircraft aluminum fuel tank on its roof that has a Vibro-Meter electrical ice sensor built into the tank's upper surface. Various data, including wind speed, ambient temperature, fuel temperature and other information are recorded on a computer in the car. Several Finnair first officers conduct tests to determine optimum operating characteristics and standards for the sensor.

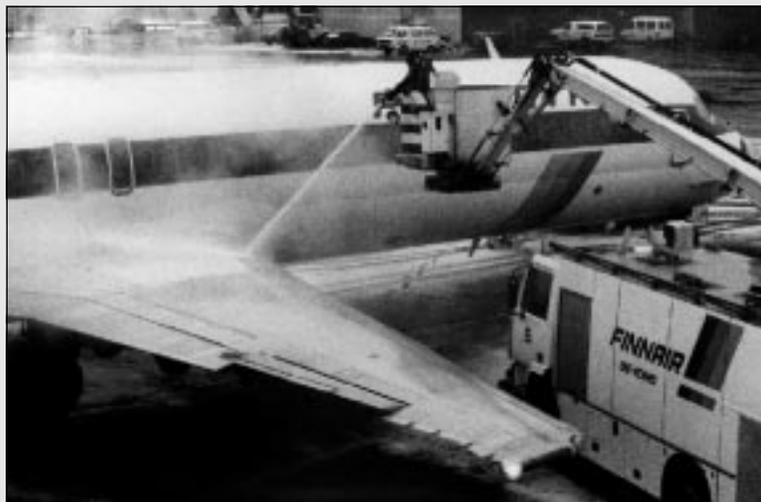
Ice forms more readily over the wing root, where the cold fuel settles and there is more metal structure, including the landing gear components, which can contribute to colder temperatures.

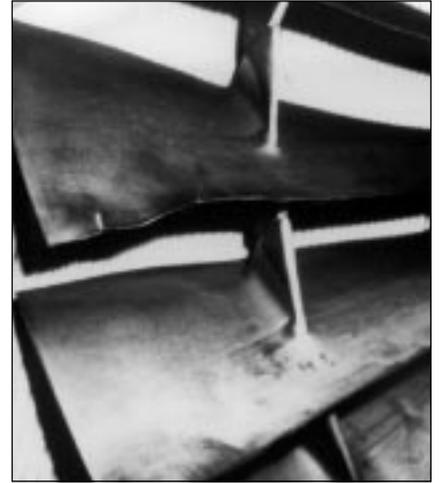
The gentle bend in the blades is characteristic of soft foreign object damage.

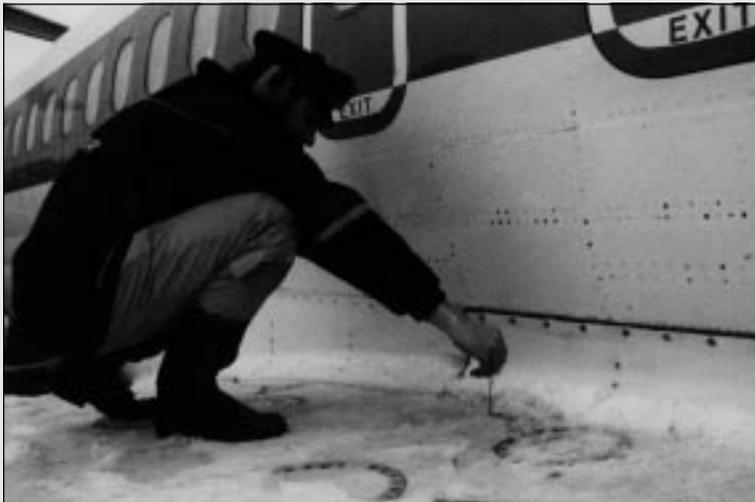
The tuft of parachute cord moved freely, but underneath the snow, clear ice had formed, and the cord’s base was frozen solid.

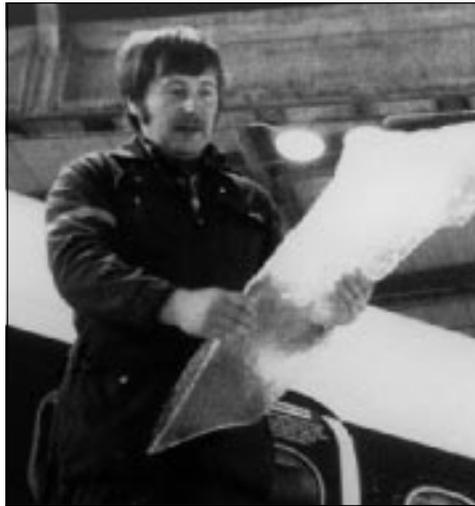
A mechanic holds a sheet of ice taken from the wing of the Finnair DC-9 that aborted a takeoff at Helsinki-Vantaa Airport in 1985 after flexing wings on the uneven runway broke the ice free, and it was ingested into the engines.

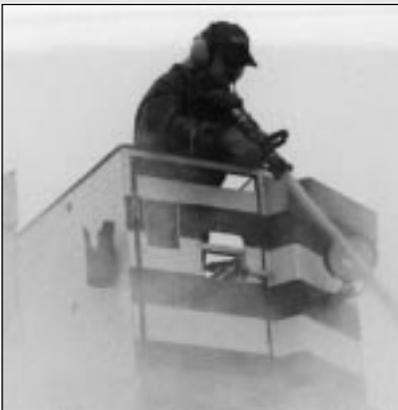
Hot water under pressure in a tight stream was required to break ice free from an aircraft wing.

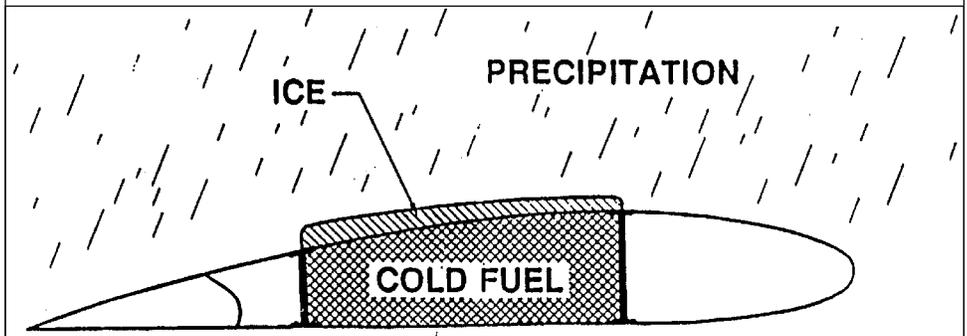
Typical Pattern of Fully Developed Ice from Cold Soaked Fuel Above Wing Fuel Tank. Air Temperature Outside the Fuel Tank Is Above Freezing

Not Necessarily a Cold Weather Phenomenon

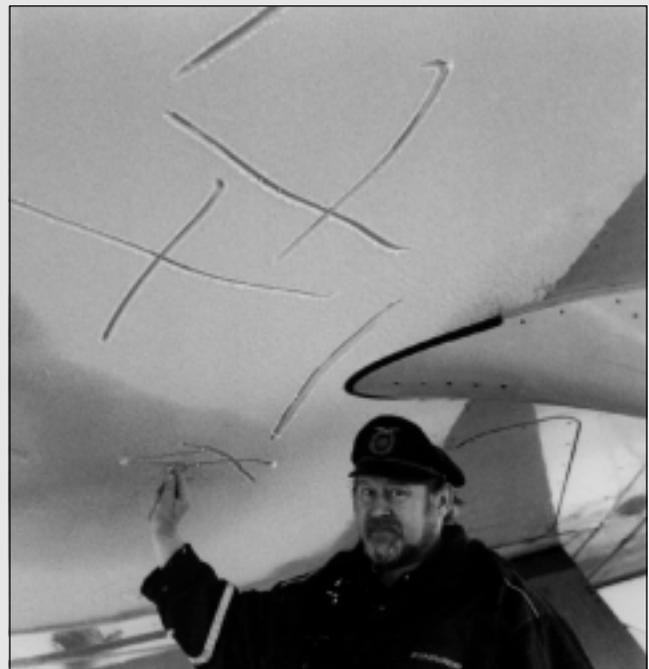
Frost formed readily under the wings in the fuel tank area.

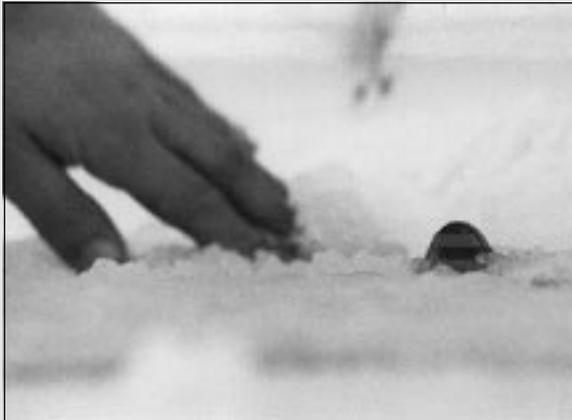
The small brightly colored horizontal tab was buried in snow and clear ice, and provided a visual indication of contamination. It has no influence on the flight characteristics of the wing.

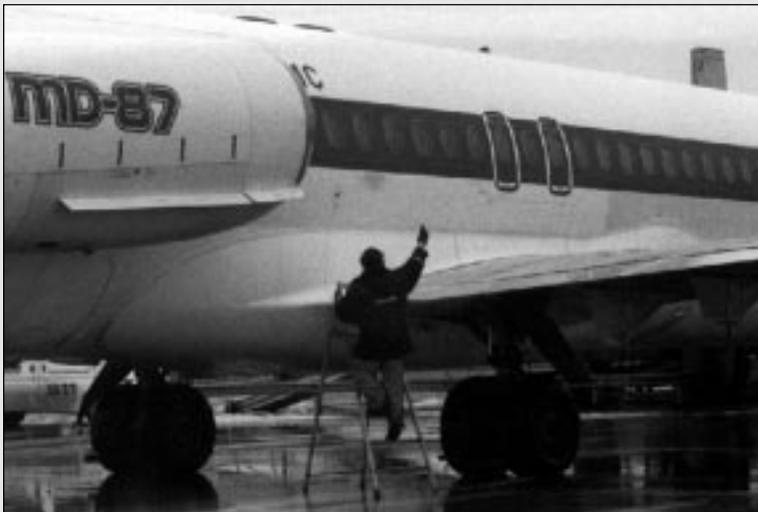
The mechanic gave a "thumbs-up" acknowledgment to the deicing truck crew that the wing surface was clean and there was no ice on it.

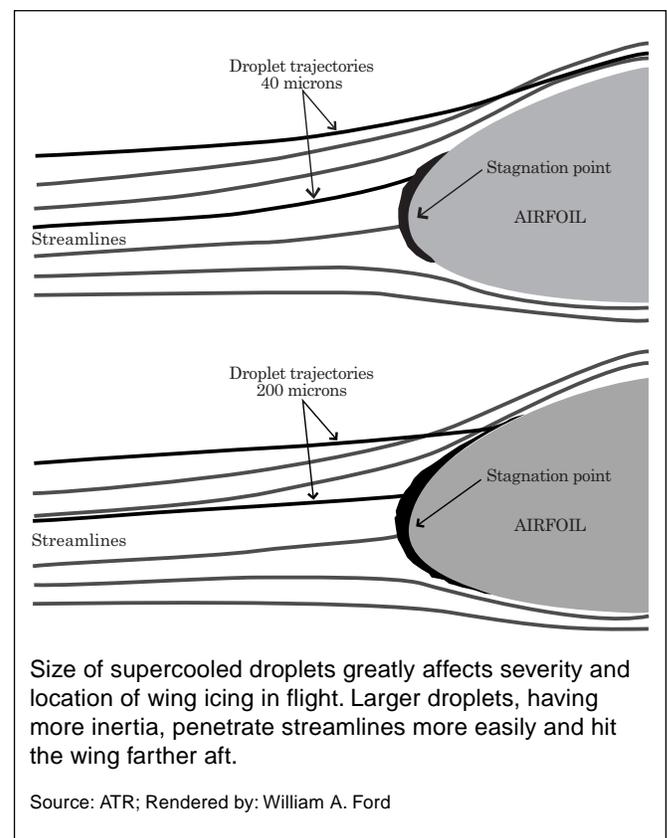
Figure 1

Imagine that we are flying from clear air into cloud that contains icing conditions: The wing cleaves the cloud like a dull knife, parting the air, redirecting it, pushing it down, creating lift. Most of the air molecules flow over or under the wing in smooth, curving paths called streamlines (see Fig. 1).

A few of the air molecules smash into the most forward part of the leading edge, milling around in a frenzied eddy in front of what engineers call the stagnation point of the airfoil. Some air molecules whirl in other small, tight eddies, caught between the upper wing surface and the laminar air flow above the wing.

Most of the tiny droplets, having little inertia, follow the streamlines closely; the wing rushes smoothly between the droplets, pushing them out of the way without touching most of them. Some of the droplets penetrate the confused air immediately in front of the stagnation point, strike the leading edge, and freeze.

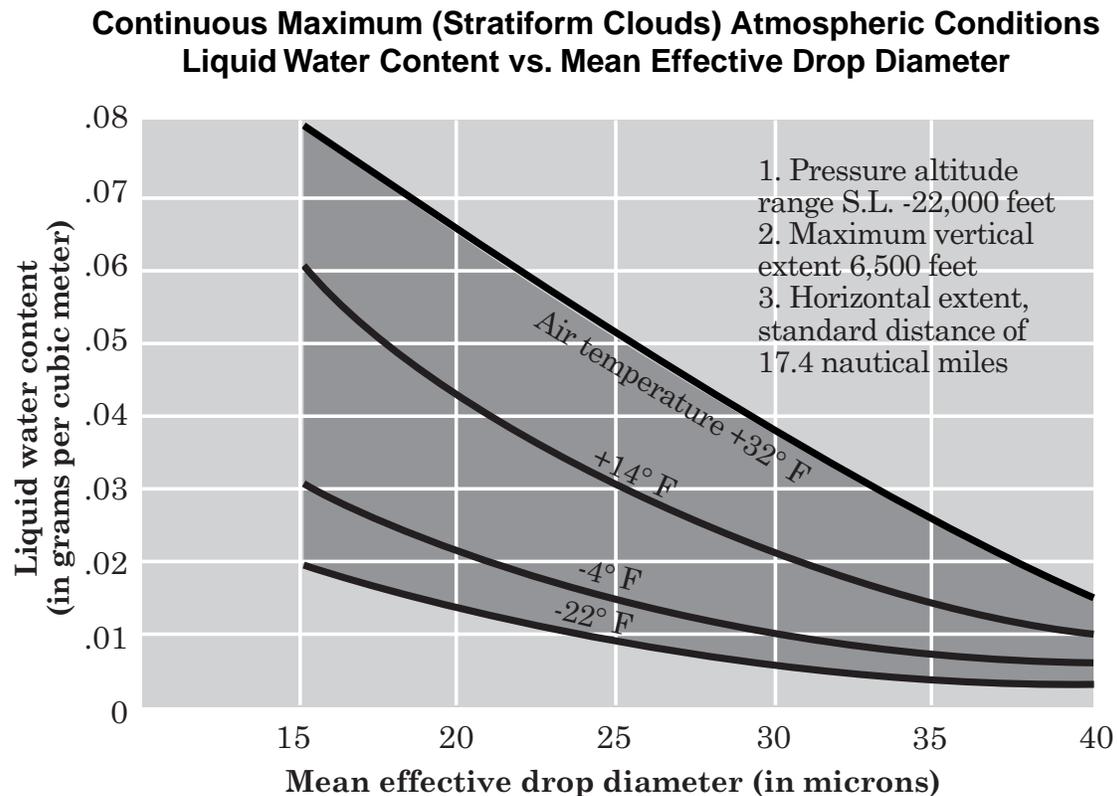
FAR Part 25, Appendix C, includes several diagrams — including this one — that define the environmental conditions aircraft icing-protection systems must deal with satisfactorily to obtain FAA certification.

Source: NACA TN NO. 1855 Class III-M Continuous Maximum

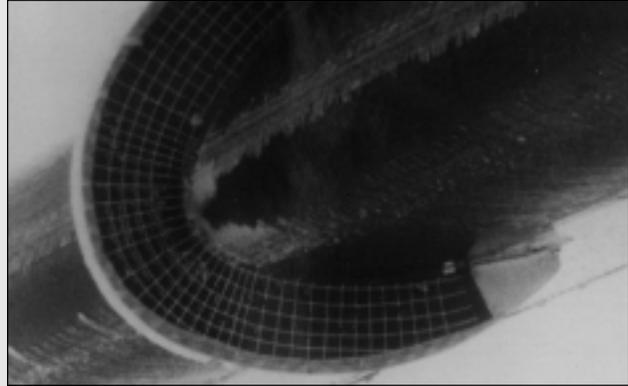
Source: U.S. National Transportation Safety Board

Supercooled drops are at temperatures below freezing, yet still in a liquid phase. To change to solid, heat (called the “heat of fusion”) must be removed from the liquid. Ice-free area shows that temperature at the leading edge is too warm to remove heat of fusion from the supercooled drops, but the temperature is colder on upper and lower surfaces.

Surface temperature varies with air pressure along the airfoil. At the leading edge, where pressure is the highest, the surface temperature will also be higher than farther aft. If the local surface temperature on the airfoil is warmer than freezing, no ice will form. Infrared measurements of a typical airfoil in the icing tunnel at a true air speed of 150 knots show that there can be a decrease in temperature of more than 1.9 degrees C (3.5 degrees F) along the airfoil. At temperatures close to freezing, there may be no ice on the leading edge, but ice can

form farther aft because of the lower temperatures. Because there is liquid runback, any ice formation aft of the leading edge tends to act like a dam, making ice growth more rapid.

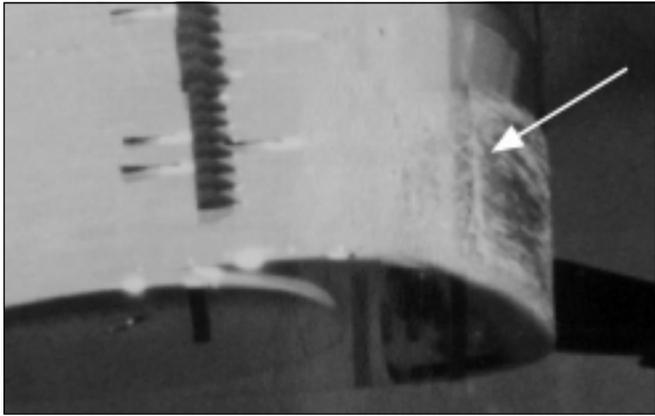
Source: Avions de Transport Regional (ATR)

Ice tends to accrete more on the upper surface (arrow) at low angle-of-attack associated with higher speeds or flap extension.

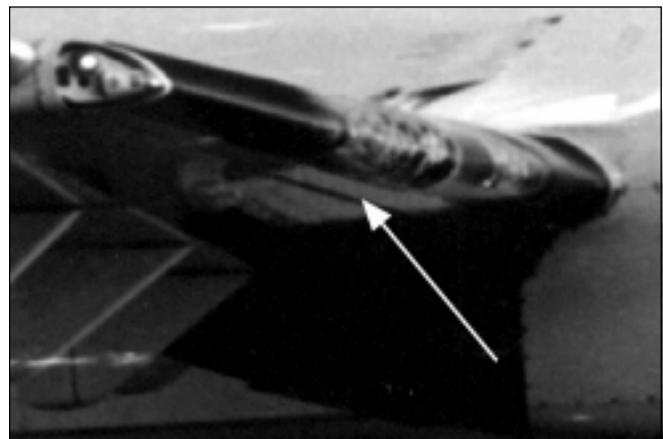
Source: Avions de Transport Regional (ATR)

Ice tends to accrete more on the lower surface (arrow) at higher angle-of-attack (slower air speed).

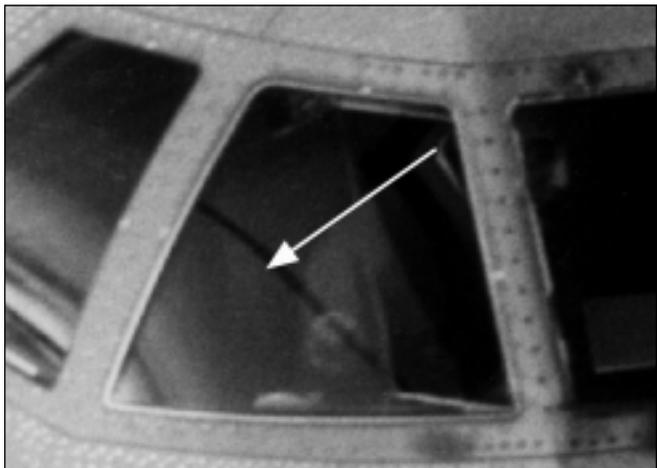
Source: Avions de Transport Regional (ATR)

Granular pattern on the unheated portion of a window (arrow) indicates freezing drizzle drops.

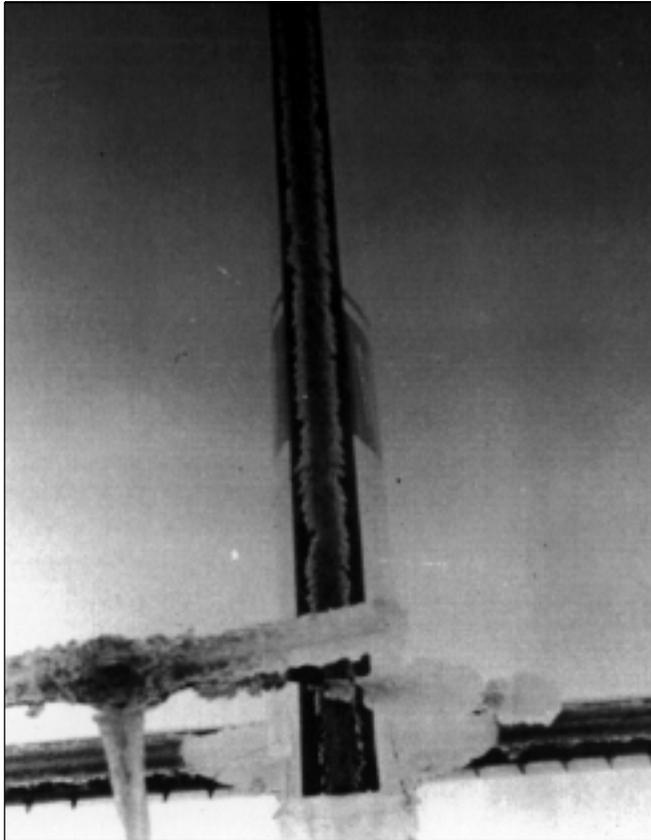
Ice can form on tailplanes and antennas faster than on wings.
