BACKGROUND

HISTORY OF RTO OPERATIONS AT EVERGREEN

ON REJECTED TAKEOFF SAFETY STATISTICS

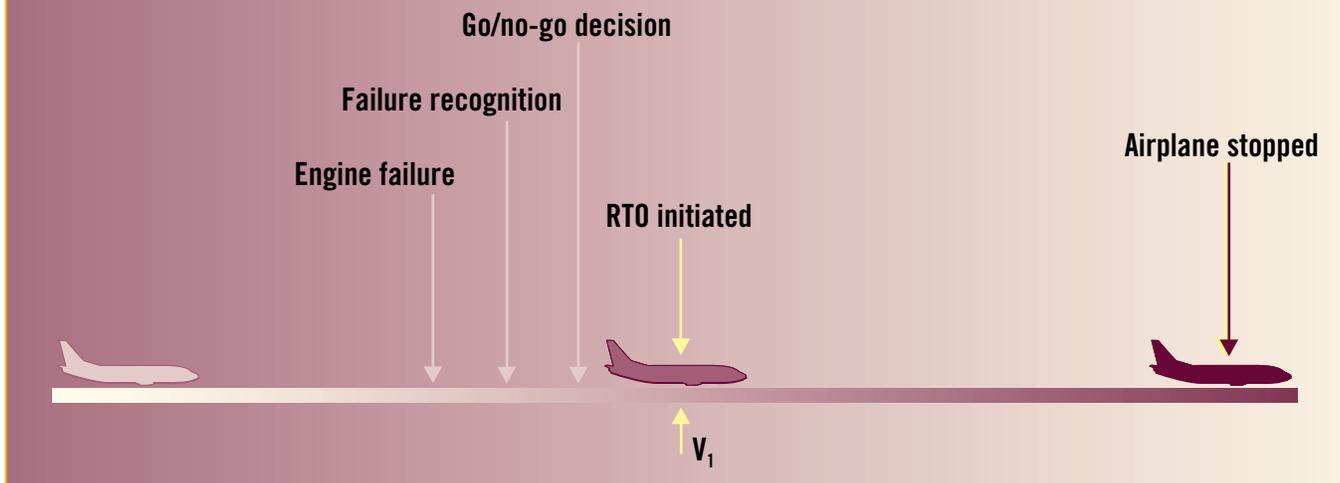
The speed selected for each takeoff, based upon approved performance data and specified conditions, which represents:

1. The maximum speed by which a rejected takeoff must be initiated to assure that a safe stop can be completed within the remaining runway, or runway and stopway;

2. The minimum speed which assures that a takeoff can be safely completed within the remaining runway, or runway and clearway, after failure of the most critical engine at a designated speed; and
3. The single speed which permits a successful stop or continued takeoff when operating at the minimum allowable field length for a particular weight.

The “go/no-go” decision must be made prior to reaching the published V_1 (fig. 1). As the speed approaches V_1 the “go” decision becomes more appealing. Our goal became to identify a reduced “decision speed” to provide increased flight crew recognition time in case of a catastrophic situation. Using the Boeing data, we initially approached the FAA with a proposal to call a reduced V_1 the “decision speed” and treat it as a V_1 speed. The flight crew would remove their hands from

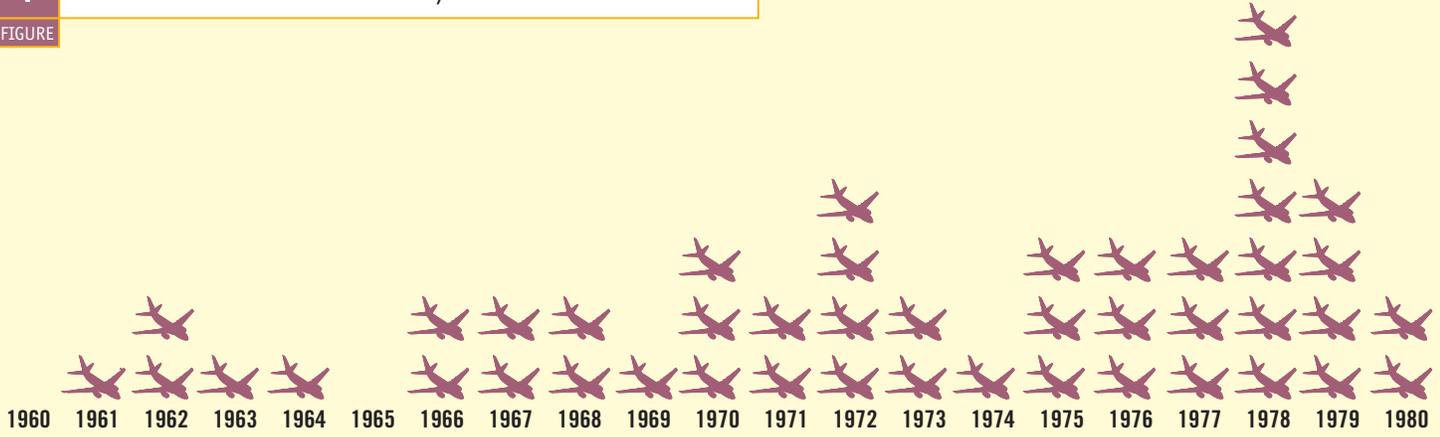
FIGURE

1 94 RTO OVERRUN ACCIDENTS/INCIDENTS SINCE 1959

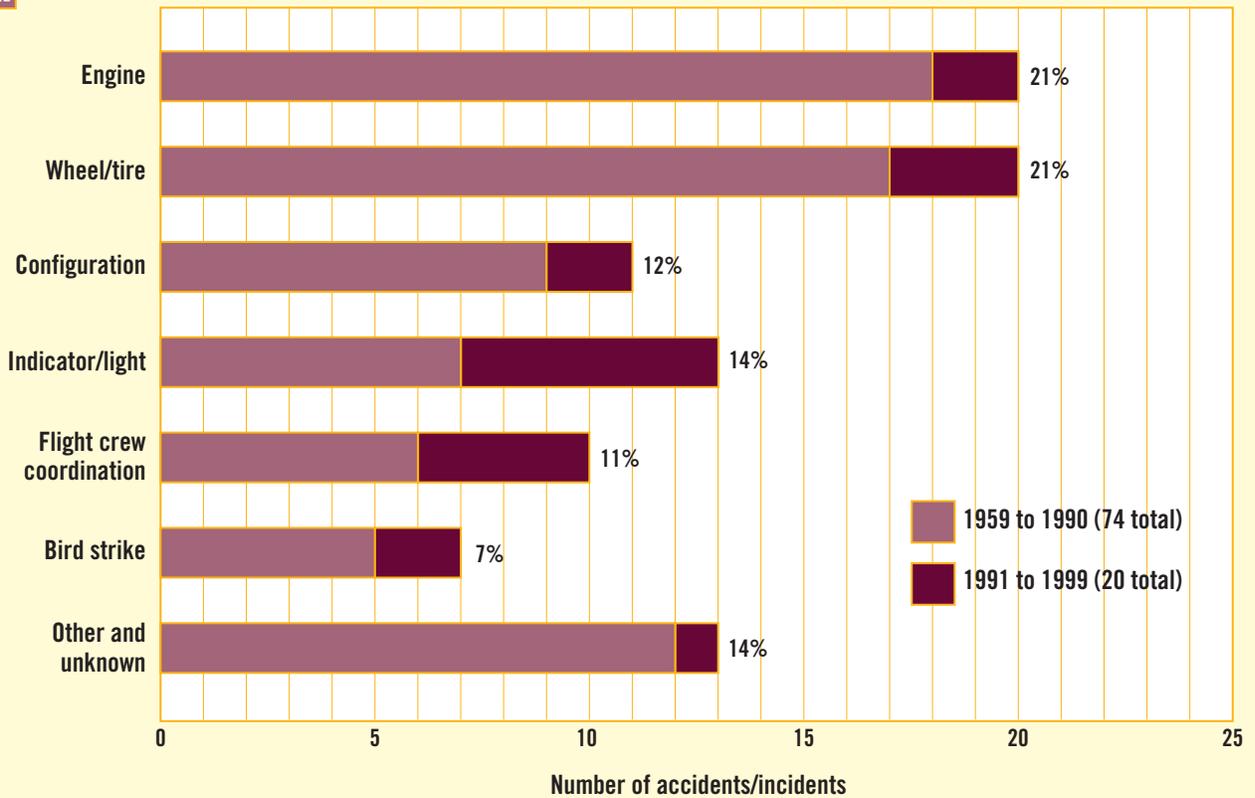
FIGURE

2 REASONS FOR INITIATING RTO (94 ACCIDENTS/INCIDENTS)

Compared to the 1960s, the 1990s showed a 78 percent decrease in the rate of RTO overrun accidents and incidents.

✈ Overruns included in TOSTA study, 74 total
 ✈ Overruns since TOSTA study, 20 total

Figure 5 in sections 2 and 4 of the TOSTA shows a chart describing seven categories of reasons for initiating an RTO in the 74 cases listed in appendix B. Figure 2 in this article incorporates the additional 20 RTO events that occurred from April 1990 through December 1999. It shows that the percentage of RTO accidents and incidents precipitated by perceived or real engine failures dropped slightly to 21 percent from 24 percent. The figure also shows an increase in the percentage of RTO events related to tire failures (real or perceived), lack of flight crew coordination, and indicator/light problems.

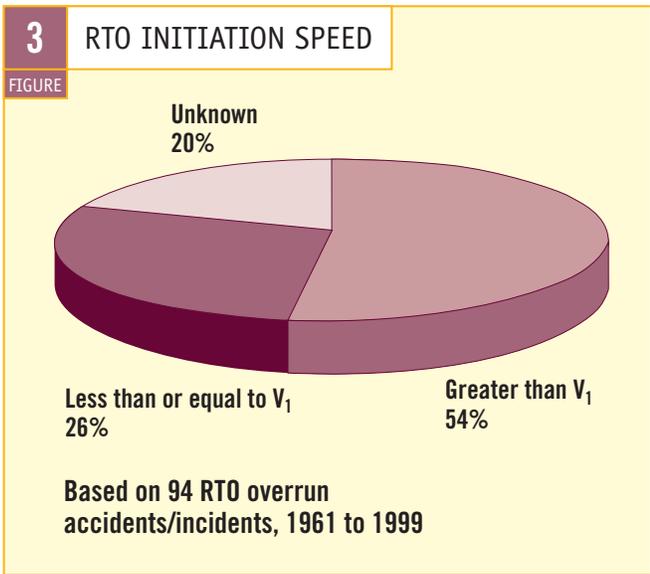
Figure 4 in sections 2 and 4 of the TOSTA shows a distribution of speeds at which the overrun RTOs were initiated and a breakout of the reported runway condition for the 74 cases in the study. Figure 3 in this article shows the breakout of RTO initiation speed for the total 94 RTO accidents and incidents reported through the end of the 20th century. The number of overrun events that began after V_1 remains at more than 50 percent. Figure 4 in this article

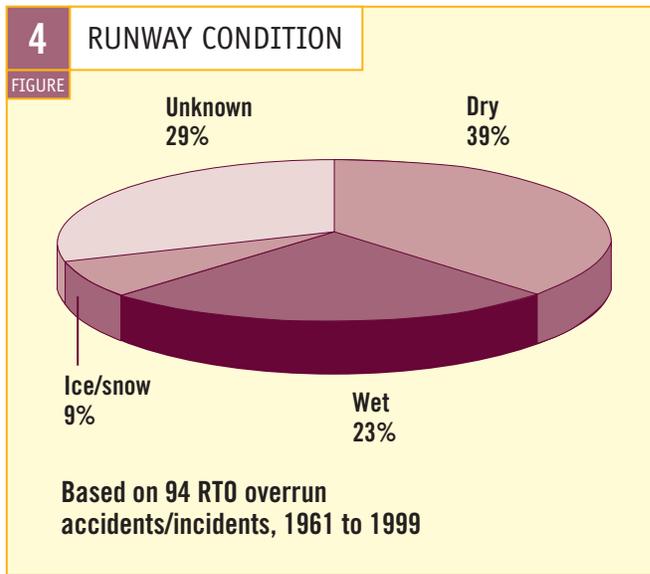
shows the updated percentages for the runway condition. These numbers remain fairly constant, with 39 percent of RTO events occurring on dry runways and 32 percent of them occurring on wet or contaminated runways.
