# VOLCANIC ASH AVOIDANCE

*Original idea from Thomas Casadevall & Thomas Murray*

**A commercial aircraft encounter with volcanic Ash can threaten safety of flight because of resulting conditions that can range from windshield pitting to loss of thrust in all engines. Developments in technology and communication networks have significantly decreased the probability of such an encounter in the last several years. Despite these developments, however, a 737-700 recently flew through a volcanic ash cloud. Updated information about advancements in ensuring safe operations and minimizing damage to the airplane during a volcanic ash encounter is now available to flight crews.**

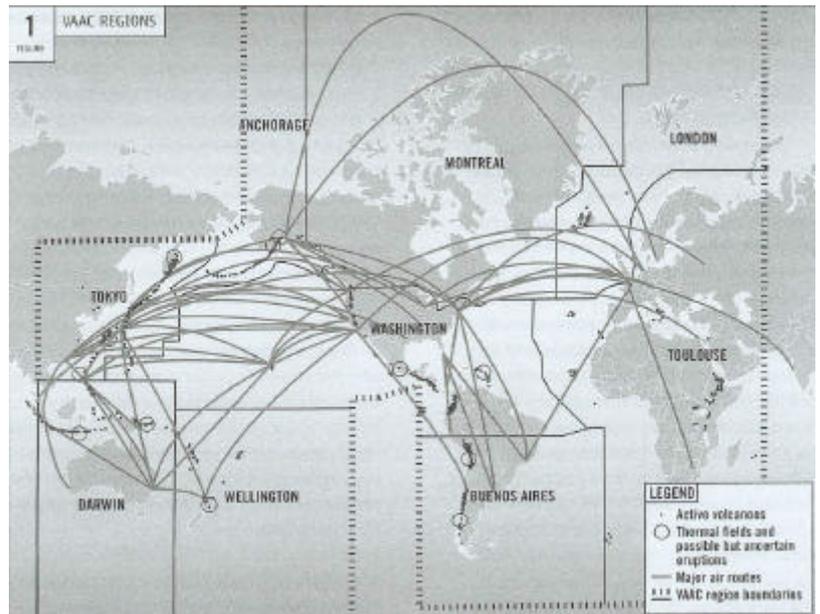
One of the outcomes of this initial meeting is the availability of today's Volcanic Ash Advisory Centres (VAAC). The VAACs provide an important link among volcano observatories, meteorological agencies, air traffic control centres, and operators. A total of nine VAACs observe and report on a particular region of the world (figure 1). One product of the VAACs is the Volcanic Ash Advisory Statement (VAAS).
