## Challenger With Frost on Wings Enters Uncontrolled Roll on Takeoff

*The report said that the judgment and concentration of the flight crew, who were aware of the wing contamination but did not have the aircraft deiced before departure, might have been impaired by the combined effects of a nonprescription drug, jet lag and fatigue.*

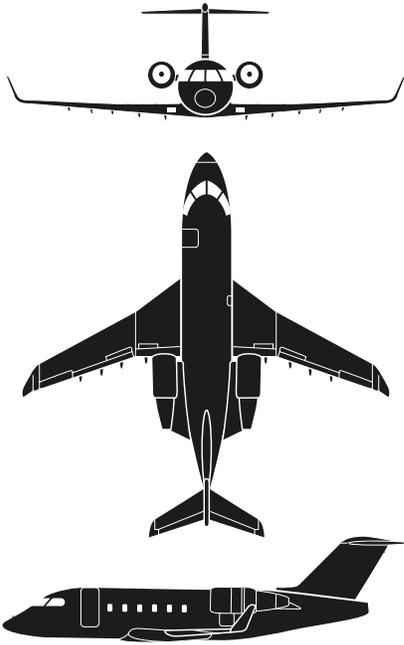
### Bombardier Challenger 604

Canadair was a subsidiary of General Dynamics Corp. when it was acquired by the Canadian government in 1976. The same year, Canadair acquired the rights to William P. Lear's LearStar 600; the company made several design changes — including a larger fuselage for more cabin space, a larger wing to accommodate more fuel and a T-tail — and renamed the twin-turboprop executive transport the Challenger 600. Deliveries began in 1980. Canadair, which was acquired by Bombardier in 1986, also used the Challenger design as the basis for a series of regional jets, which first entered service in 1992.

The Challenger 600, which has AlliedSignal (now Honeywell) ALF 502L-2 engines, was replaced in 1983 by the Challenger 601, which has General Electric CF34-3A engines and winglets. Production of the Challenger 601 was terminated in 1996.
