Cockpit Coordination, Training Issues Pivotal in Fatal Approach-to-Landing Accident

The crash of an Indian Airlines Airbus A320 underscored safety issues ranging from cockpit resource management to airport emergency procedures.

Editorial Staff Report

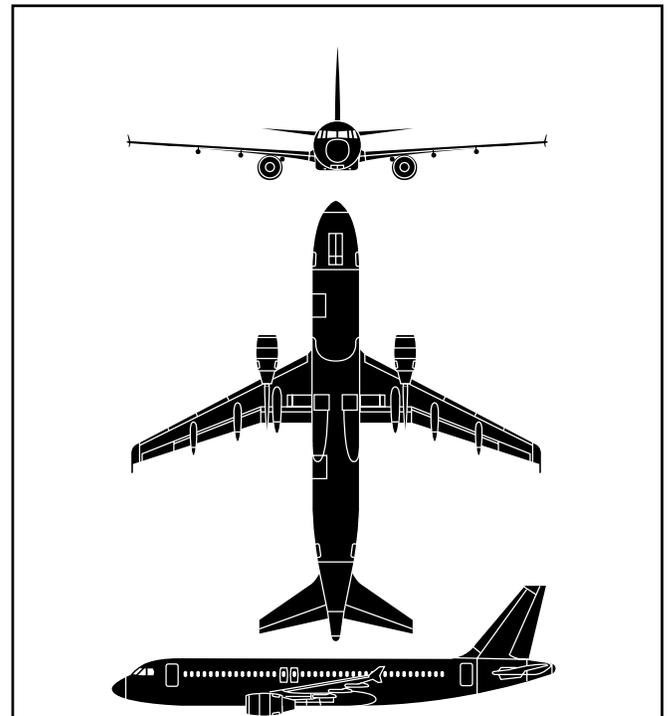
The twin-engine Airbus A320 was first flown in 1987. The short/medium range jetliner is built jointly by Aerospatiale in France, Deutsche Airbus in Germany, British Aerospace in the United Kingdom, Belairbus in Belgium and CASA in Spain. The A320 uses a fly-by-wire control system and side stick controls in place of the usual control columns in the cockpit. Its range with CFM56 engines and 150 passengers is 3,302.4 miles (5,318 kilometers).
