## B-737 Crew's Unstabilized Approach Results in Overrun of a Wet Runway

*Air traffic control instructions caused the Boeing 737 to be high, fast and close to the runway when the crew conducted a turn to establish the airplane on final approach to Burbank, California, U.S. Investigators concluded that the flight crew's only safe option at the time was a go-around.*

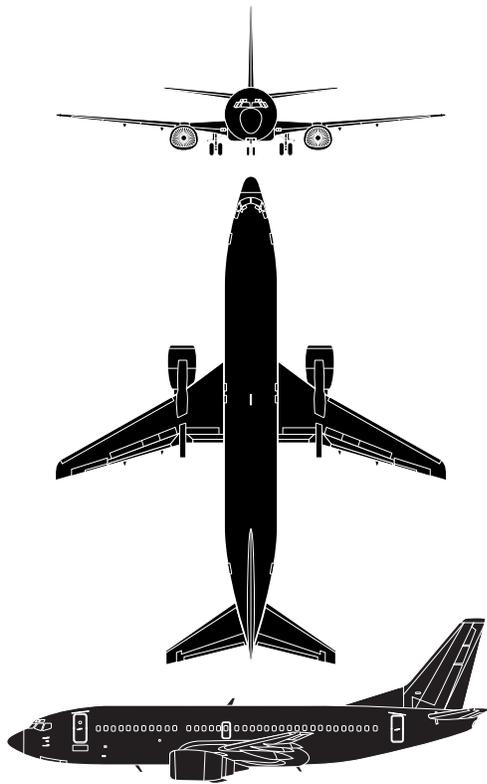
### Boeing 737-300

The Boeing Co. in 1965 announced the decision to build a short-range, twin-turboprop transport. The aircraft, designated the 737, was designed to use many components and assemblies from the tri-engine B-727. The first B-737 flew in April 1967, and deliveries of the first production model, the B-737-200, began before the end of 1967.

The Pratt & Whitney JT8D-9A engines, each producing 14,500 pounds thrust (64.5 kilonewtons), on the B-737-200 were replaced with CFM International CFM56-B engines, each producing 20,000 pounds thrust (88.97 kilonewtons) on the B-737-300.
