## B-757 Damaged by Ground Strike During Late Go-around from Visual Approach

*Deviations from standard operating procedures, deficient crew resource management and crew distraction were cited as factors in a controlled-flight-into-terrain accident that caused substantial airplane damage but no injuries.*

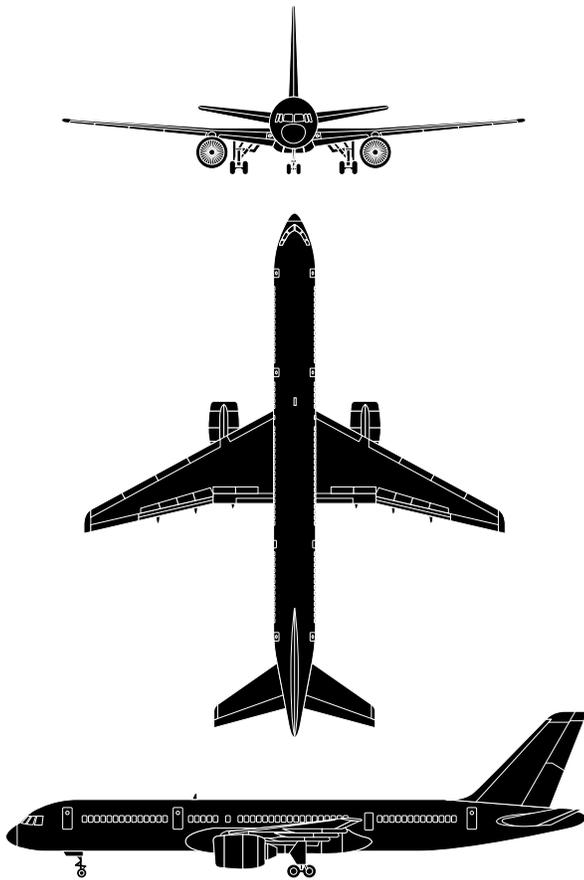
## Boeing 757

The Boeing 757-200 series is a medium-range airliner designed to carry 186 passengers in a typical mixed-class configuration. The B-757 can accommodate up to 239 passengers in charter service, putting its capacity between that of the Boeing 737-400 and the Boeing 767. A longer range version and a freighter configuration of the B-757 are also available.

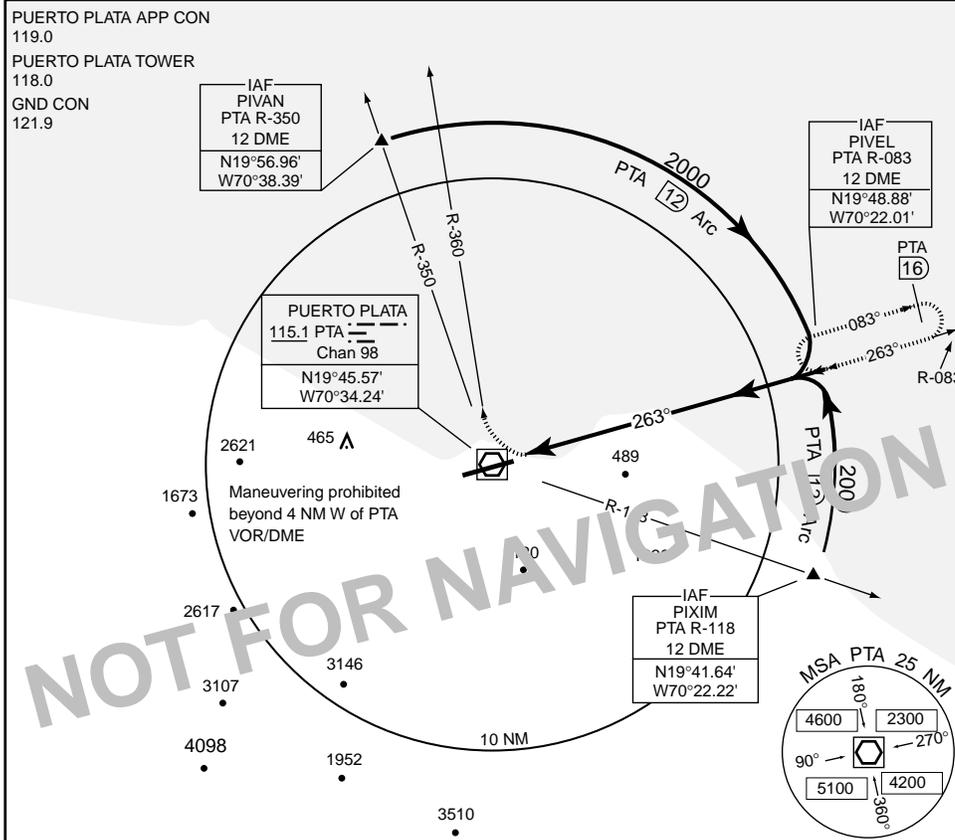
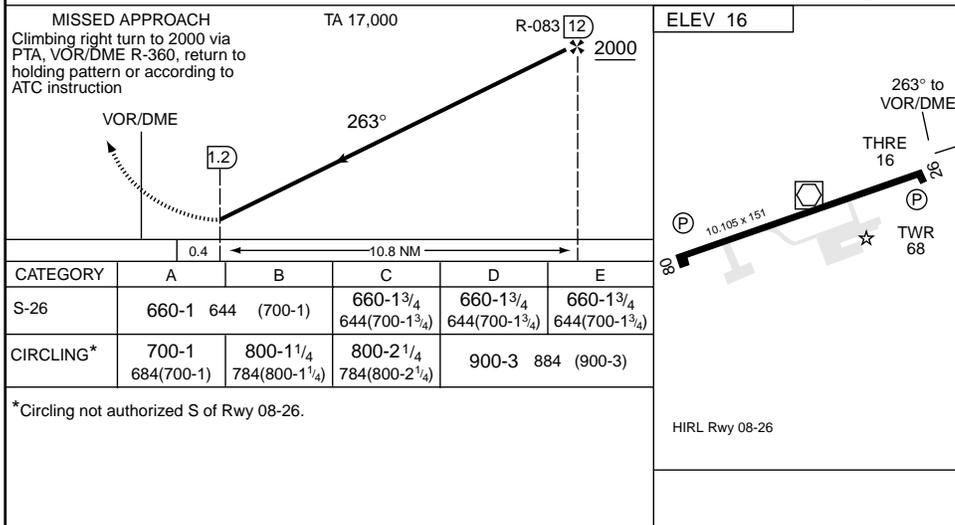
## VOR/DME RWY 26

[USA] AL-2518 [DGAC]

GREGORIO LUPERON INTL (MDPP)  
PUERTO PLATA, DOMINICAN REPUBLIC

19° 46' N-70° 34' W

“The FO asked the commander if he was intending to land on Runway 26 or [to] do a tear-drop turn to position [the airplane to land on] Runway 8. The commander confirmed that the circuit was for Runway 26, since he was confident that this approach was clear and he was unsure about the weather conditions on the approach to Runway 8,” said the report.
