## Absence of Aircraft Load Data Cited in Failed Takeoff in Benin

*No documents accurately showed the B-727's weight and balance. The airplane's takeoff weight likely was higher and its center of gravity likely was farther forward than the values calculated by the flight crew. High-density-altitude conditions prevailed during the attempted departure from a relatively short runway.*

FSF Editorial Staff

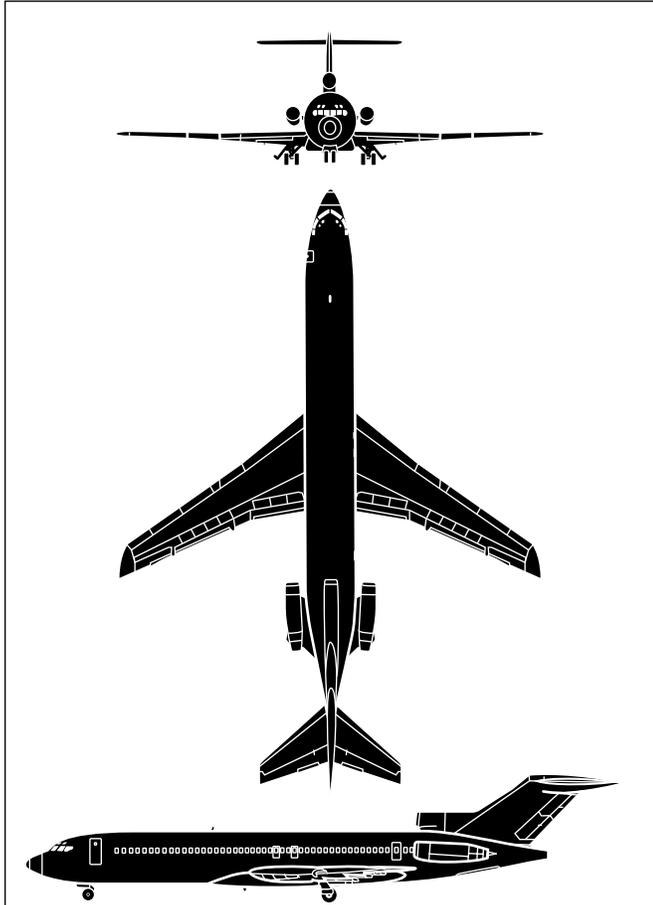
### Boeing 727-200

The three-engine, short/medium-range B-727 was introduced into service in 1960. The B-727-200, introduced in 1967, is a "stretched" version, with three-meter (10-foot) fuselage extensions both forward and aft of the main landing gear wheel wells.
