Wind Shear Sends Commuter Aircraft Plunging Out of Control

When the captain elected to continue the approach through known thunderstorm activity, tragedy was only minutes away.

—
Editorial Staff Report

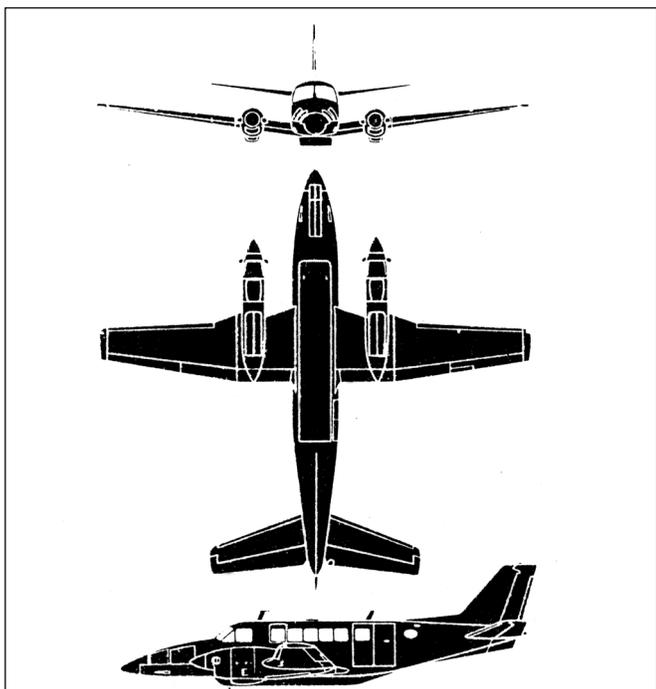
Beechcraft C99 Airliner

The B99, the predecessor of the C99, first flew in 1966 and deliveries began in 1968. A large main cargo door allows the aircraft to be used for either all-cargo or cargo/passenger operations. The C99, with increased power and systems refinements, was first delivered in 1981.
